## Conservation of Azimganj Serai

# AZIMGANJ SERAI

Conservation | Landscape Development

## Azimganj Serai: Conservation & Landscape

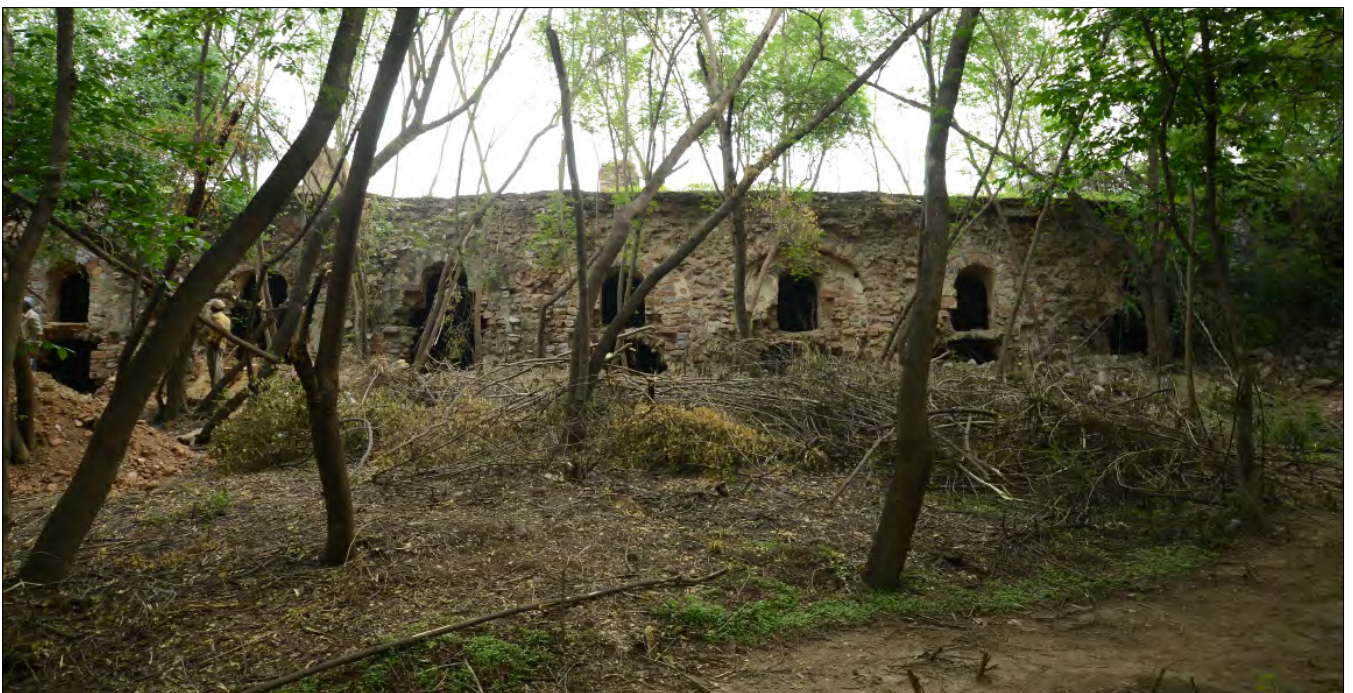
*(Below) Azimganj Serai: before conservation in 2010. Conservation works on this monument, protected by the Department of Archaeology, Government of Delhi are also being carried out with their co-funding.*

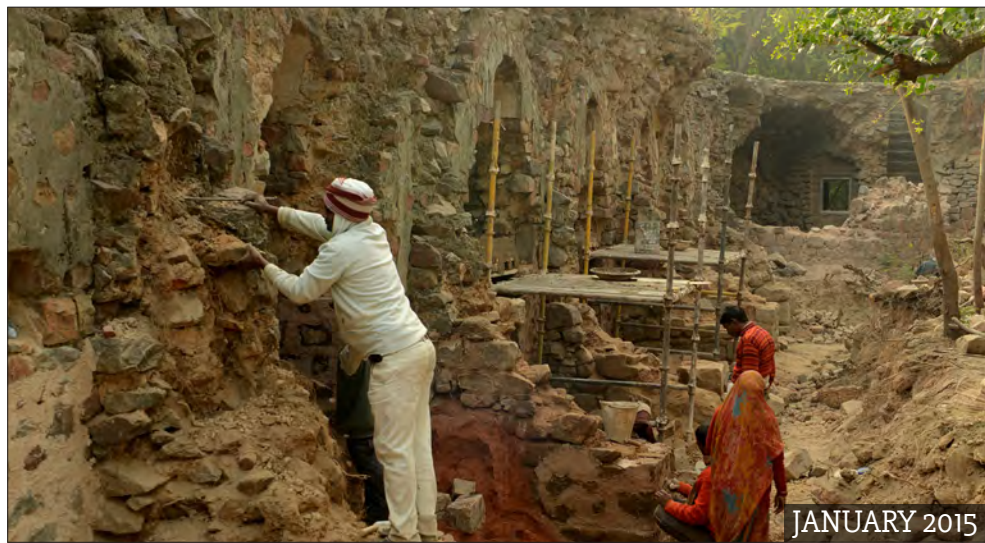
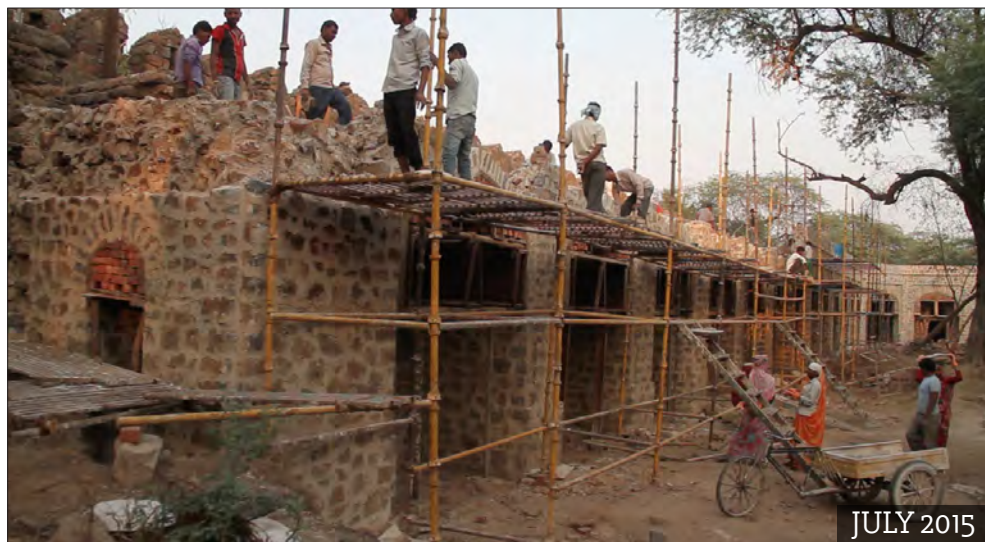
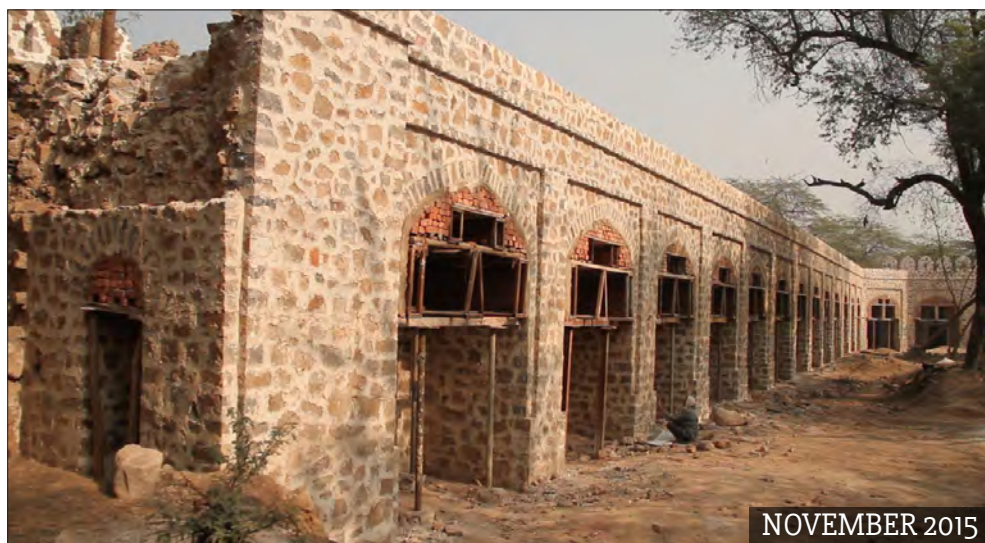
*(Above) Collapsed portion of the Serai were carefully stabilized by master craftsmen building with techniques and materials used by the original builders.*

- Conservation works in 2015 were carried out on 27 chambers in the South-eastern corner and 28 chambers in the North-western corner of the monument.
- Stone rubble masonry works for reconstruction of 52 of these partially collapsed rooms have been completed. This work required great precision and care as in some cells nearly 40 percent of the structure had collapsed and thus standing portions were unstable and was in urgent need of conservation.

- Deep filling and careful stitching with stone of large cracks in the structure has been done all across the structure.
- Specialised shuttering is being used for conservation of arches, vaults and domes, thereby ensuring consistency of profile and reducing time spent in scaffolding works.
