AGA KHAN TRUST FOR CULTURE

**CHAUSATH KHAMBA CONSERVATION**

Aga Khan Trust for Culture,  
with co-funding of Federal Republic of Germany, New Delhi  
and in partnership with the Archaeological Survey of India  
undertook the conservation of Chausath Khamba during 2011-2014.

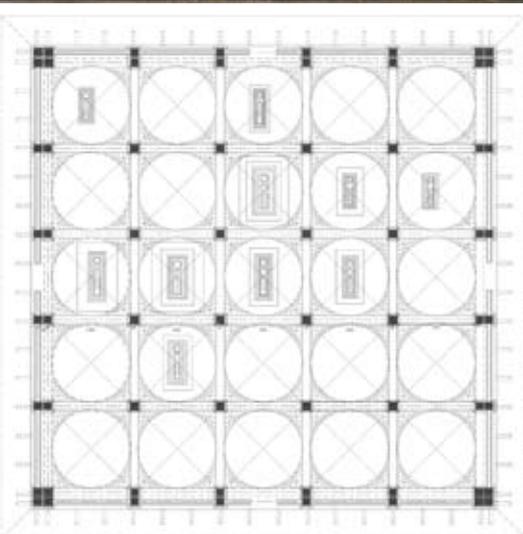
(Top) 19<sup>th</sup> century archival painting of Chausath Khamba; (Middle) A detailed architectural documentation of the structure, and (Bottom) stone-by-stone assessment of the structure showing cracks and condition of the domes prior to commencement of conservation works in 2011

A high definition survey, using 3D laser scanning technology, was carried out on the structure as a precursor to conservation works. This was followed with a stone-by-stone assessment of the entire structure to map the profile and defects on each individual stone coupled with photo and video documentation. To complete a structural analysis pits were dug to study the foundations – which were surprisingly found to reach a depth greater than five metres.

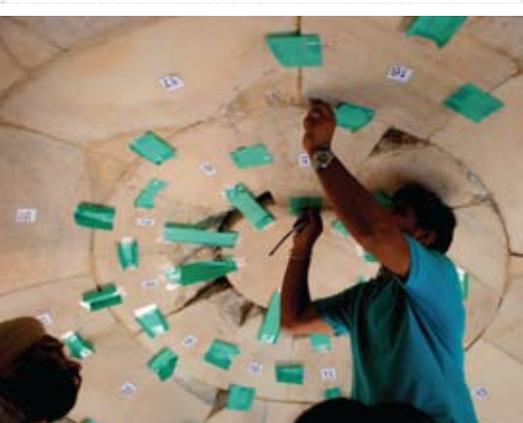
The study of the structure revealed that over 80% of the stone blocks had severe cracks and past repairs had inappropriately only filled up burst portions of stone blocks with white cement – masking the damage but allowing the deterioration to accelerate.

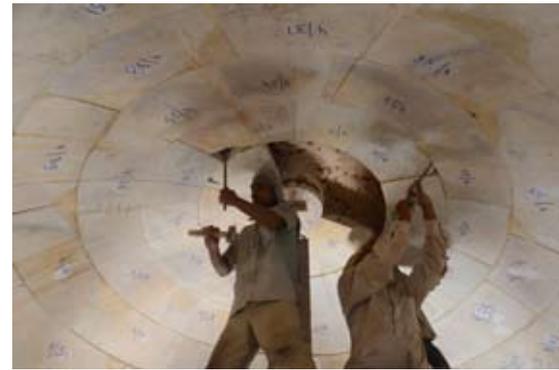
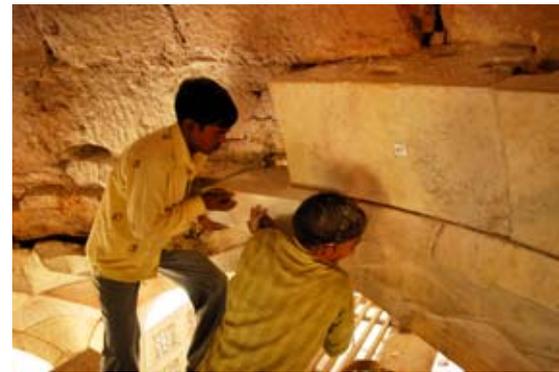
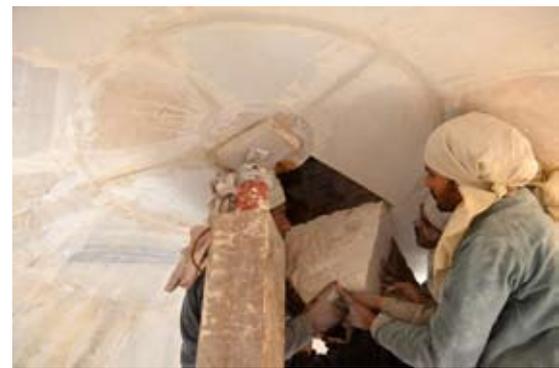
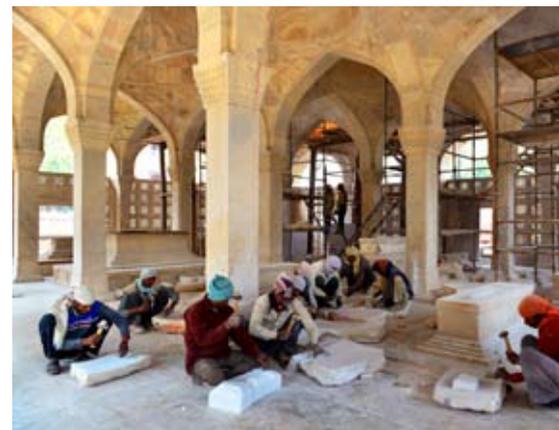
The multi-disciplinary conservation team comprising experienced engineers, craftsmen and conservation architects could only access the iron dowels from below as the documentation had revealed over 1m thick masonry above the marble domes. Each stone was thus required to be numbered and mapped.

Once a specially designed support framework was built, the keystone was held in place and rings of marble blocks were dismantled and carefully reassembled on the floor. Iron dowels manually removed and stone indents of matching size prepared for corners which had burst.

(Above) Various stages of conservation of one dome: 1. Numbering each stone; 2. Dismantling the marble blocks and repairing of cracks in the masonry; and 3. Repair of marble blocks with indents of matching stone where these had burst by master craftsmen using tools, techniques used by the original builders and 4. Re-installation of marble blocks in the original location.

The stone carvers, using traditional tools and building techniques took eight months to successfully repair the first dome – on the northwest corner – thus establishing the repair methodology for the mausoleum. This allowed urgently needed repairs on the roof to be taken in hand – first dismantling the cement layers applied in the 20<sup>th</sup> century and once the cracks had been cleaned, stitched and filled with lime grout a layer of lime concrete with traditional additives such as brick aggregate was laid to slope.

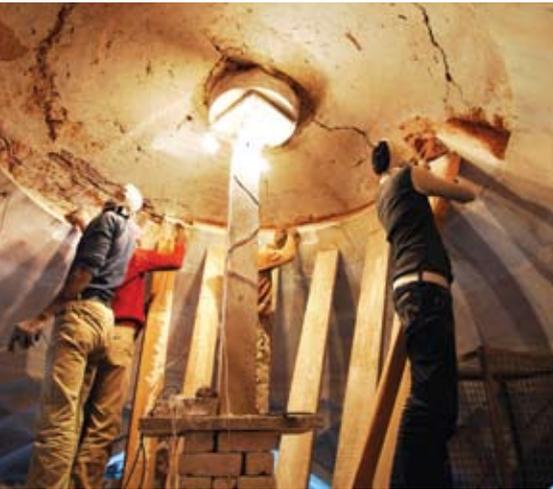
The brick masonry above the marble domes was found to have severe cracks, often over 1 m deep and up to 112 cm in width. The cracks were stitched with similar material and lime grout from the roof above used to fill inaccessible portions.

*The manner in which this complicated conservation work was undertaken bears remarkable tributes to Indian master craftsmen. (Top) Stitching and grouting of cracks in the masonry while dismantling marble blocks for repair; (Middle) Cracks on the terrace were allowing water penetration and resulting damage; (Bottom) repairs on the roof by adding a layer of lime concrete with traditional additives like Jaggery and Bael fruit pulp.*

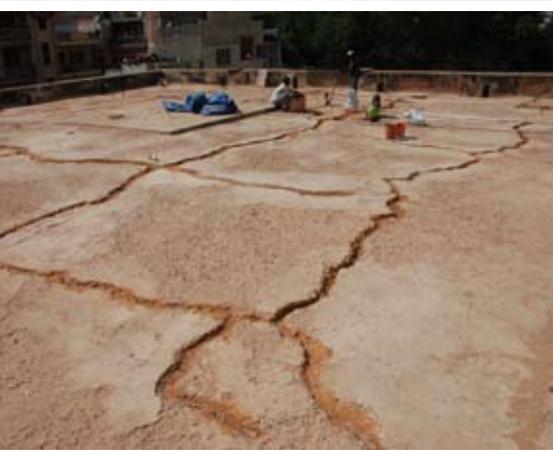
The marble blocks of the 25 domes were tied to one-another and embedded in the brick masonry over the domes with iron dowels. The rain water spouts from the inaccessible roof got blocked resulting in large quantities of rain water collecting on roof. This resulted in the rapid deterioration of the roof and large scale water ingress from the roof leading to the corrosion, rusting and expansion of the iron dowels. The significant pressure from the expanding iron dowel led to bursting of the marble blocks in all parts of the mausoleum – domes, arches, facade, pendentives and even the column capitals – threatening structural failure and collapse of the structure.
