Humayun's Tomb - Sunder Nursery - Nizamuddin Basti  
URBAN RENEWAL INITIATIVE

# ISA KHAN'S TOMB - GARDEN

# ORNAMENTAL CEILING

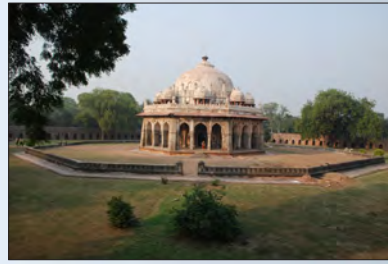
*The striking Mosque within the garden-tomb has a sandstone façade and a lofty central dome. The three bay wide structure has a large plinth with a contemporary well.*

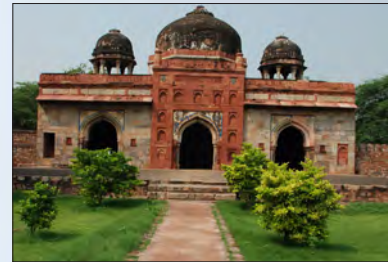
*The gateway would have had a lofty entrance arch and the interior side has three vaulted bays. Past repairs have obliterated all original details on the façade.*

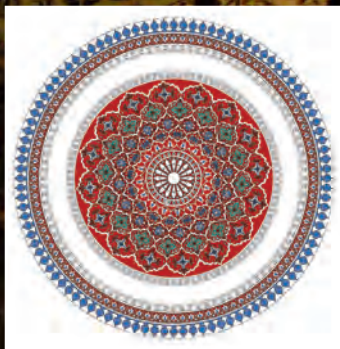
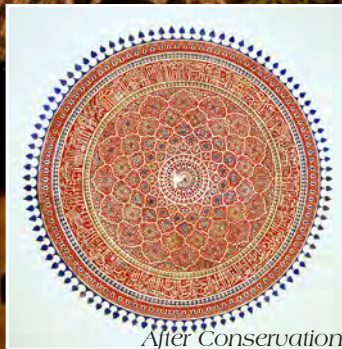
The highly ornamental ceiling of Isa Khan's Tomb had suffered severe decay due to neglect and water ingress. Also with the dome white-washed and cement plastered, it was too dark for the ceiling to be visible. Careful restoration of the ornamentation has been carried out by master craftsmen and the cement plaster replaced with lime plaster thereby significantly enhancing the historic character of the tomb chamber.

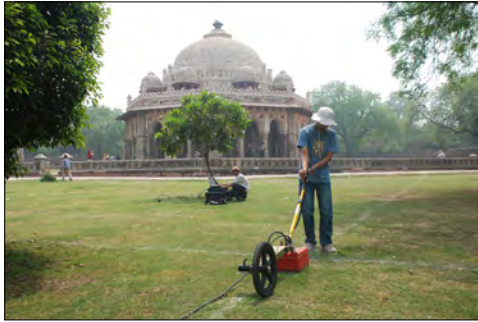
Ground Penetrating Radar Survey

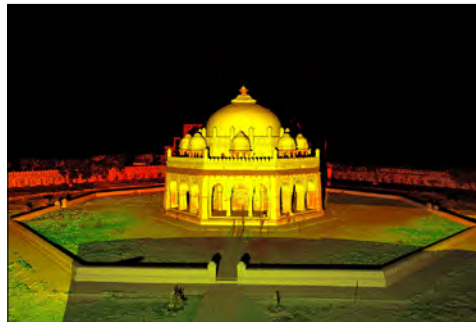
3-D High Definition Survey using laser scanning technology

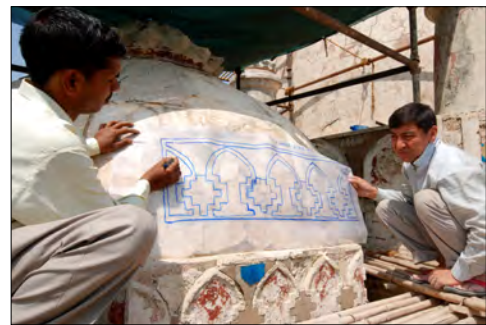
An exhaustive documentation of tile patterns on the canopies was carried out

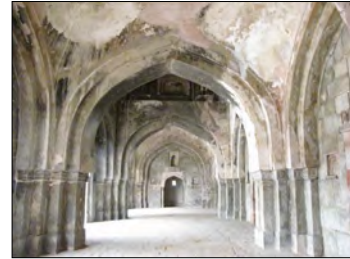
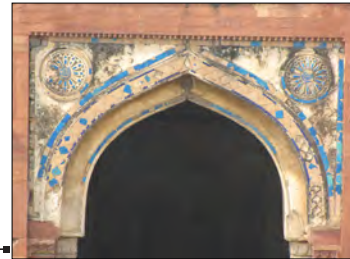
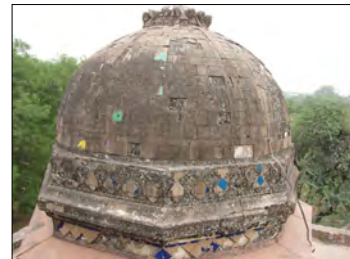
Prior to the commencement of conservation works, over 500 drawings including condition assessment were prepared, documenting each detail, including ornamental plasterwork and ceramic tilework in detail.

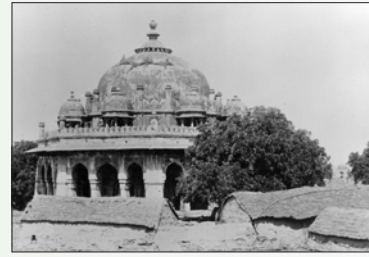
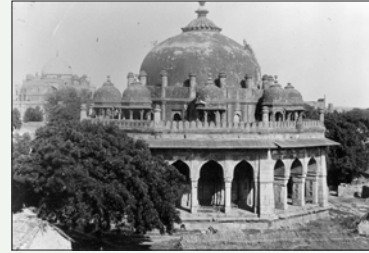
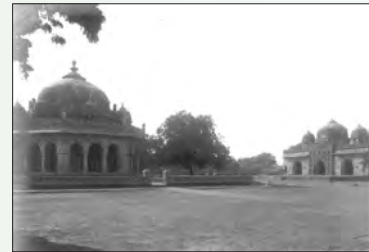
Early 19<sup>th</sup> century photograph of Isa Khan's Tomb depicting a complete finial on both the dome and the canopies, and the garden retaining wall.

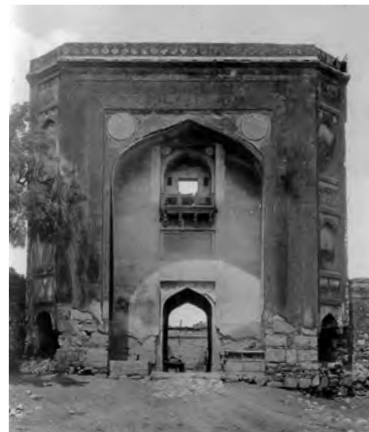
The profile of this arched gateway, together with the western enclosure wall before its demolition in 1916 is visible in the photograph taken by Samuel Browne from the roof of Humayun's Tomb looking westwards.

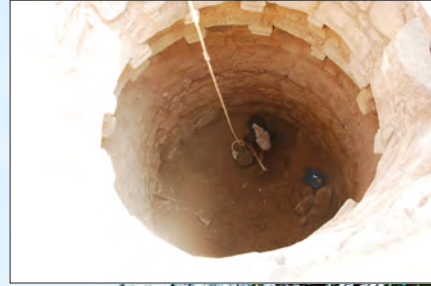
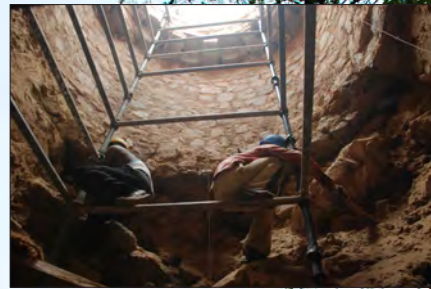
At least a dozen wells within the project area have been discovered and desilted to their original depth. These wells were filled-in in the 20<sup>th</sup> century when rubbish had made these useless to draw water.

A combination of traditional techniques of lowering skilled craftsmen into the well with buckets and use of modern technology such as use of pumps have been employed as well as structural repairs which followed after the clearance of rubble and earth which were dumped into the well in the 20<sup>th</sup> century.

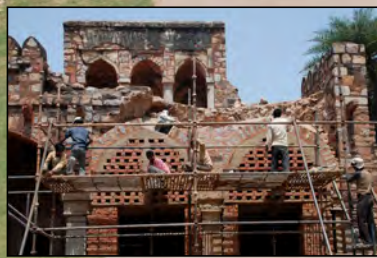
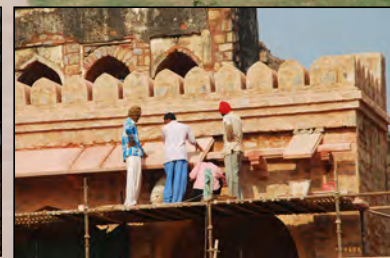
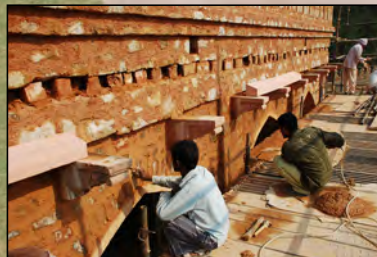
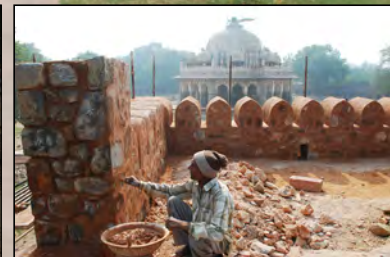
On the northern end of the complex is a gateway which allows entry to visitors. The outer façade of the gateway has suffered from inappropriate past repairs to an extent that the original details have been obliterated. The internal portion had mostly collapsed with the western bay still standing. Conservation works aimed at structural repairs and restoring the architectural integrity to the extent possible.

*Following structural repairs to the domed ceiling, the battlemented parapet wall was re-built using traditional materials, tools and building techniques*

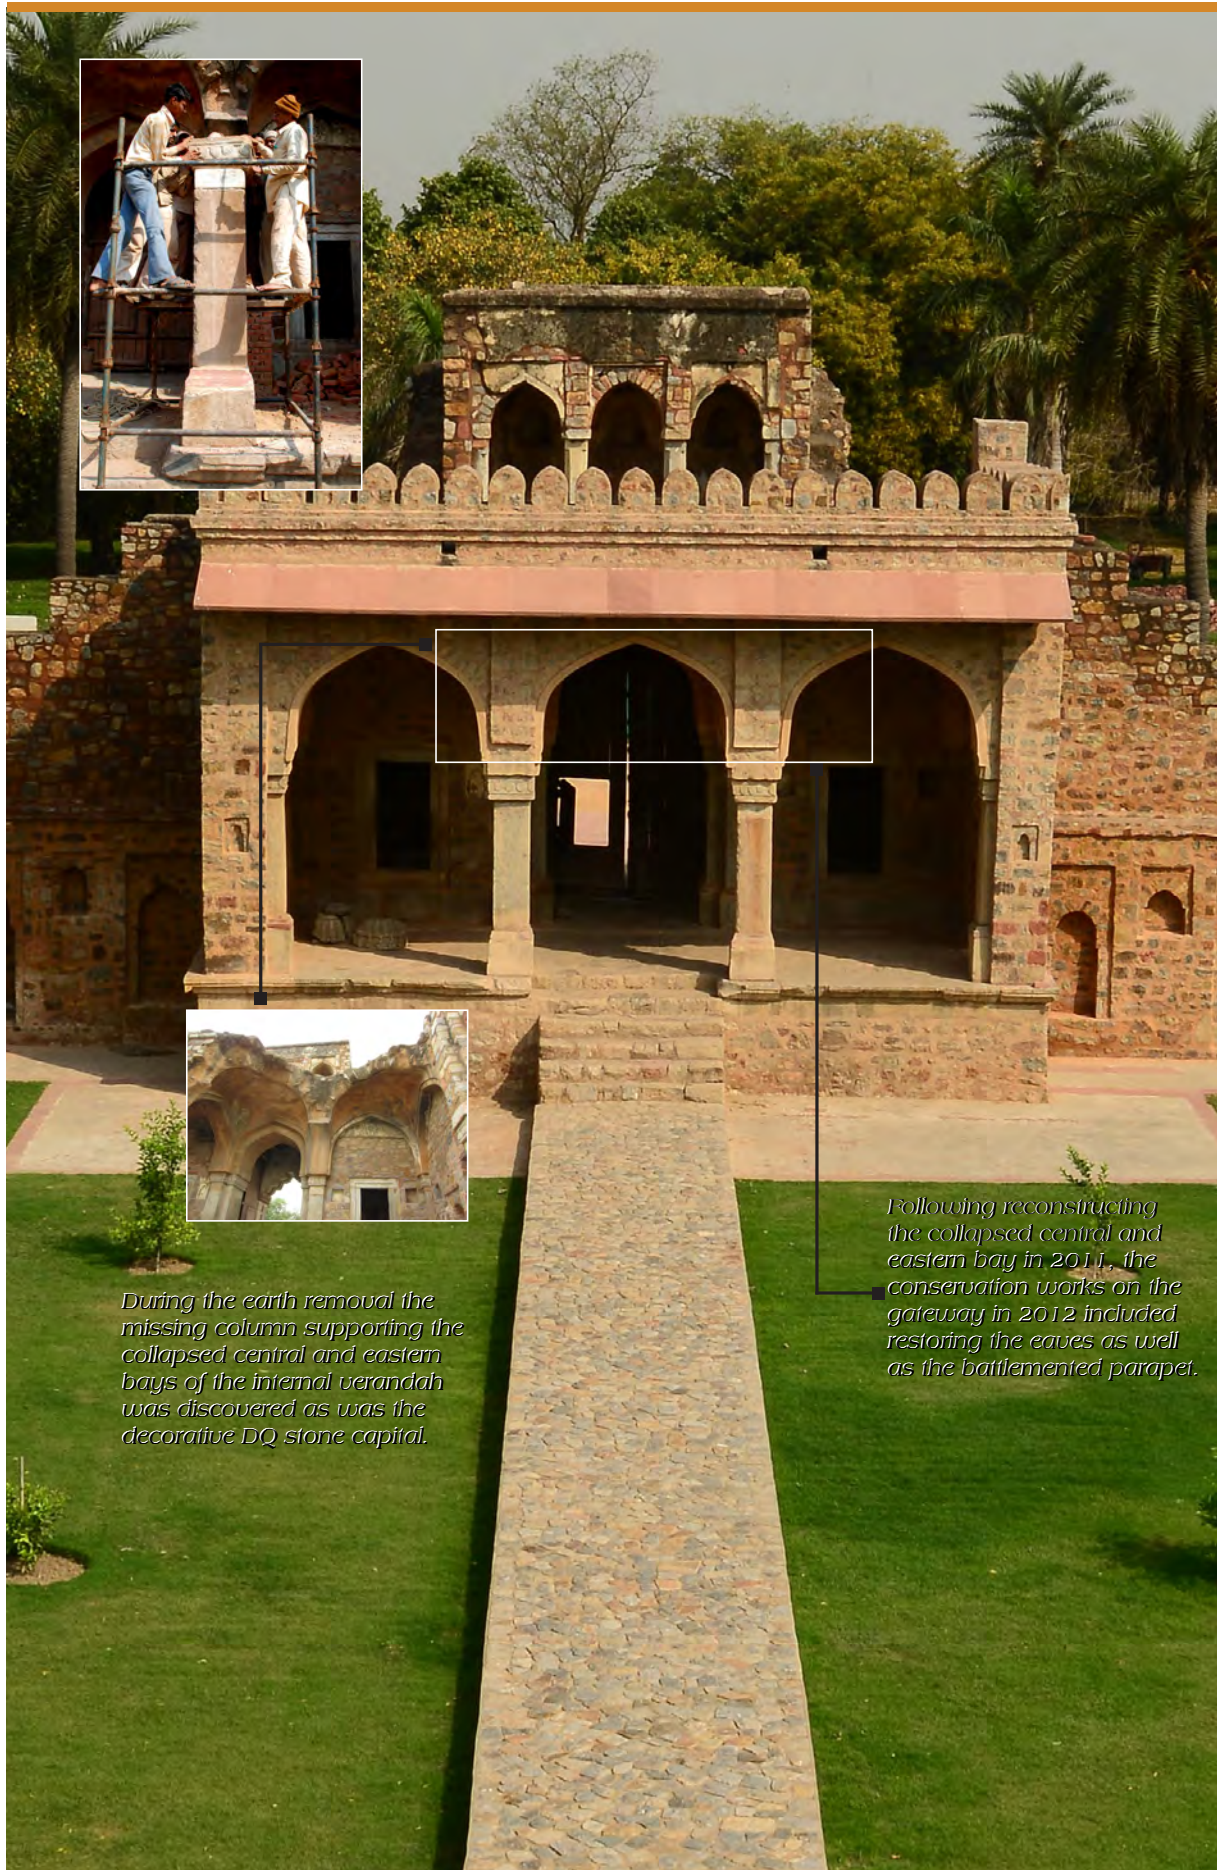
*During the earth removal the missing column supporting the collapsed central and eastern bays of the internal verandah was discovered as was the decorative DQ stone capital.*

*Following reconstructing the collapsed central and eastern bay in 2011, the conservation works on the gateway in 2012 included restoring the eaves as well as the battlemented parapet.*

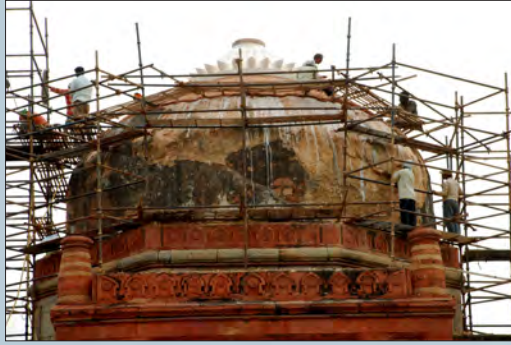
Within the tomb-garden stands an imposing mosque on a raised plinth. As with the other structures in the complex, the mosque suffered on account of inappropriate repairs as well as loss of architectural elements such as the tile-work on the canopies.

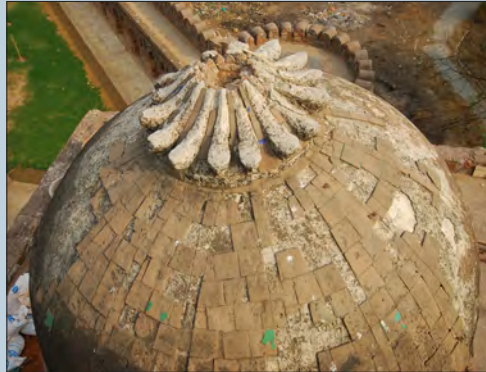
Remnants of tilework on the façade and the canopies

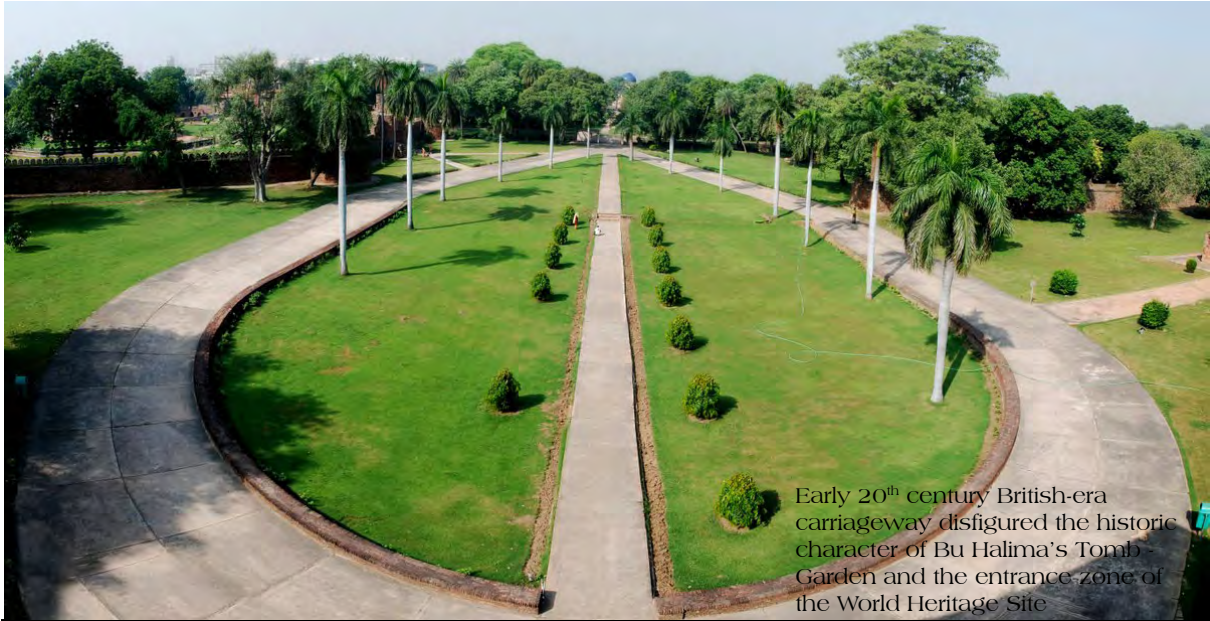
Early 20<sup>th</sup> century British-era carriageway disfigured the historic character of Bu Halima's Tomb - Garden and the entrance zone of the World Heritage Site
