BATASHEWALA - MUGHAL GARDEN TOMB COMPLEX

CONSERVATION REPORT
2011-2015

AGA KHAN DEVELOPMENT NETWORK

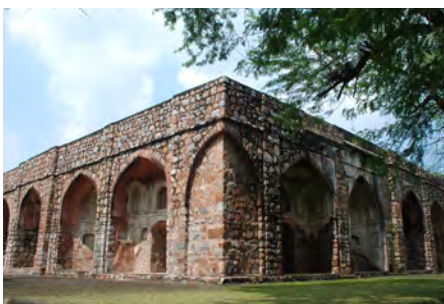
Mirza Muzaffar Hussain's Tomb
Before conservation in 2010

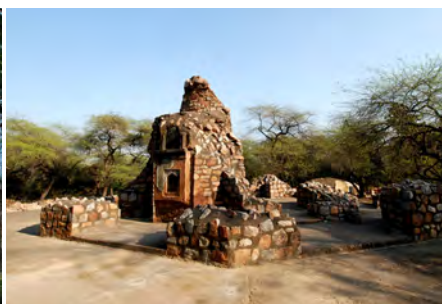
Chota Batashewala
Before conservation in 2010

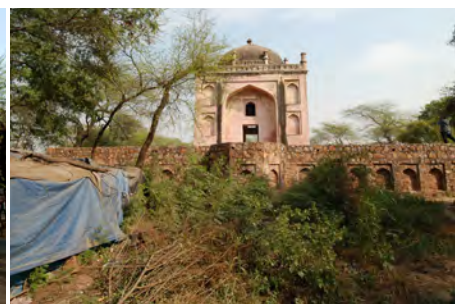
Mughal Tomb
Before conservation in 2010

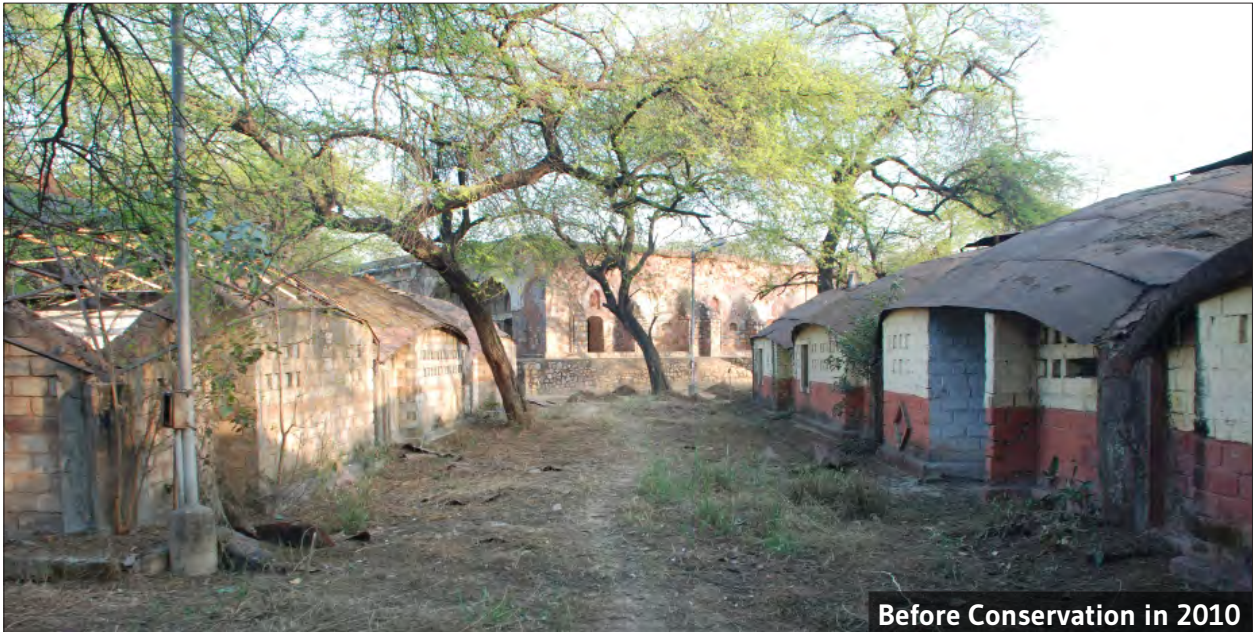
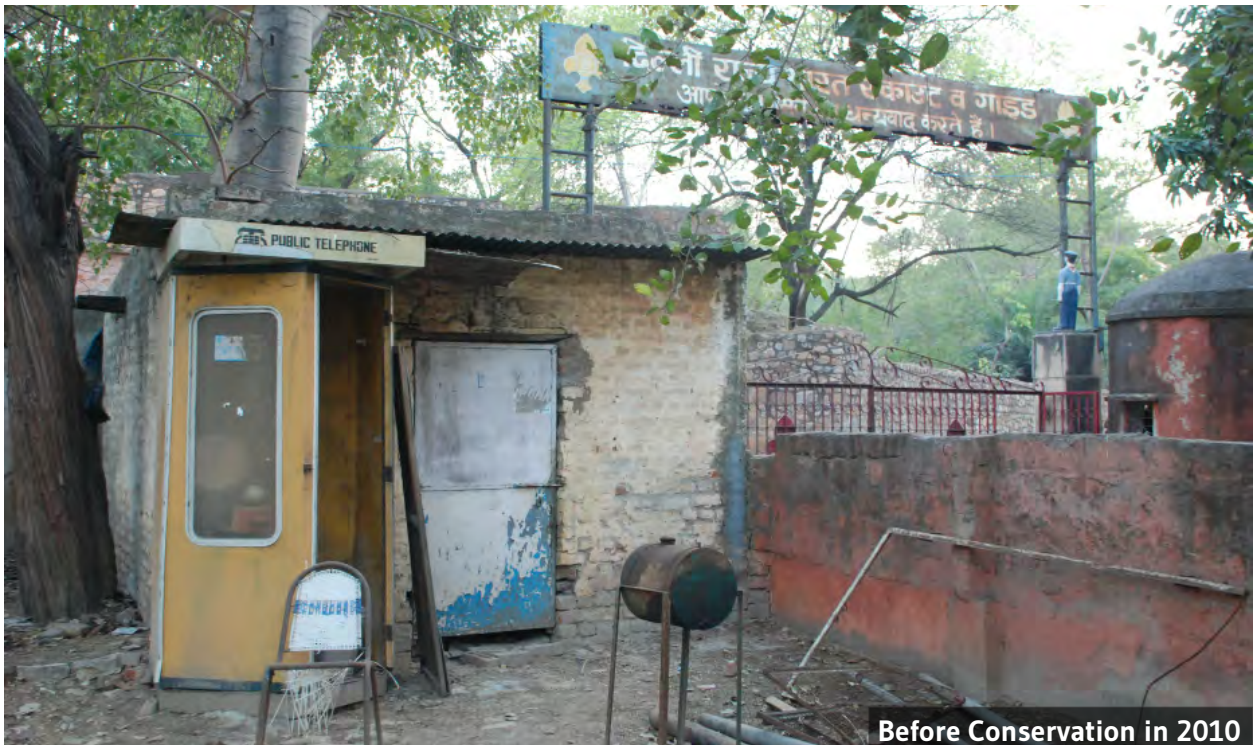
Batashewala Complex in 2010

In 1989, over 150 'temporary buildings' were erected within the enclosed gardens. Following over 10 years of effort by AKTC which included litigation, these were demolished in 2010 and land reclaimed by the Archaeological Survey of India.

The 1989 buildings erected by Bharat Scouts and Guides were built across the 11 acre mughal garden-tomb complex in close proximity to the monuments. Demolition of enclosure walls was also carried out to build these inappropriate structures.

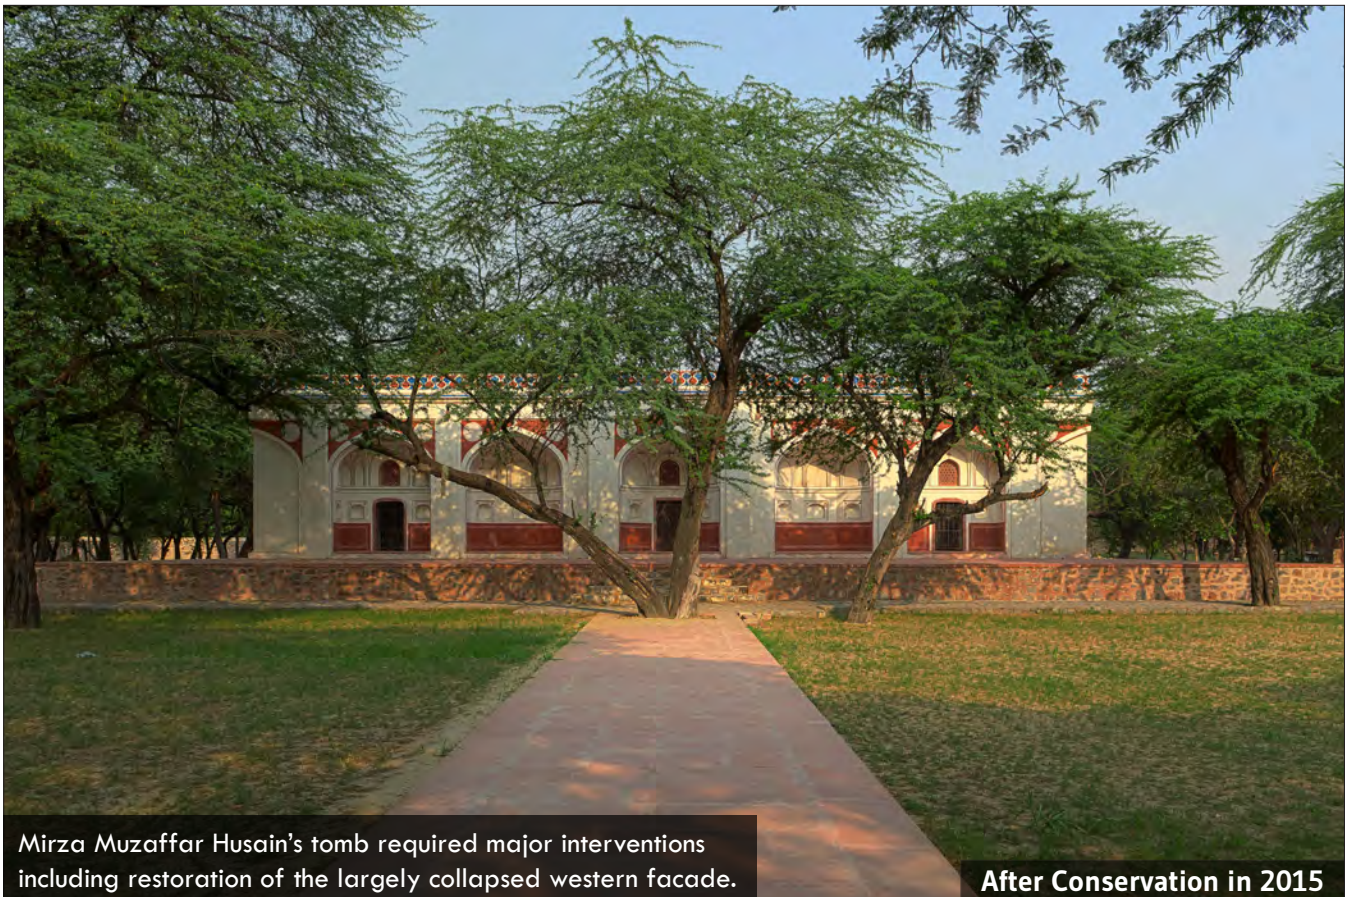
Mirza Muzaffar Husain's tomb required major interventions including restoration of the largely collapsed western facade.

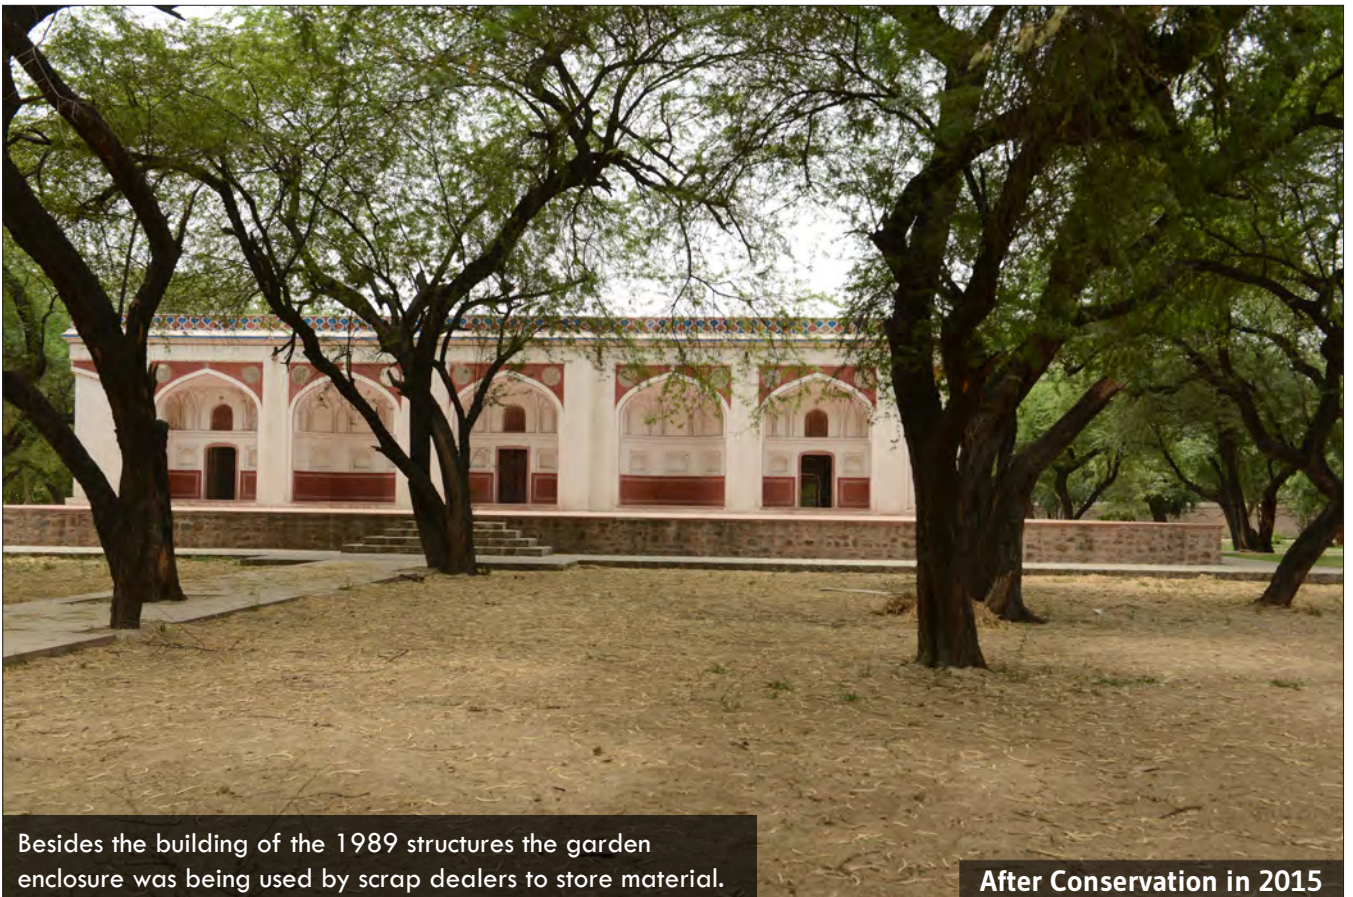
Besides the building of the 1989 structures the garden enclosure was being used by scrap dealers to store material.

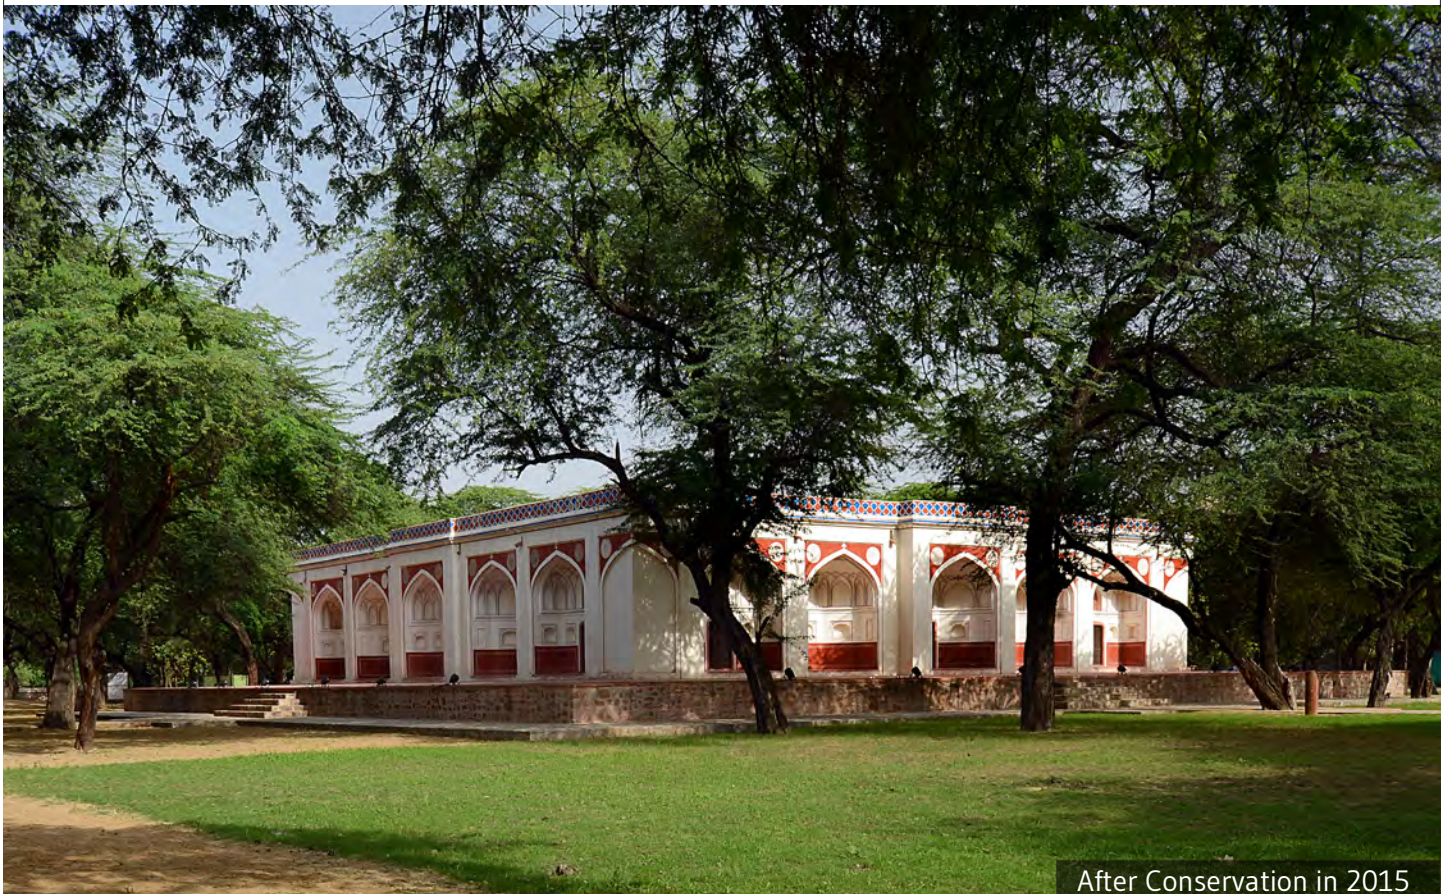
After Conservation in 2015

The southern facade (left corner of picture) of Mirza Muzaffar Hussain's Tomb inappropriately reconstructed by the Archaeological Survey of India in 2001-3 - using arches instead of half domes - required to be demolished prior to reconstruction as per original profile and construction.

The collapsed eastern facade was restored while the southern facade – inappropriately reconstructed only a decade ago – required dismantling and reconstruction as per the original design. Similarly, the roof, which had deteriorated, was required to be re-laid with lime concrete to create an adequate slope.

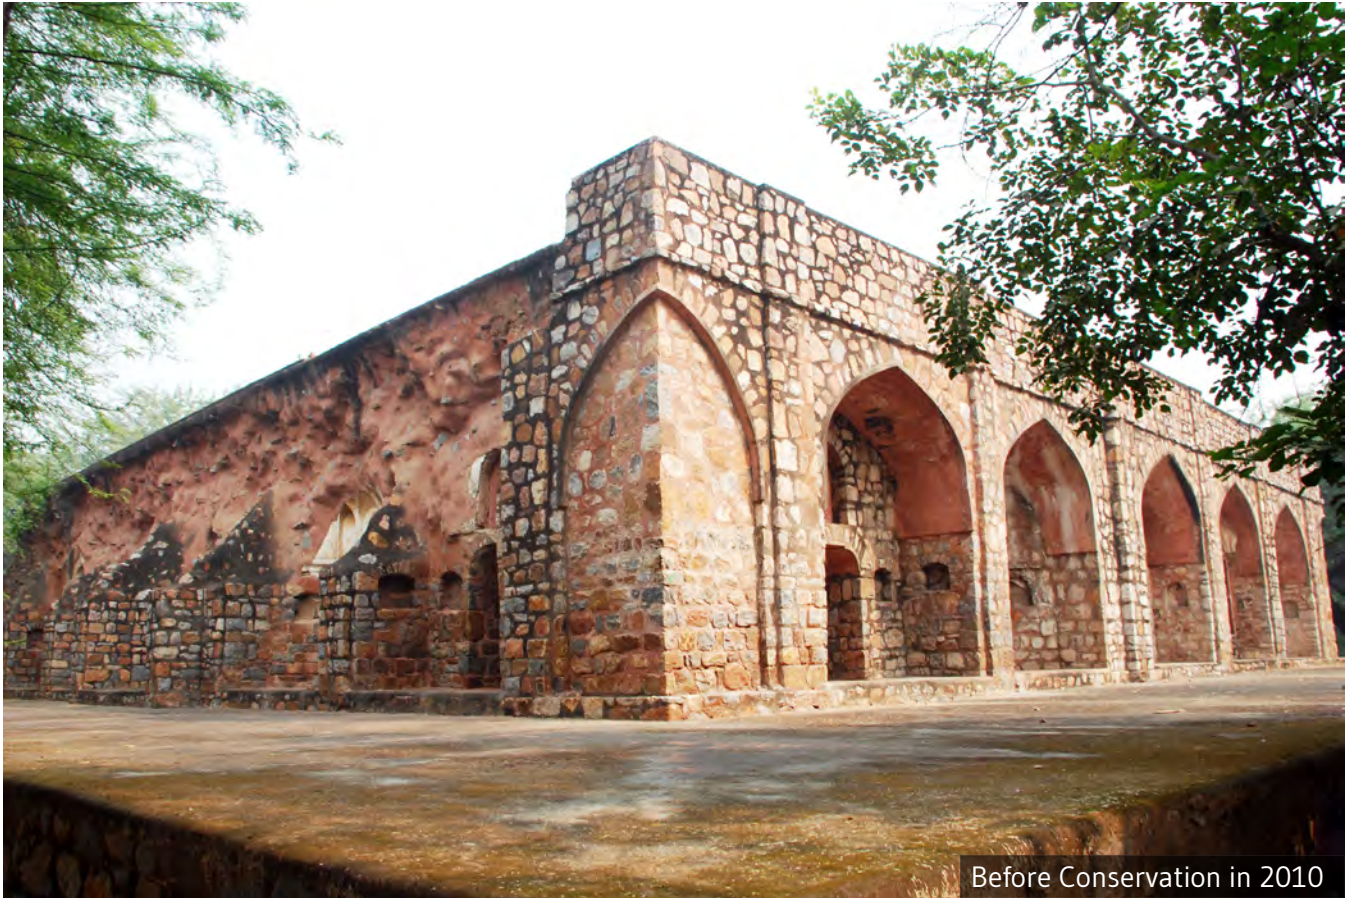
The western and southern facades of the structure required significant interventions to remove past inappropriate repairs and to ensure long term preservation of fast collapsing portions of the structure

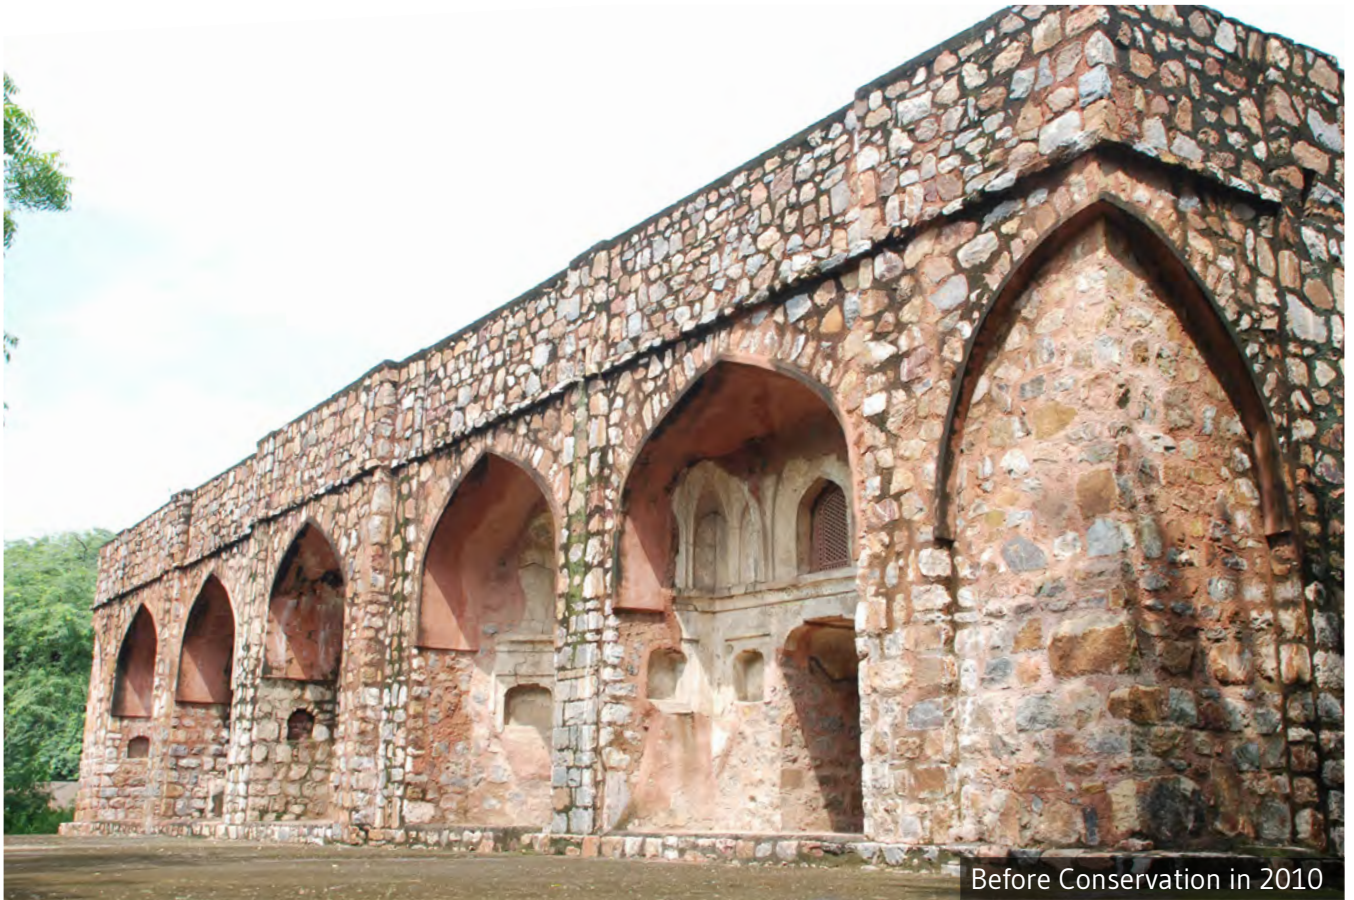
Before Conservation in 2010

Mirza Muzaffar Hussain's Tomb is symmetrical along its central axis and thus any half facade is repeated 8 times. Conservation of the collapsed western facade was largely carried out on the basis of the standing eastern arcade.

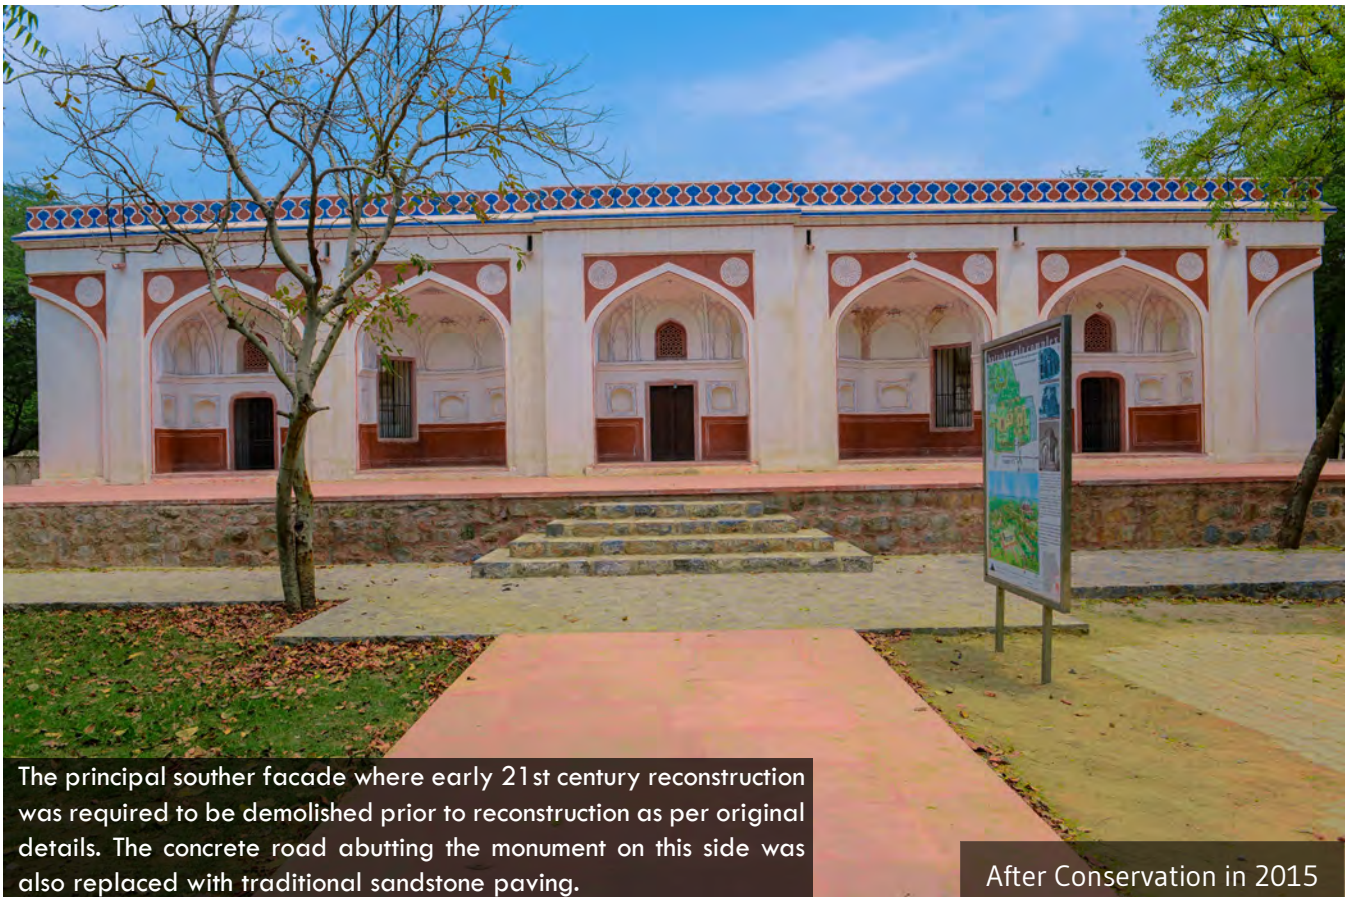
The principal souther facade where early 21st century reconstruction was required to be demolished prior to reconstruction as per original details. The concrete road abutting the monument on this side was also replaced with traditional sandstone paving.

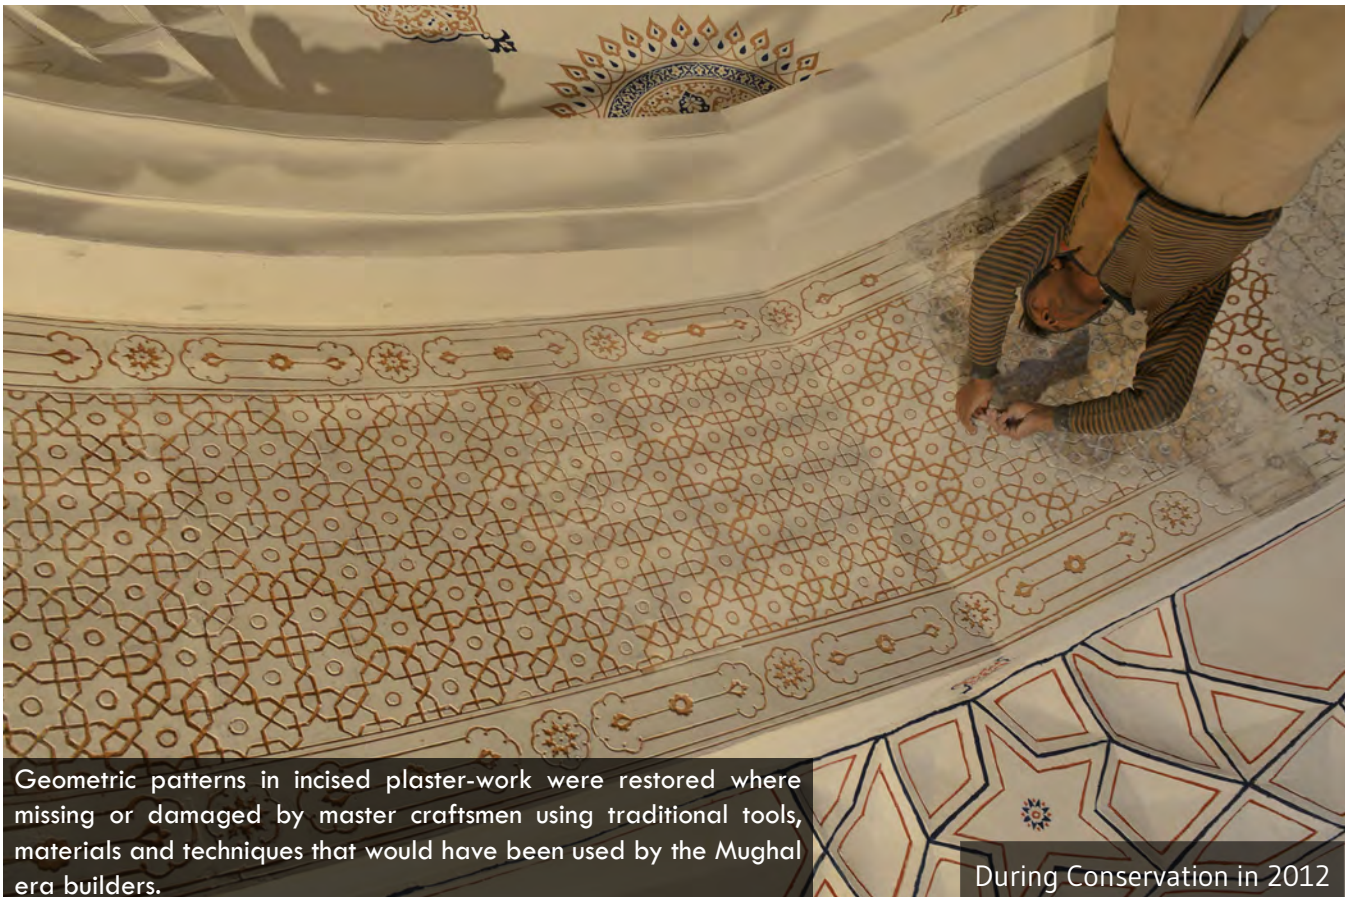
Geometric patterns in incised plaster-work were restored where missing or damaged by master craftsmen using traditional tools, materials and techniques that would have been used by the Mughal era builders.

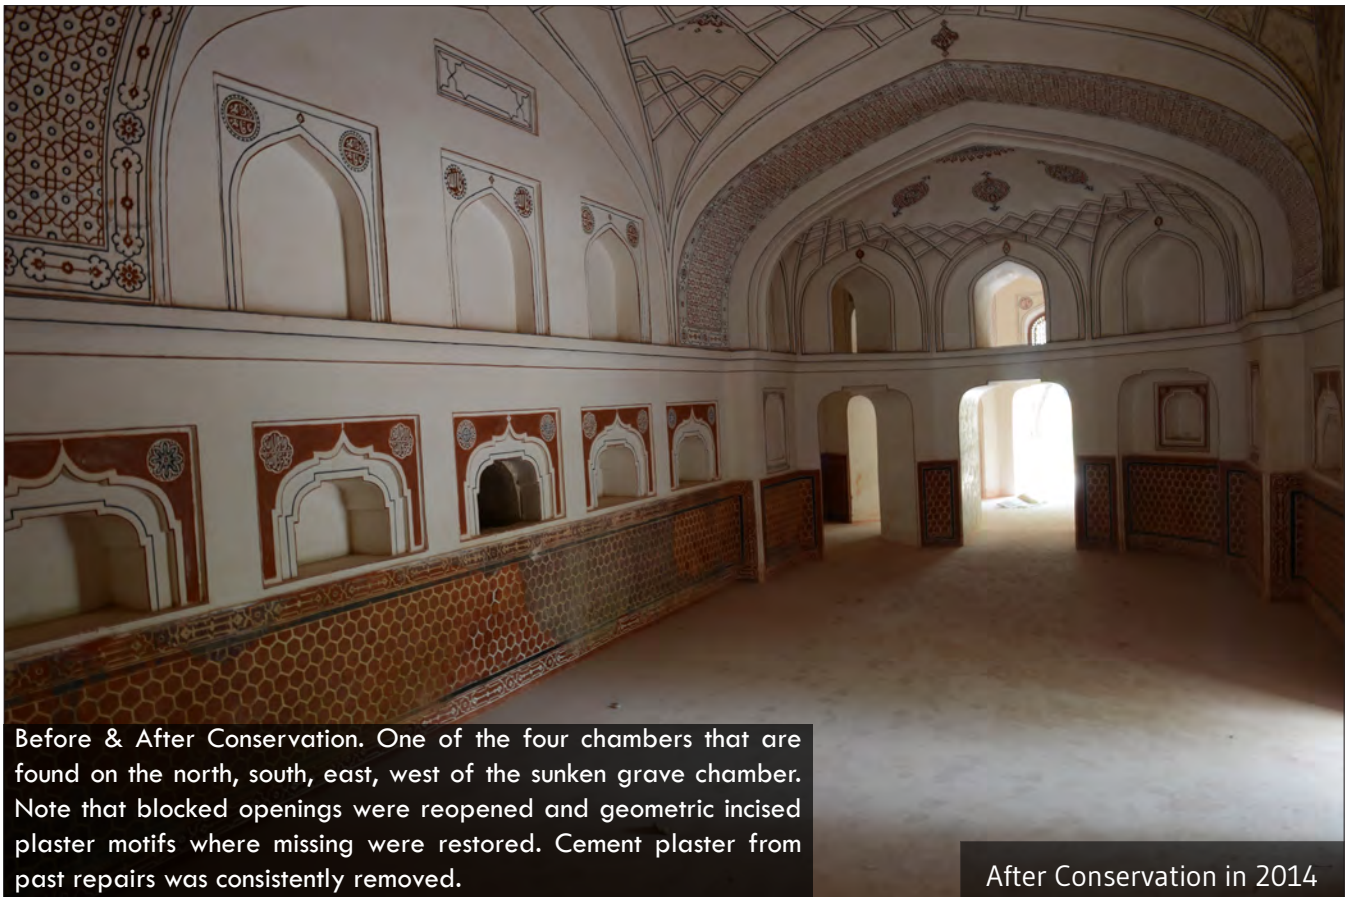
Before & After Conservation. One of the four chambers that are found on the north, south, east, west of the sunken grave chamber. Note that blocked openings were reopened and geometric incised plaster motifs where missing were restored. Cement plaster from past repairs was consistently removed.

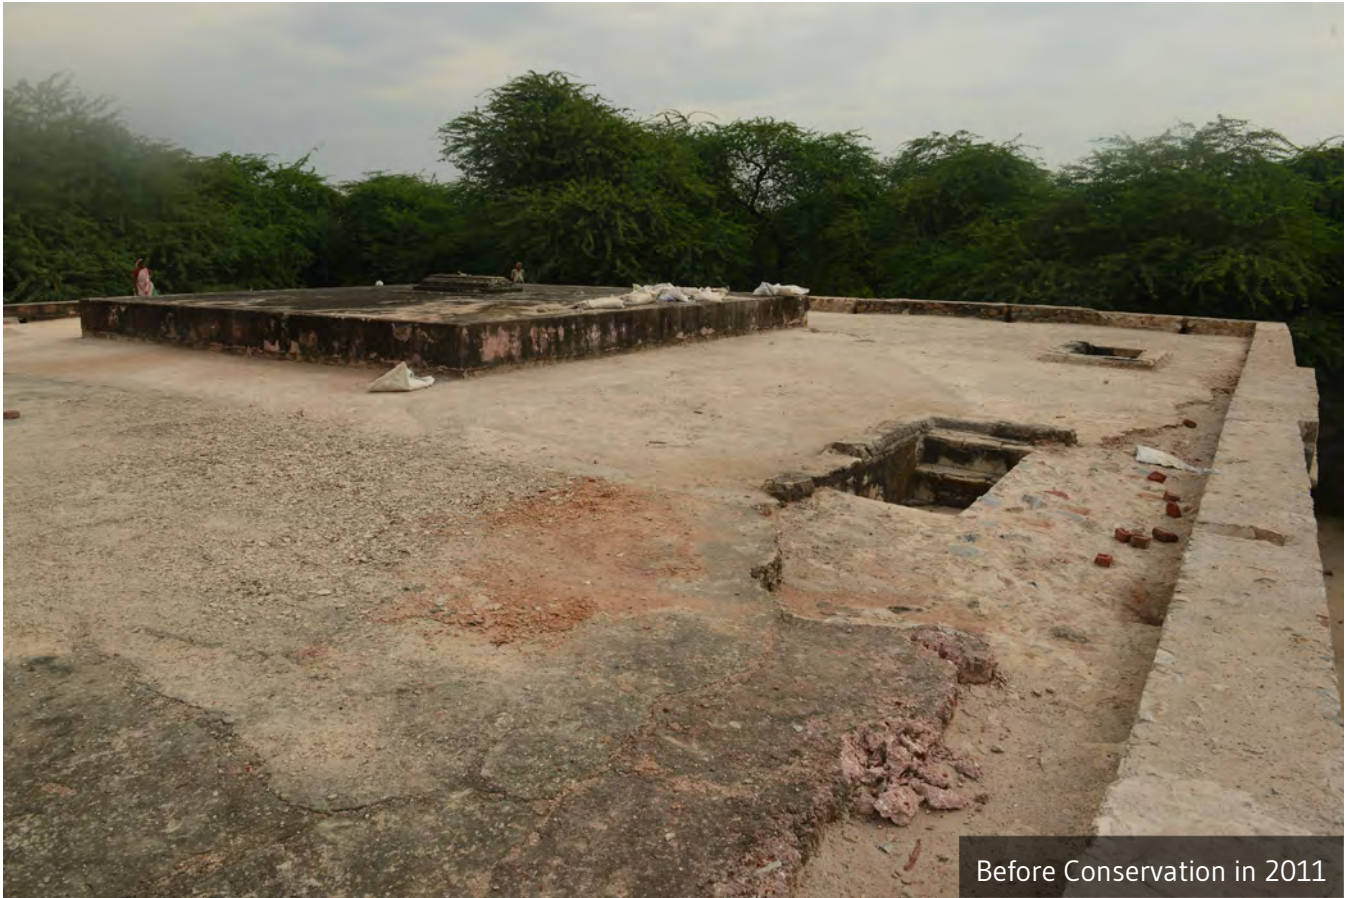
Cement concrete layers on the roof of Mirza Muzzafar Hussain's tomb were found to be of poor strength and inappropriately laid and allowing water percolation and thus were required to be carefully and manually dismantled.

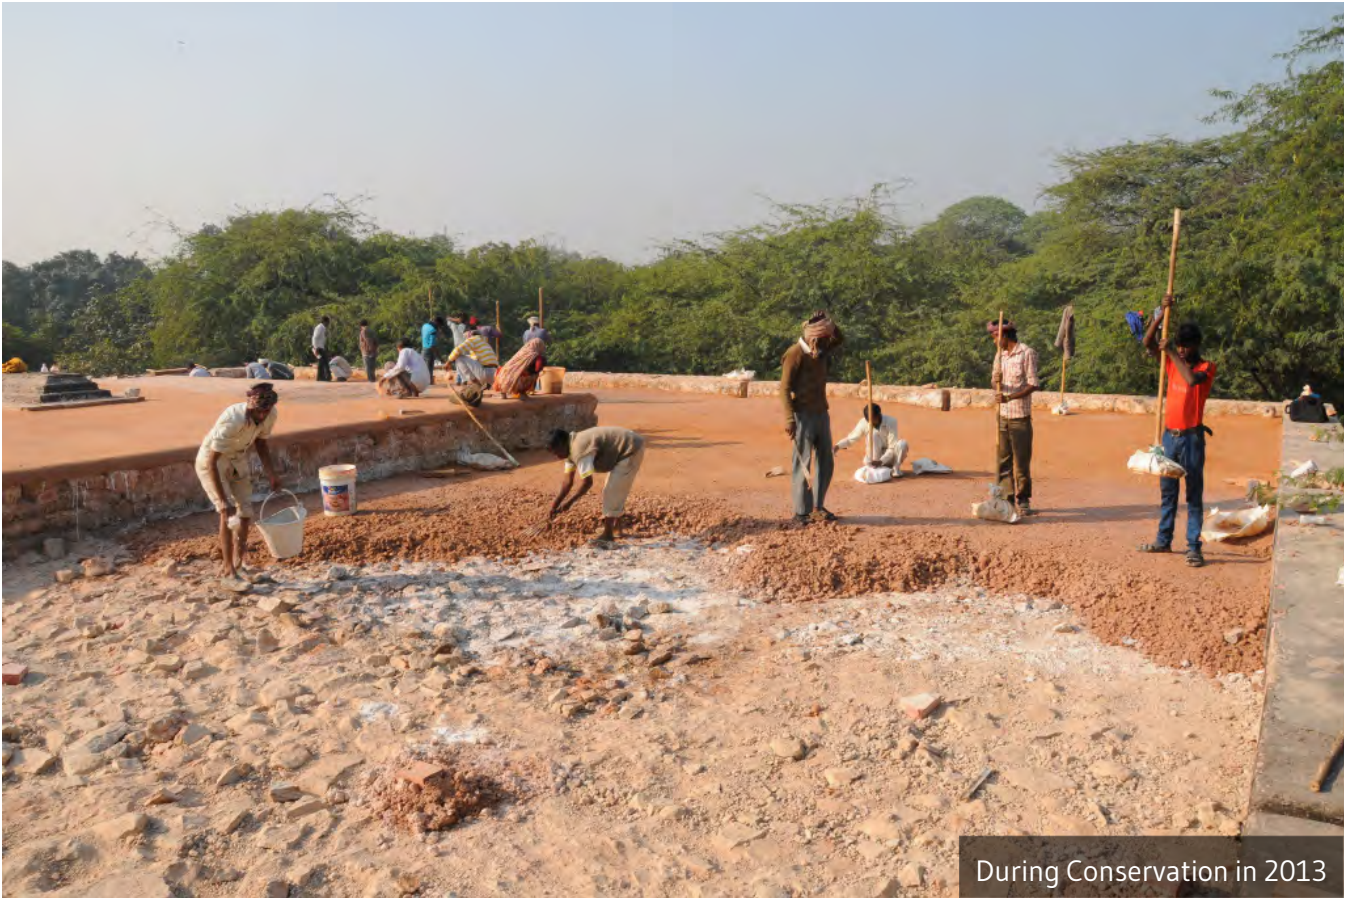
A traditional layer of lime concrete with brick aggregate and traditional additives and adequate slope was laid on the roof of Mirza Muzzafar Hussain's tomb in 2013.

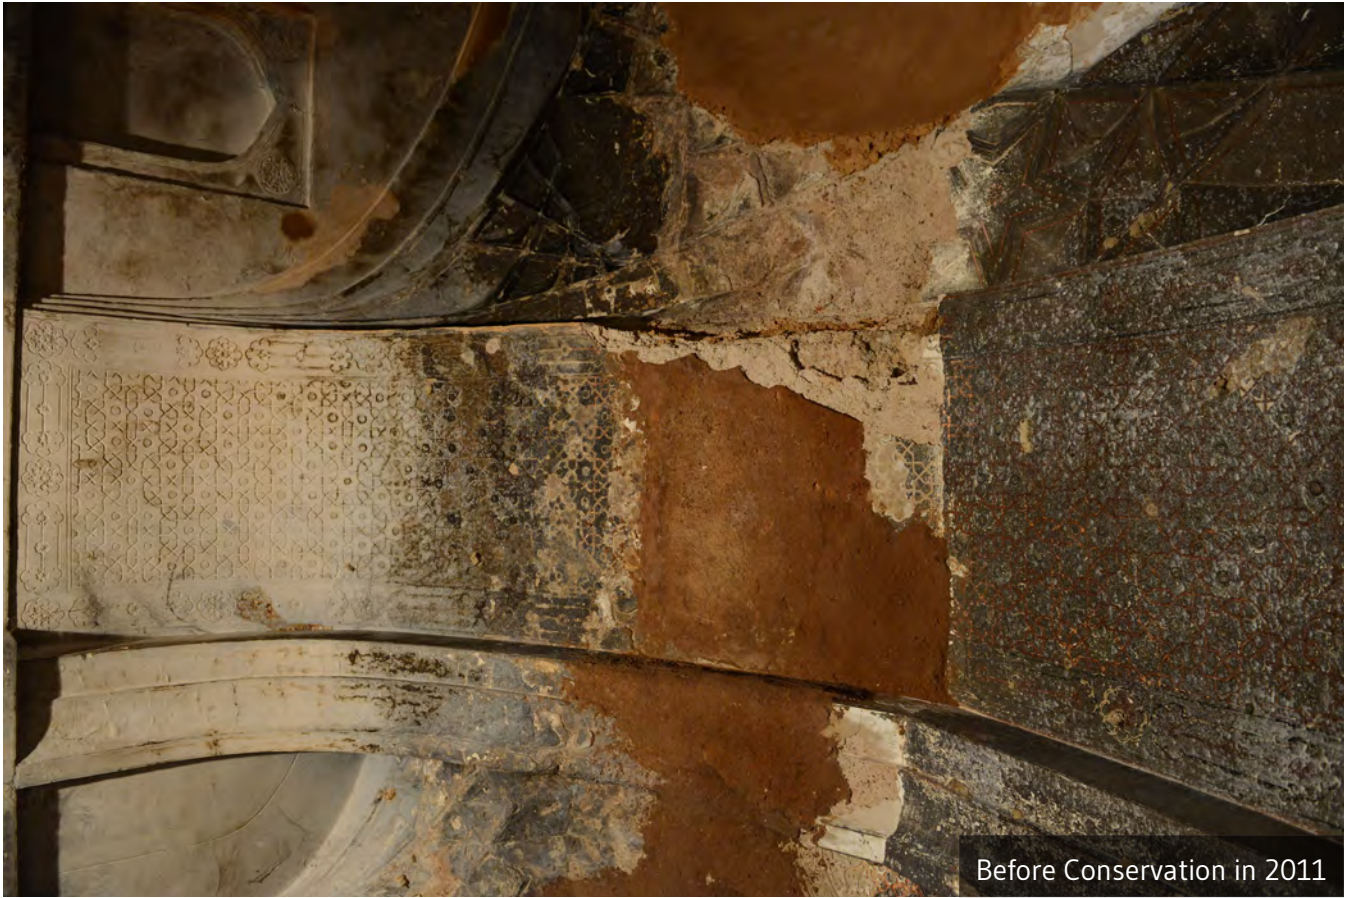
Cleaning of soot and other accumulations on the wall and ceiling surfaces revealed an intricate geometric incised plaster which was carefully restored - matching the original - where missing.

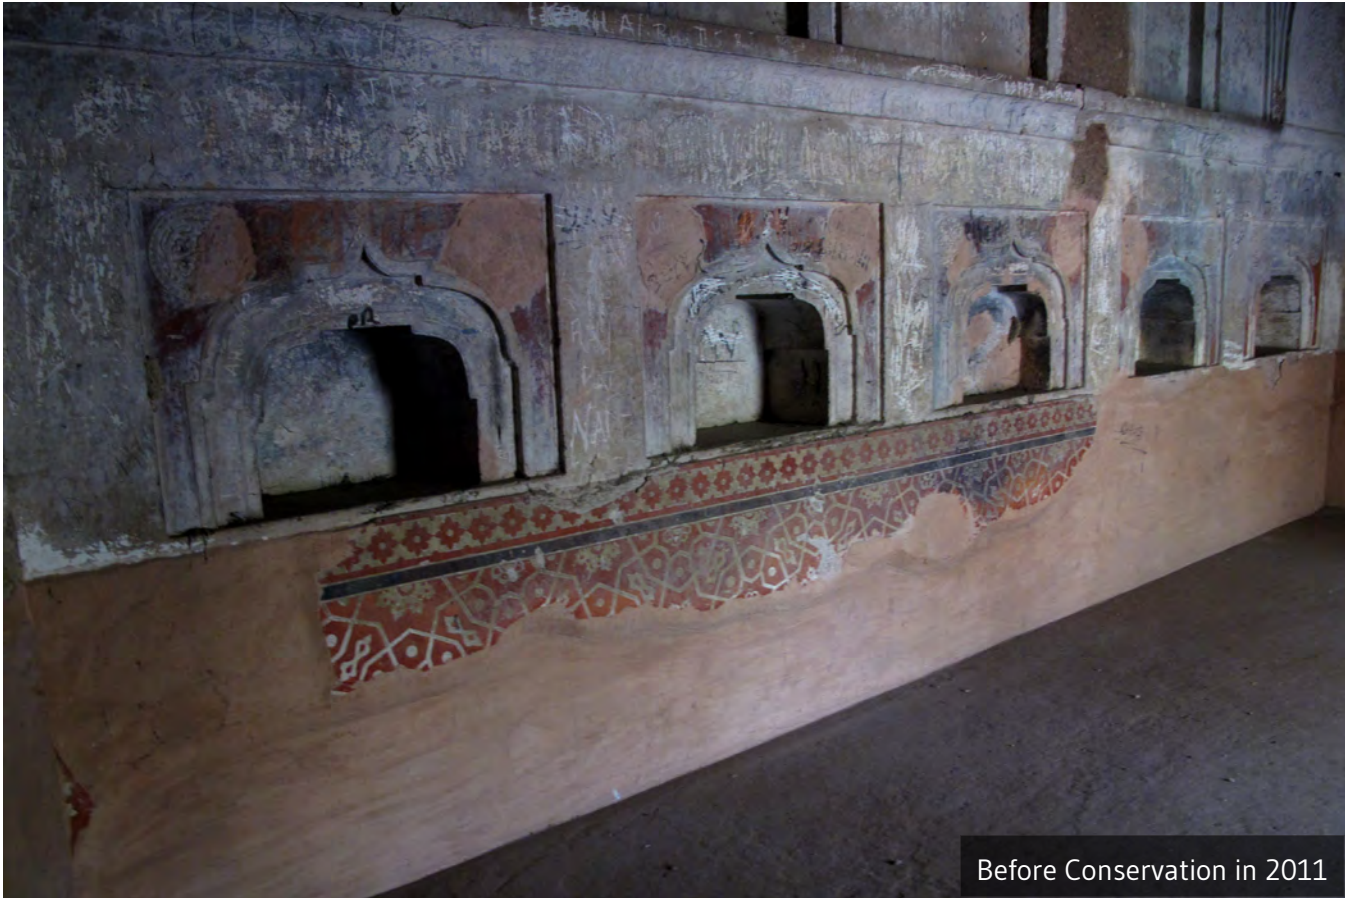
Wall surface of the central chamber where the geometric pattern, typical of Islamic buildings was restored on the basis of in-situ evidence from the structure itself.

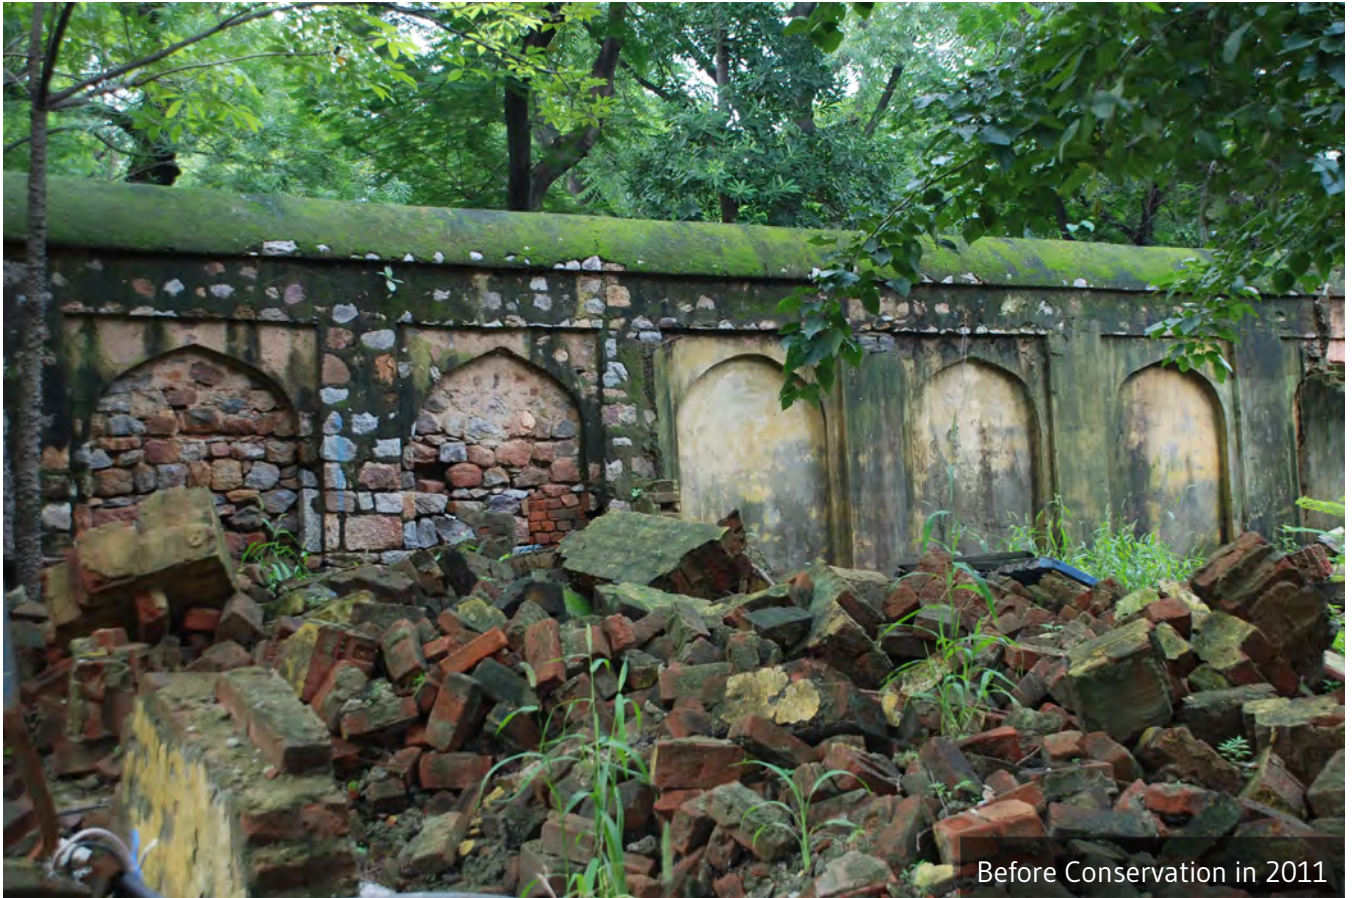
Large section of the enclosure wall were demolished in 1989 but standing portions and foundations of the entire length were discovered following the demolition of structures built in 1989 - allowing repair and reconstruction of the enclosure wall.

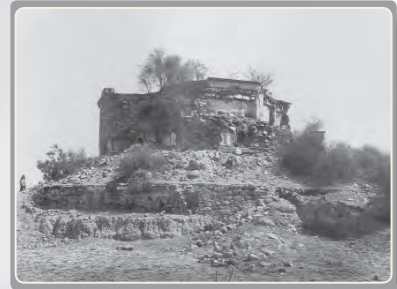
Earliest image of Chota Batashewala showing the monument in the most intact form with the Mughal Tomb in the background

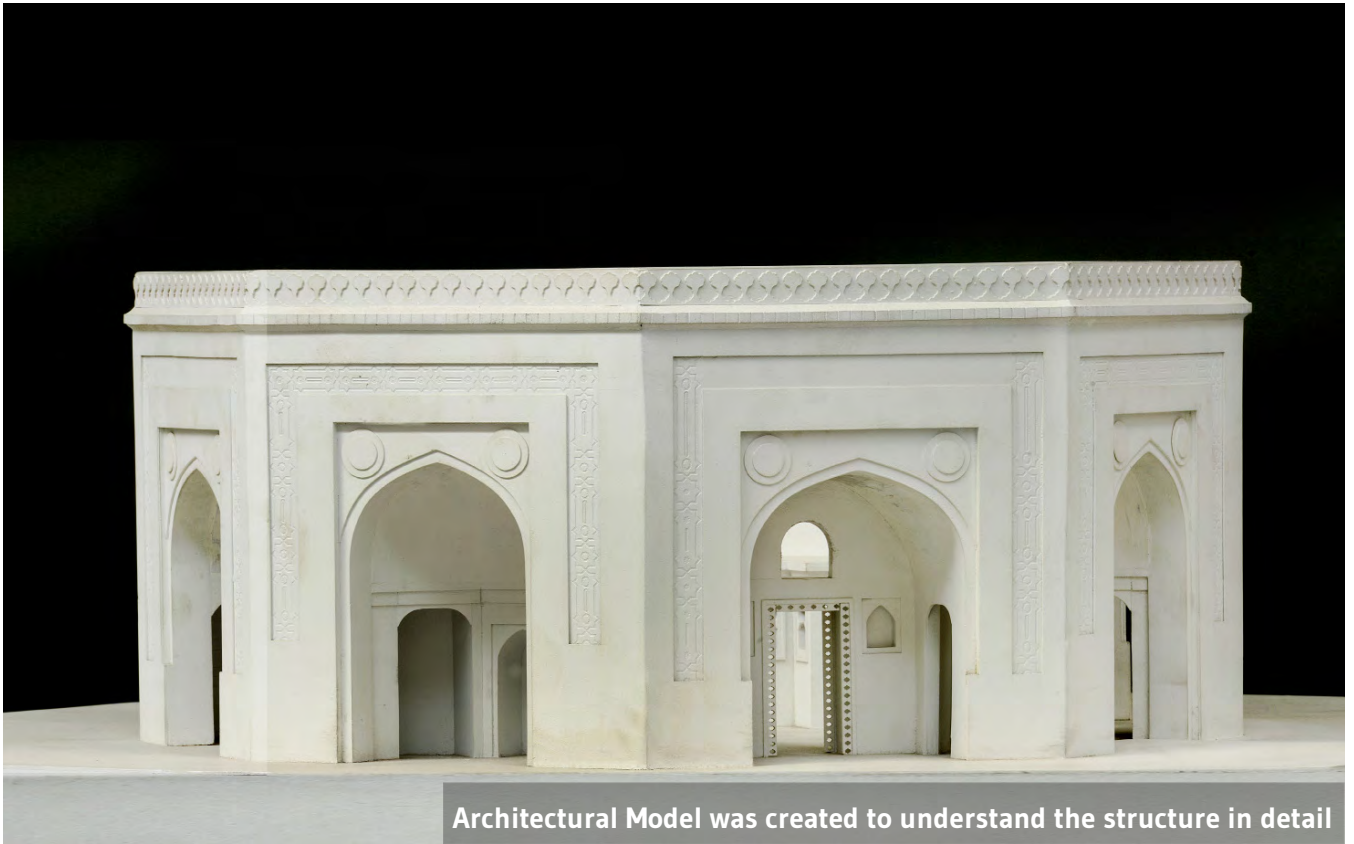
Architectural Model was created to understand the structure in detail

In view of the large scale collapse of the monument following the levelling of land in 1989 by Bharat Scouts and Guides, a study model of the building was prepared at the onset of conservation works on the basis of archival images and standing portions.

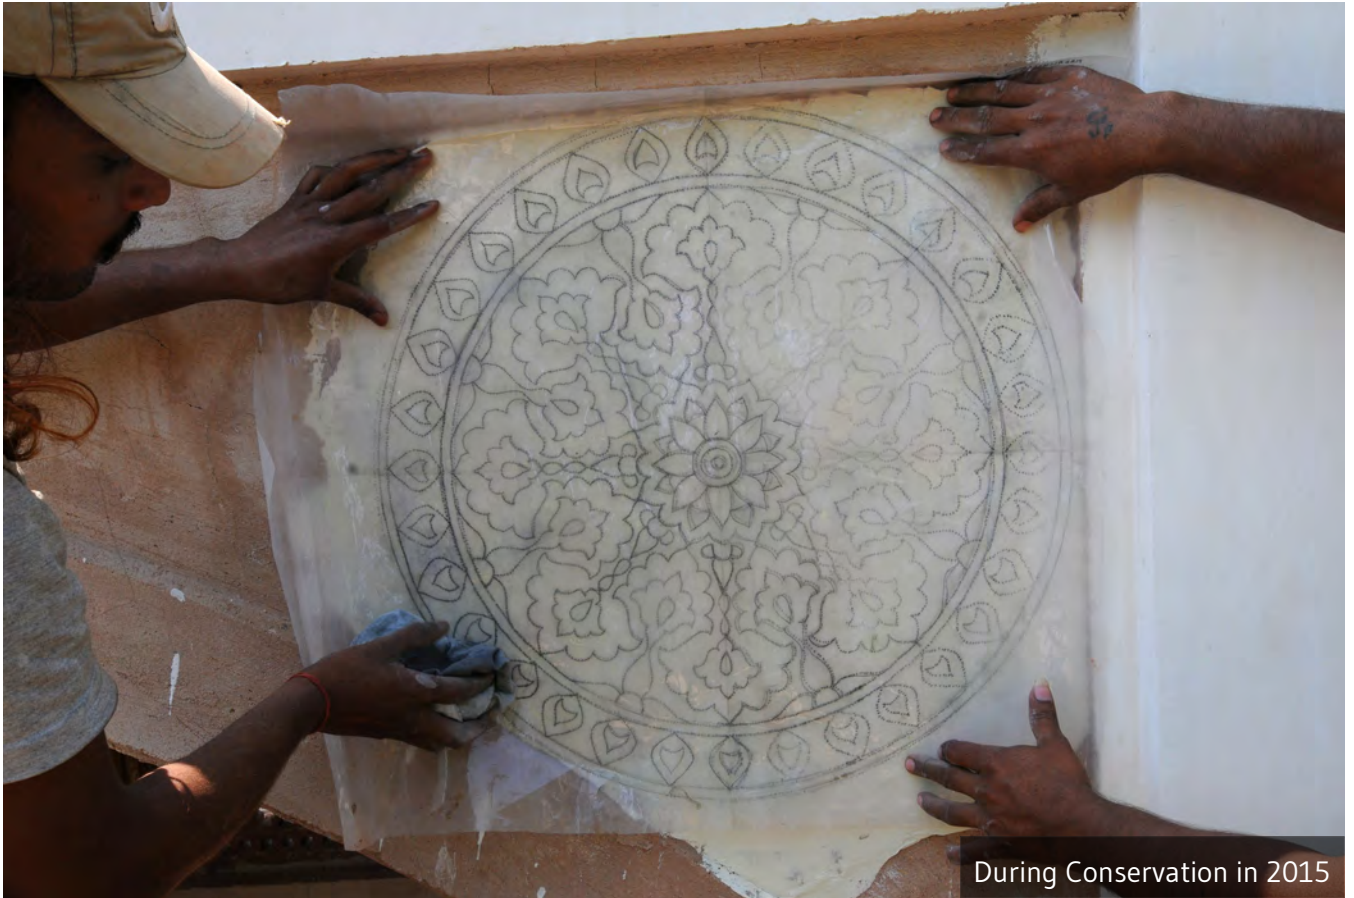
During Conservation in 2015

Incised plaster patterns were prepared with templates that were used to mark the pattern on freshly applied layer of plaster.

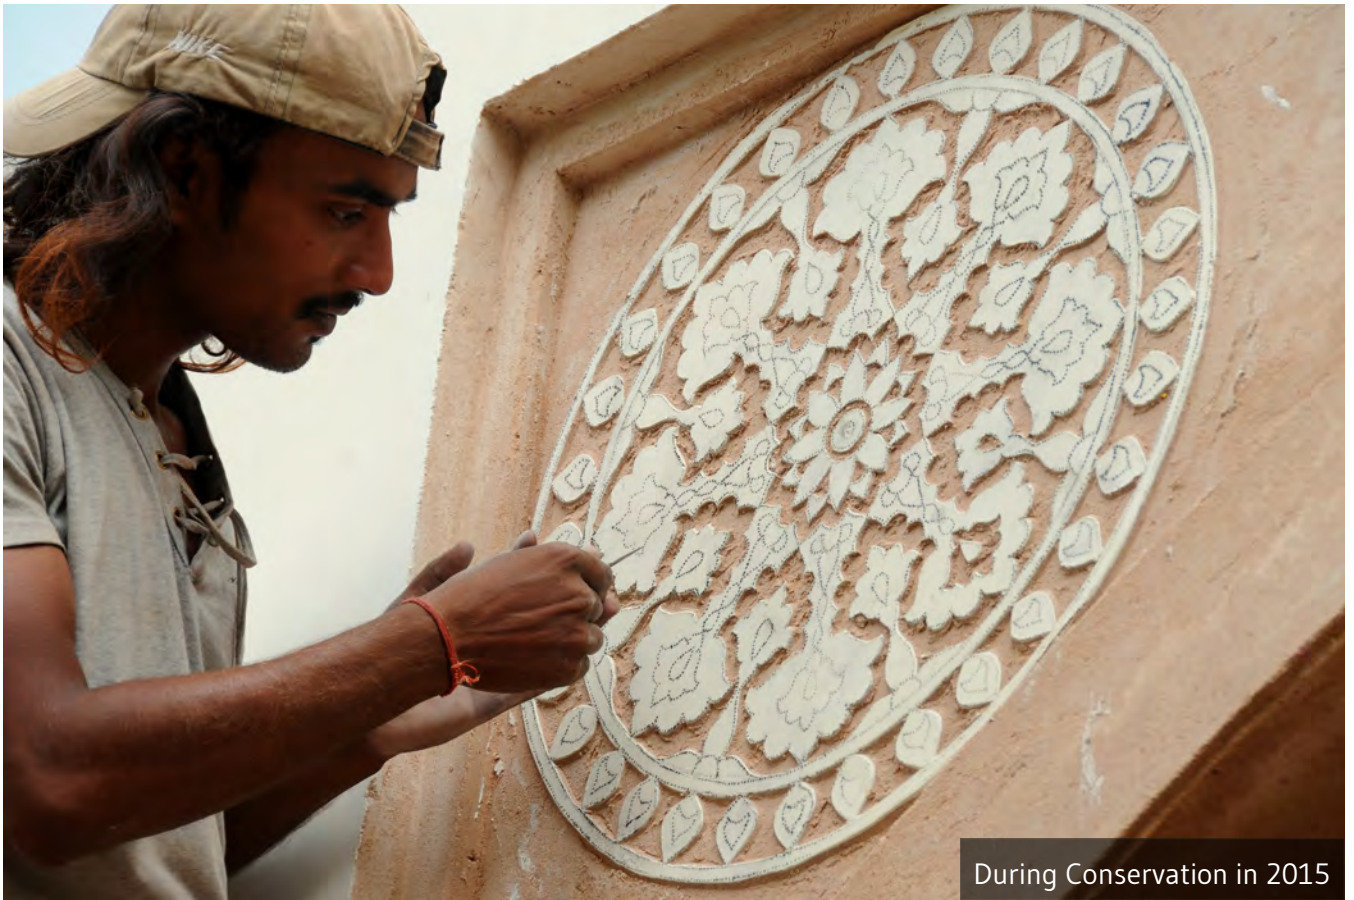
One of the medallions at Chota batashewala mahal, manually incised as would have been carried out by the Mughal builders.
