BATASHEWALA - MUGHAL GARDEN TOMB COMPLEX

CONSERVATION REPORT
2011-2015

AGA KHAN DEVELOPMENT NETWORK

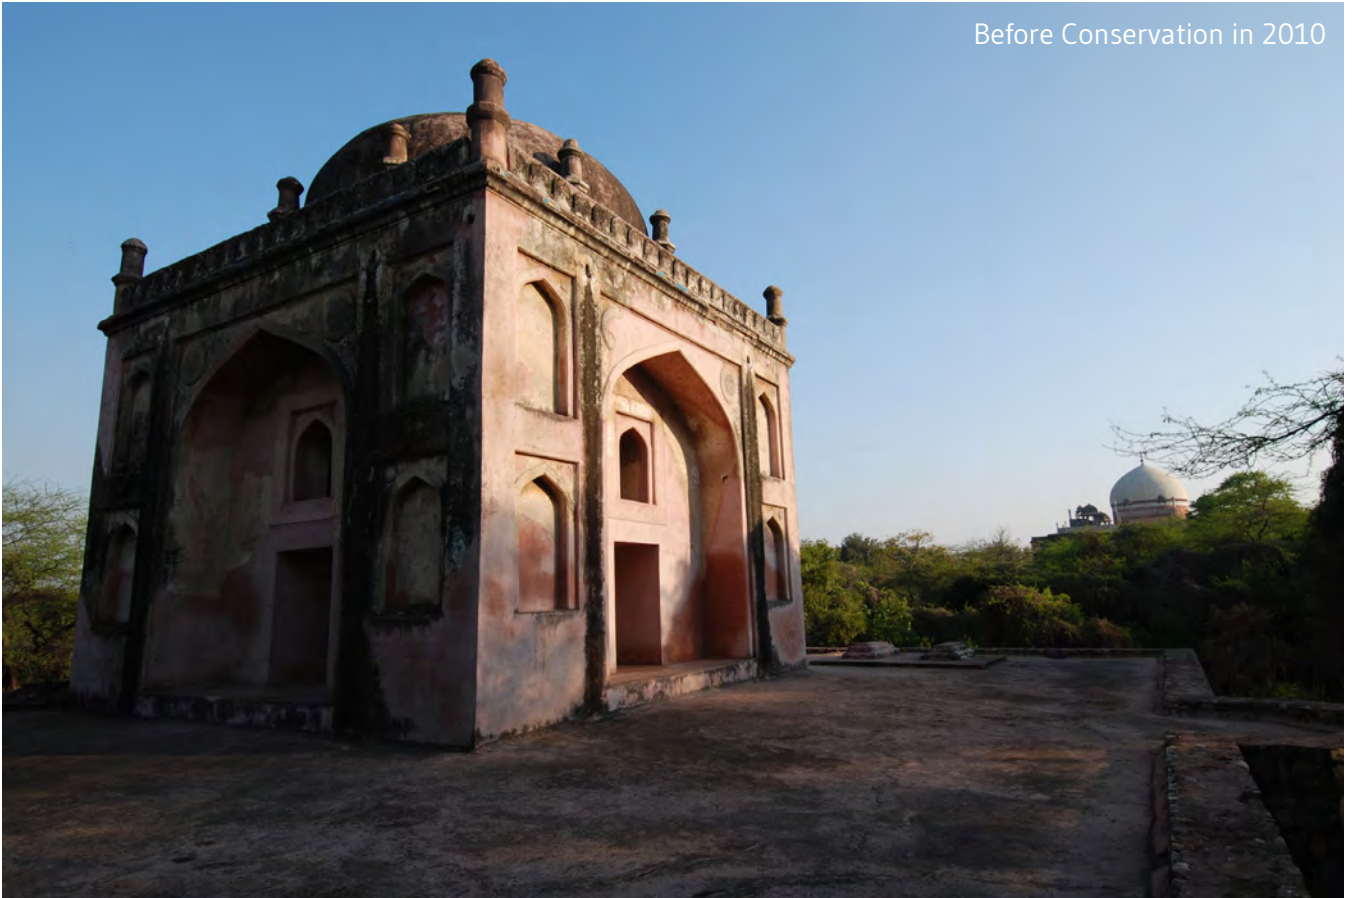
Before Conservation in 2010

The structure had suffered from inappropriate repairs in the 20th century. Careful interventions were required to restore the architectural intentions of the Mughal builders, including rebuilding the lower platform and removal of cement plaster, which was used here extensively.

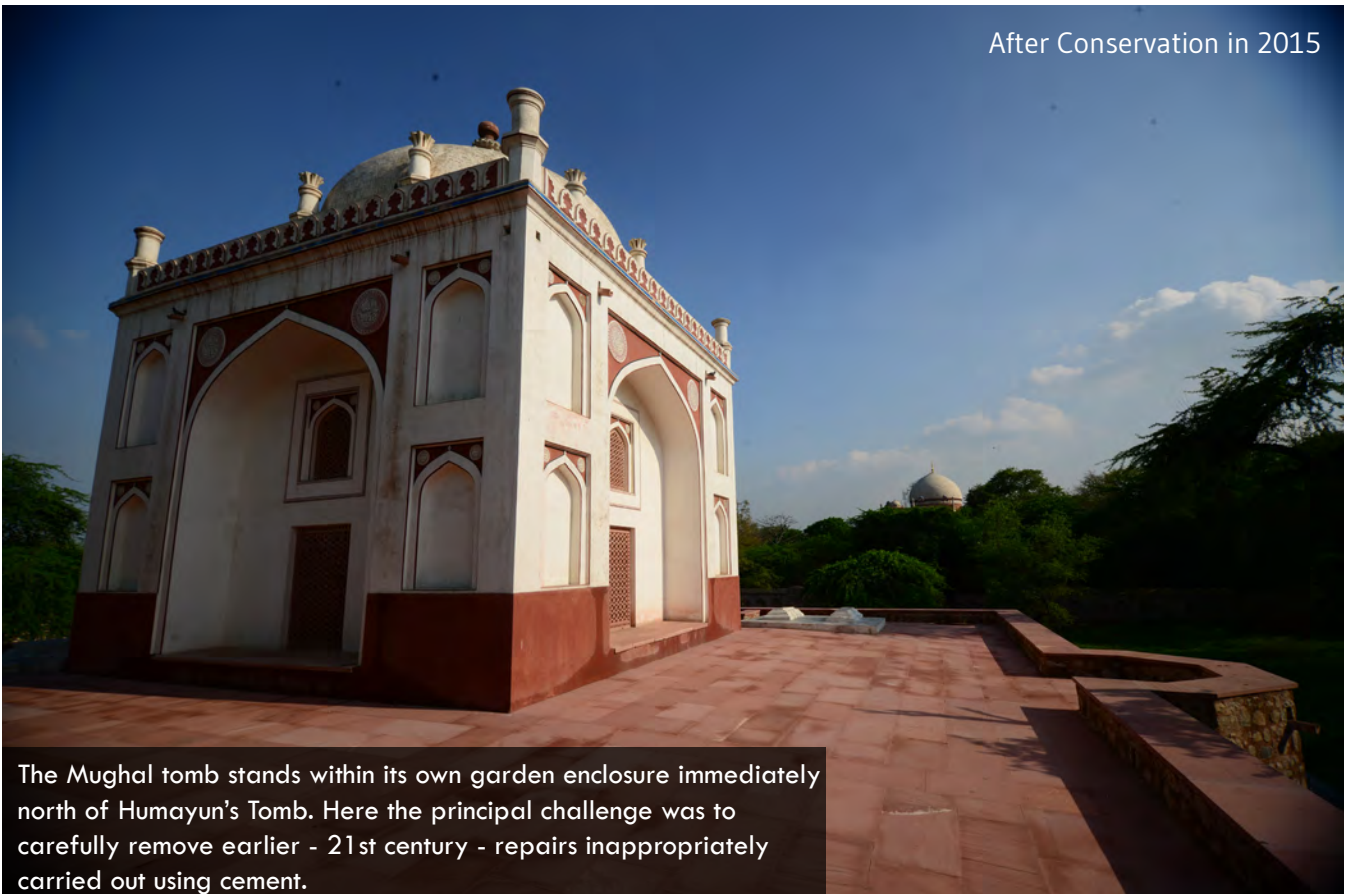
The Mughal tomb stands within its own garden enclosure immediately north of Humayun's Tomb. Here the principal challenge was to carefully remove earlier - 21st century - repairs inappropriately carried out using cement.

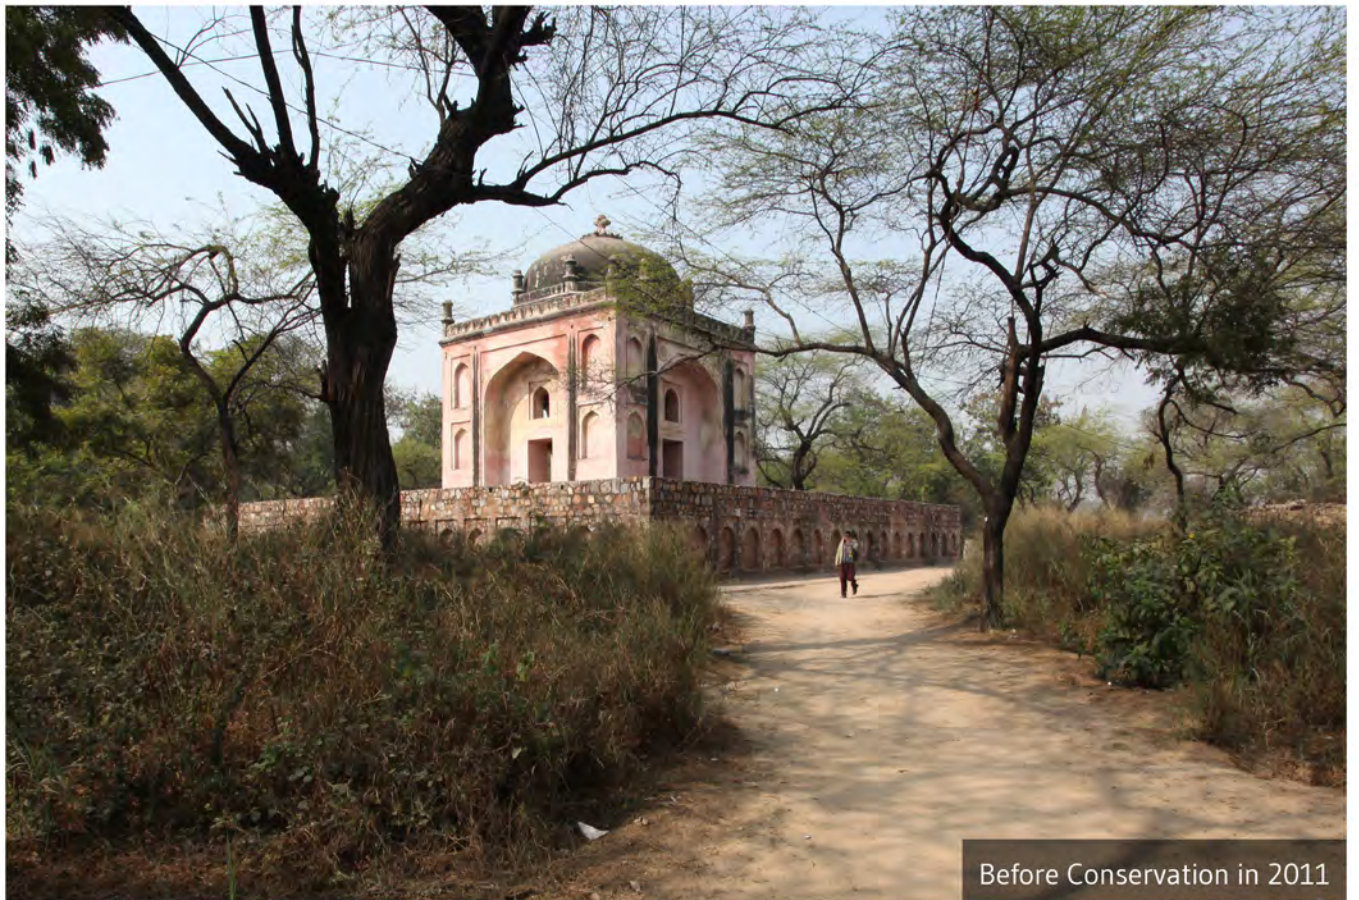
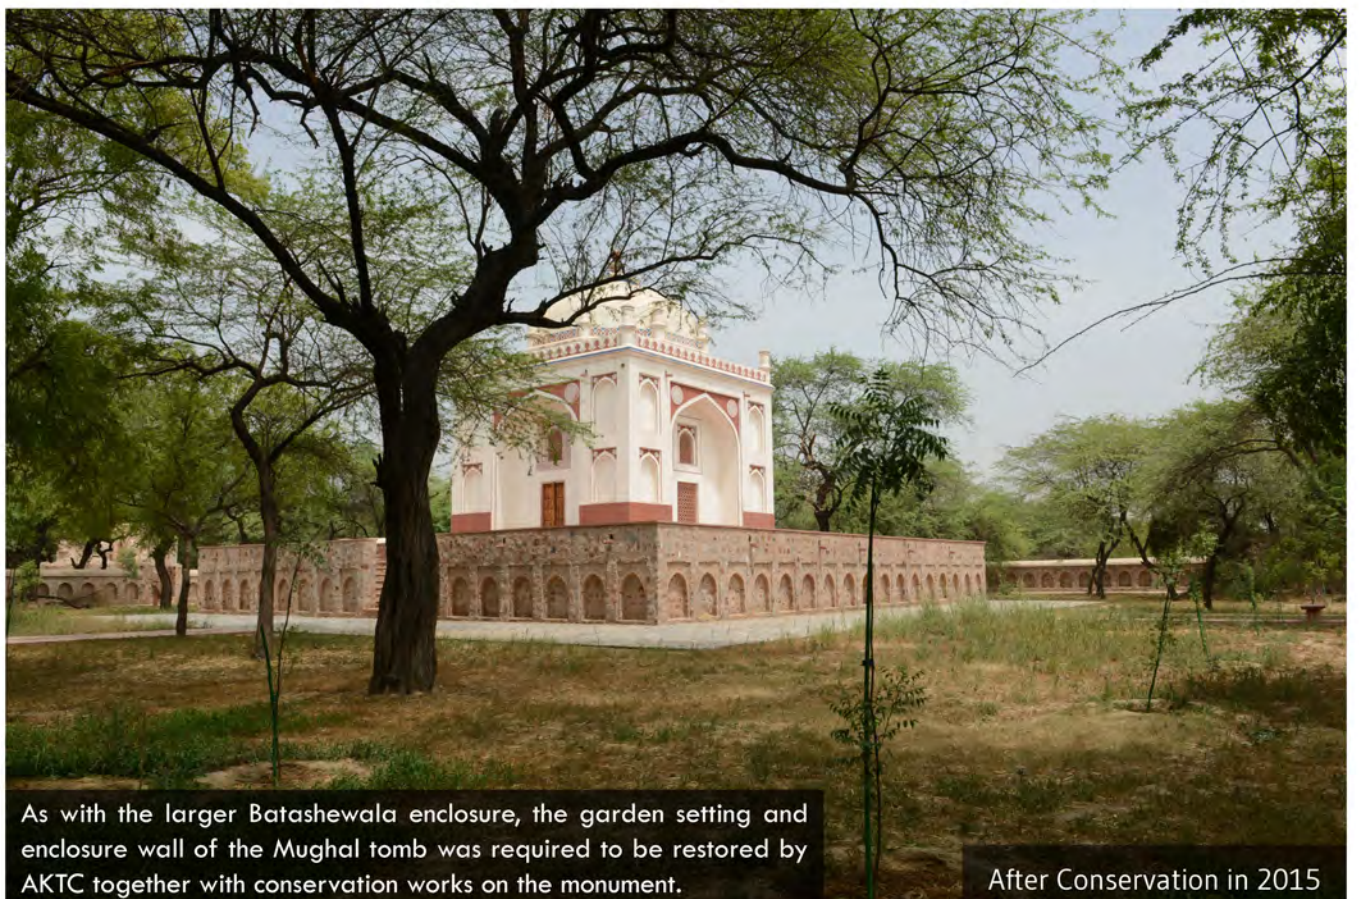
As with the larger Batashewala enclosure, the garden setting and enclosure wall of the Mughal tomb was required to be restored by AKTC together with conservation works on the monument.

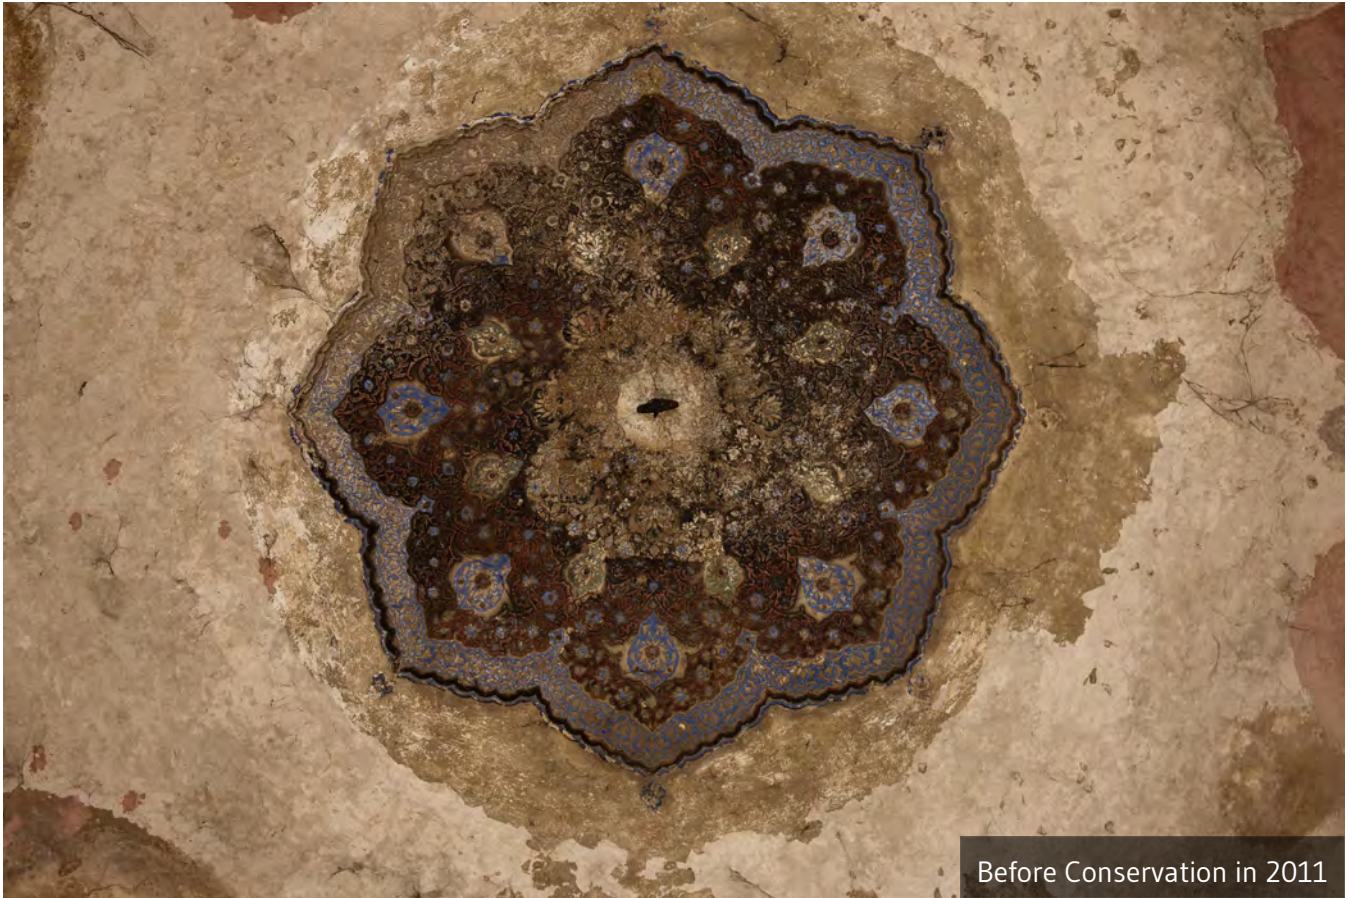
Before Conservation in 2011

The profusely ornamental ceiling with painted incised plaster was first required to be cleaned off soot and 20th century paint layers prior to restoring missing portions.

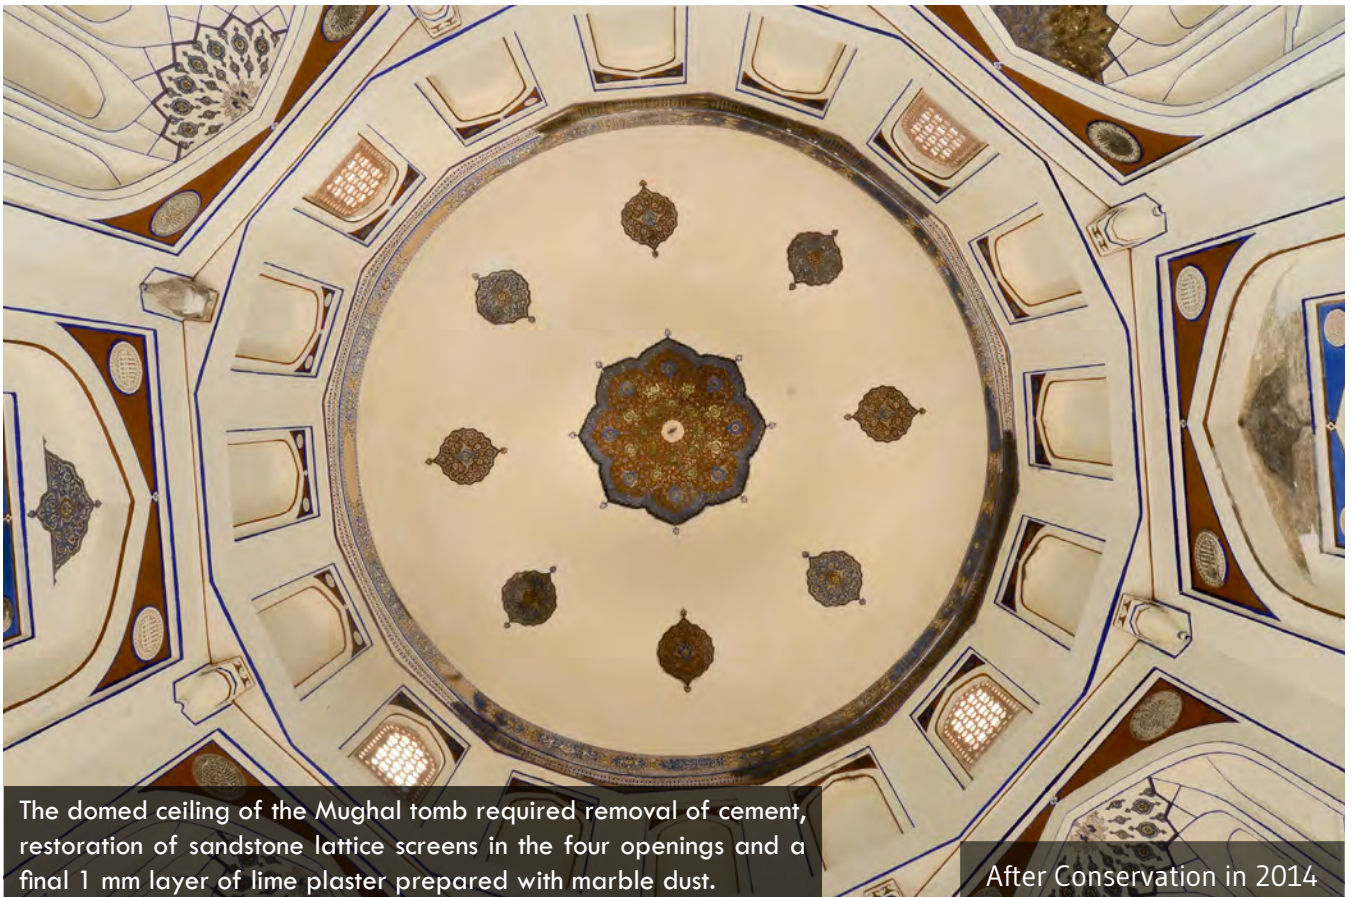
Before Conservation in 2011

The domed ceiling of the Mughal tomb required removal of cement, restoration of sandstone lattice screens in the four openings and a final 1 mm layer of lime plaster prepared with marble dust.

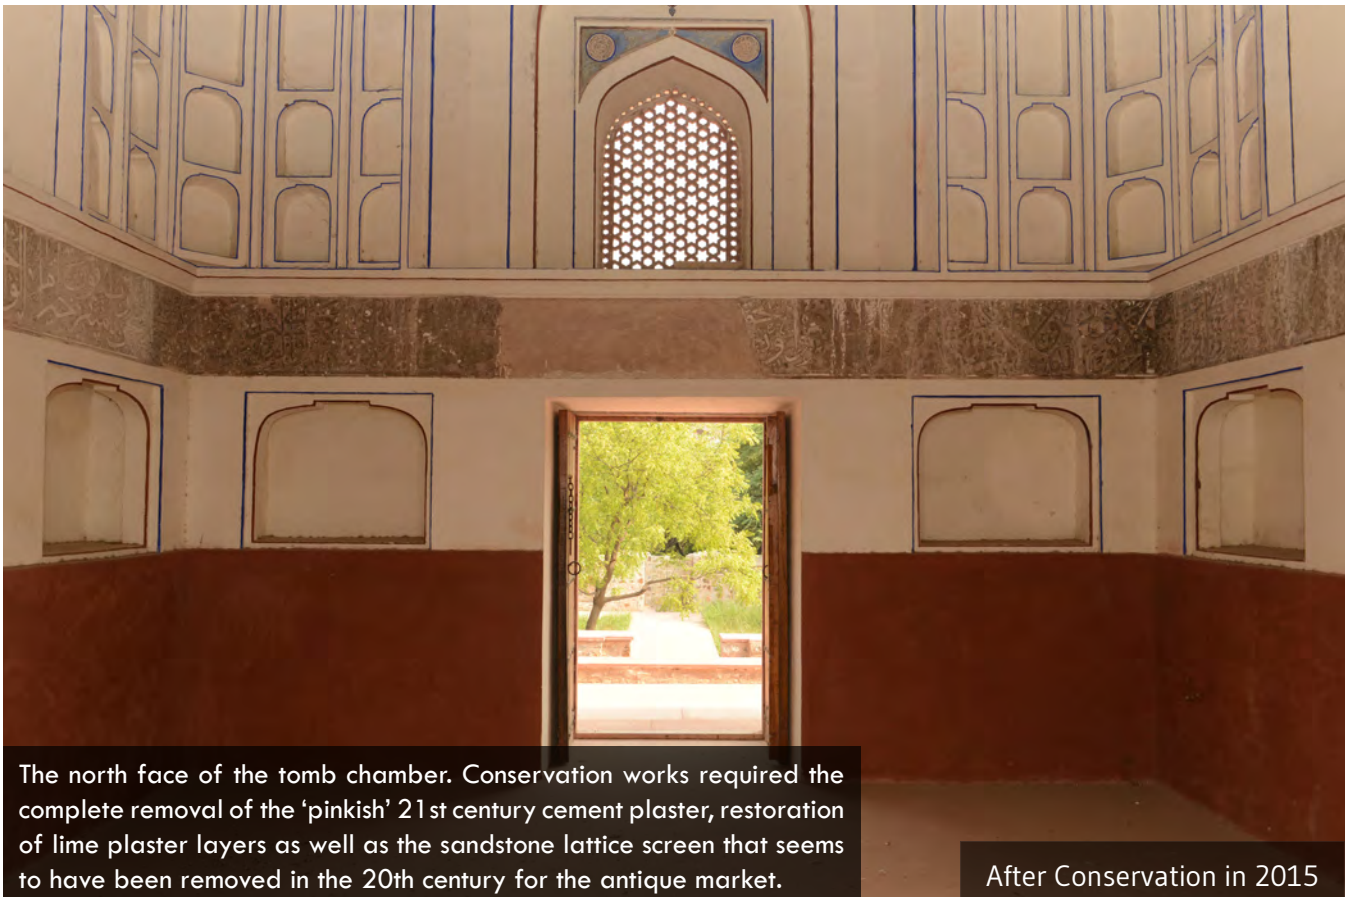
Before Conservation in 2011

The north face of the tomb chamber. Conservation works required the complete removal of the 'pinkish' 21st century cement plaster, restoration of lime plaster layers as well as the sandstone lattice screen that seems to have been removed in the 20th century for the antique market.

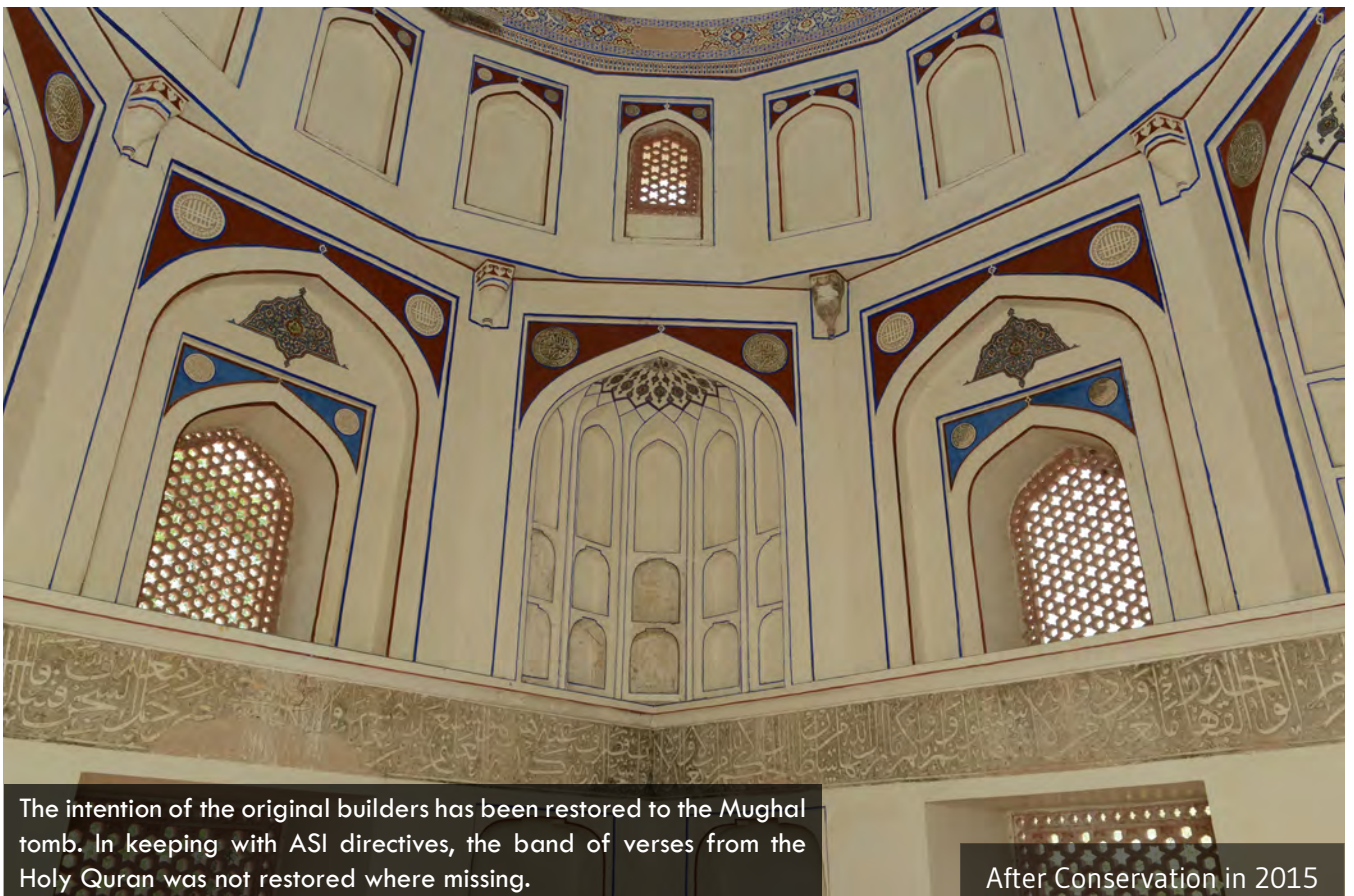
The intention of the original builders has been restored to the Mughal tomb. In keeping with ASI directives, the band of verses from the Holy Quran was not restored where missing.

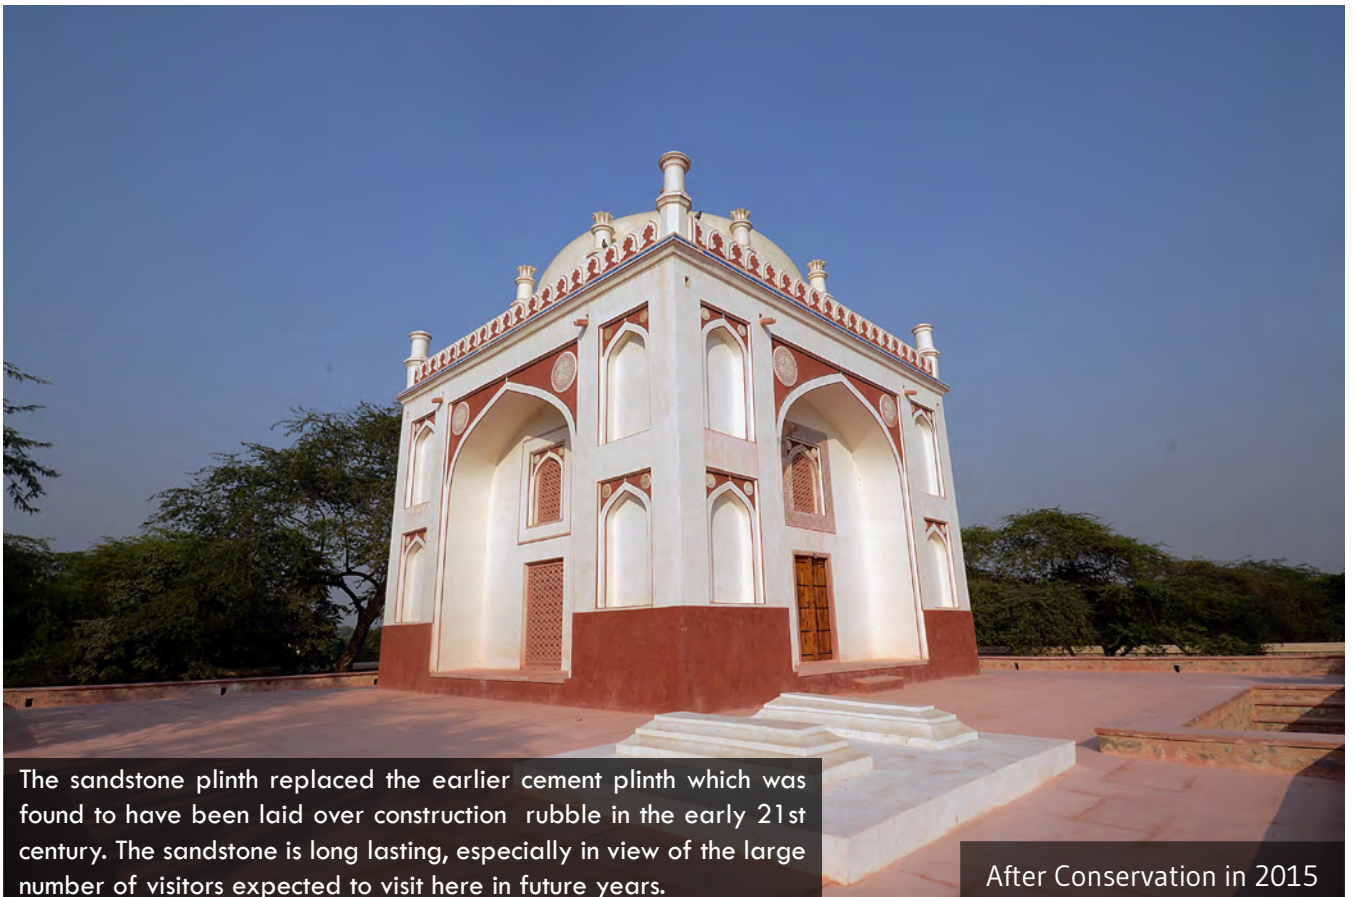
The sandstone plinth replaced the earlier cement plinth which was found to have been laid over construction rubble in the early 21st century. The sandstone is long lasting, especially in view of the large number of visitors expected to visit here in future years.

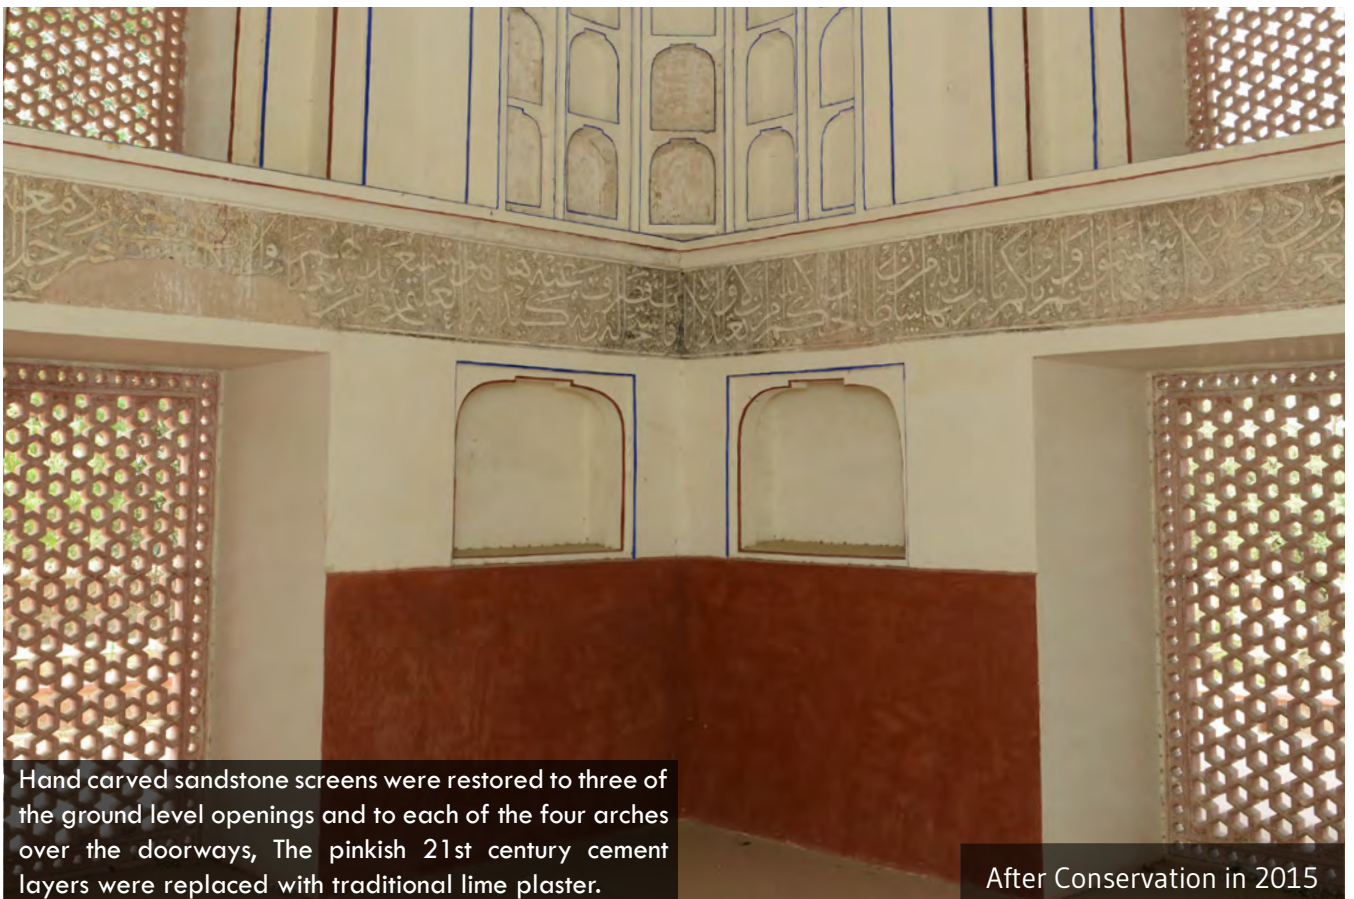
Hand carved sandstone screens were restored to three of the ground level openings and to each of the four arches over the doorways, The pinkish 21st century cement layers were replaced with traditional lime plaster.

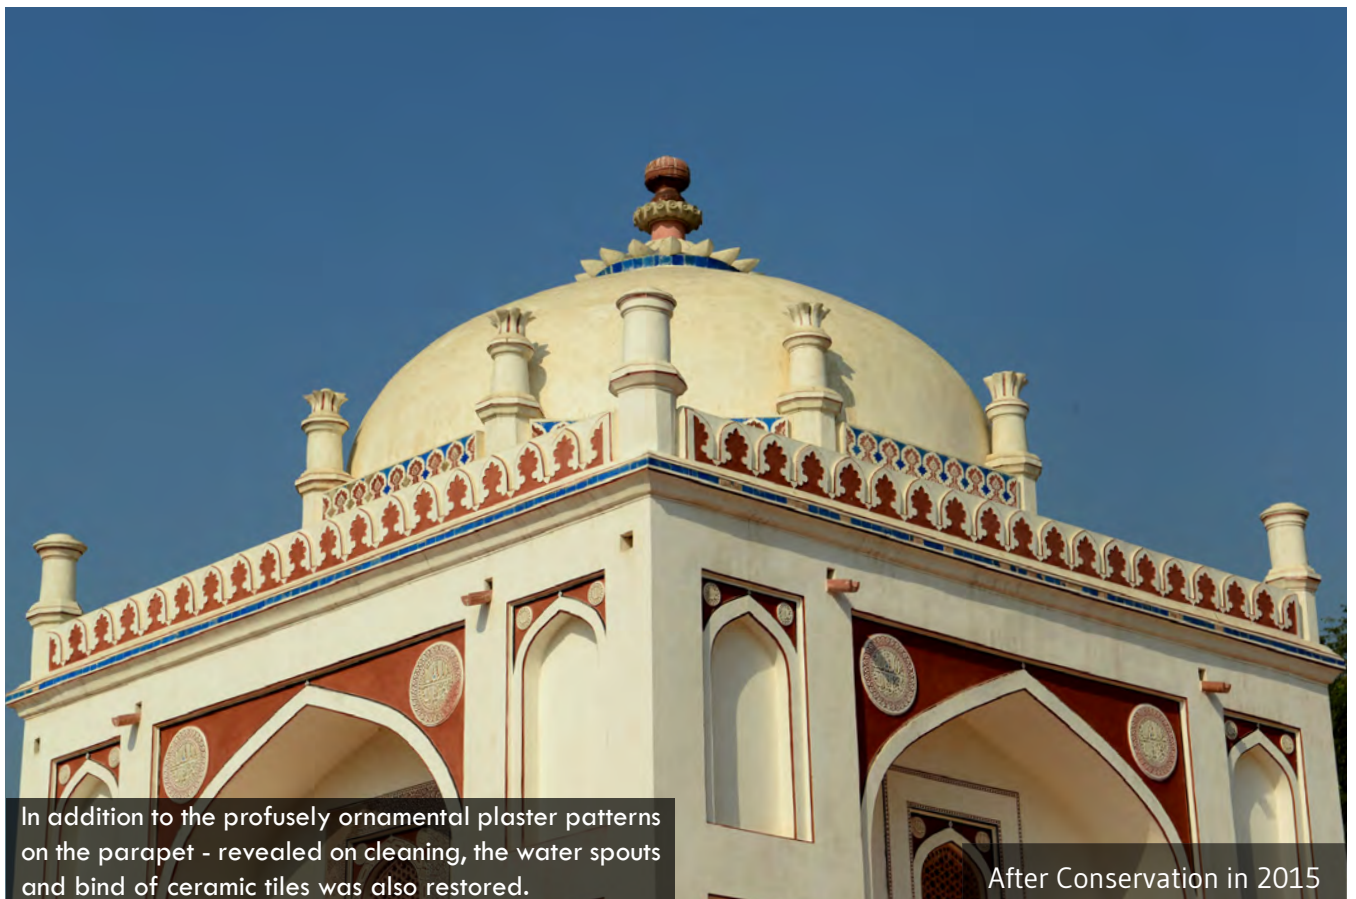
In addition to the profusely ornamental plaster patterns on the parapet - revealed on cleaning, the water spouts and bind of ceramic tiles was also restored.

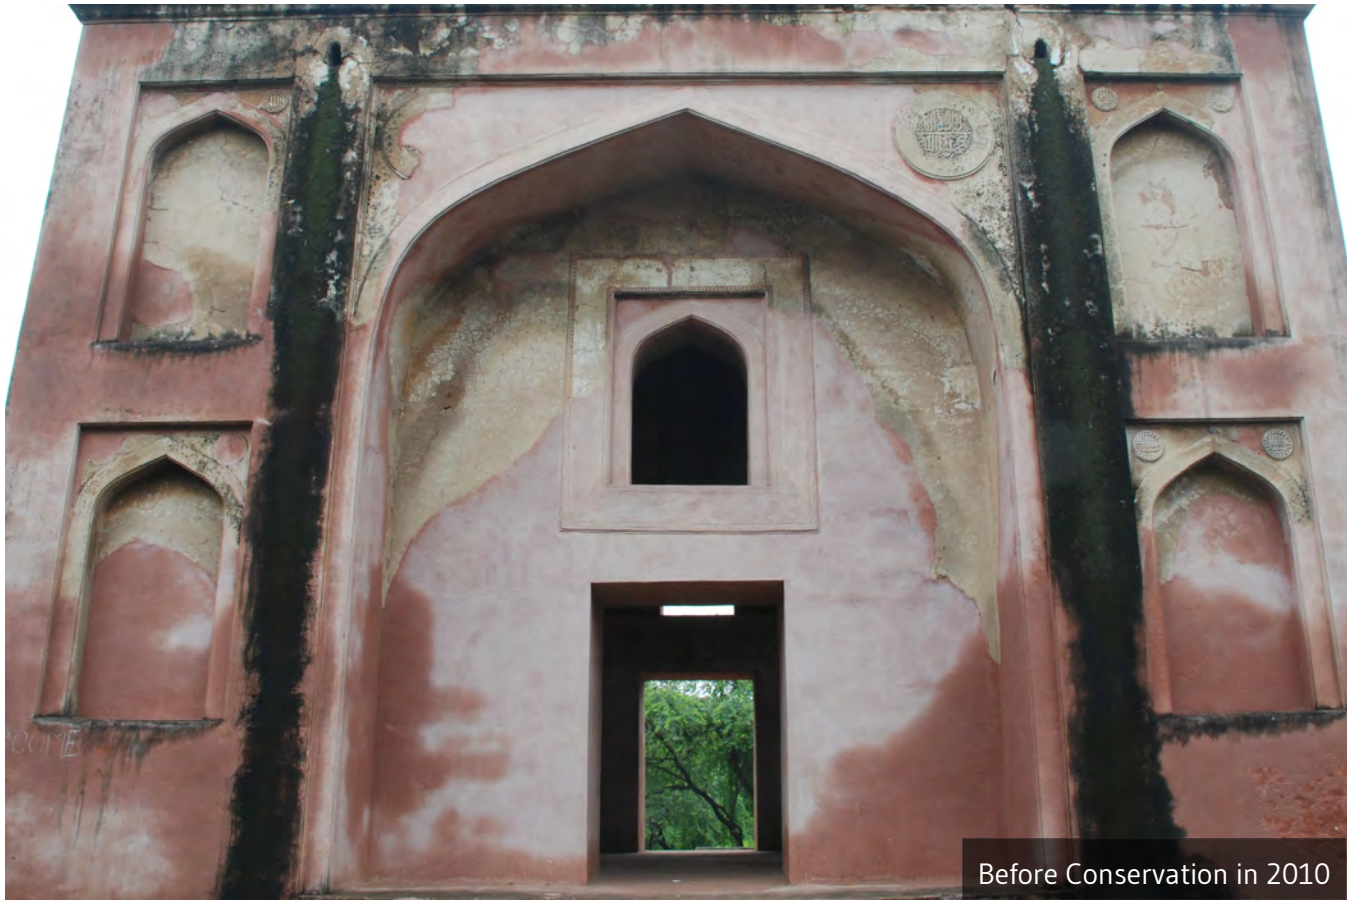
On all four facades of the building conservation works commenced with removal of recent cement layers followed by re-plastering with lime plaster mixed with traditional additives such as marble dust for the final 1 mm layer.

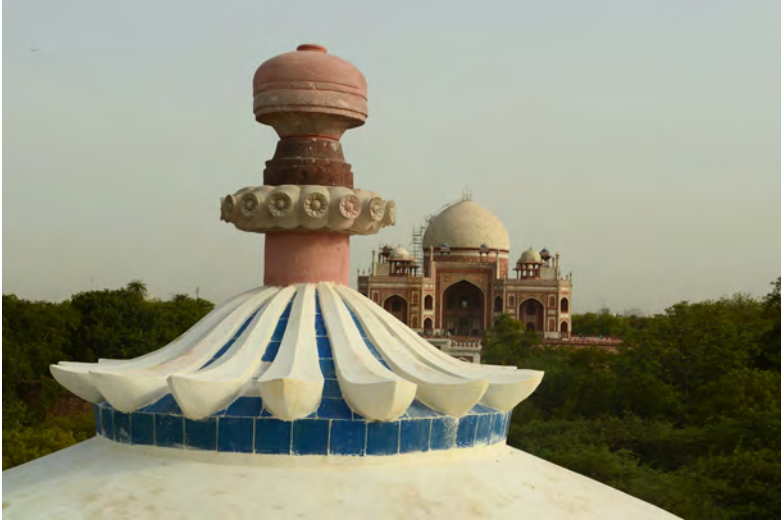
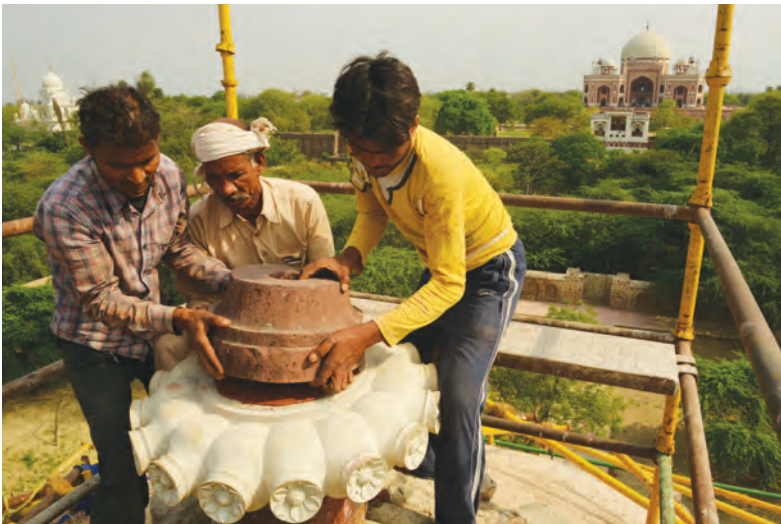
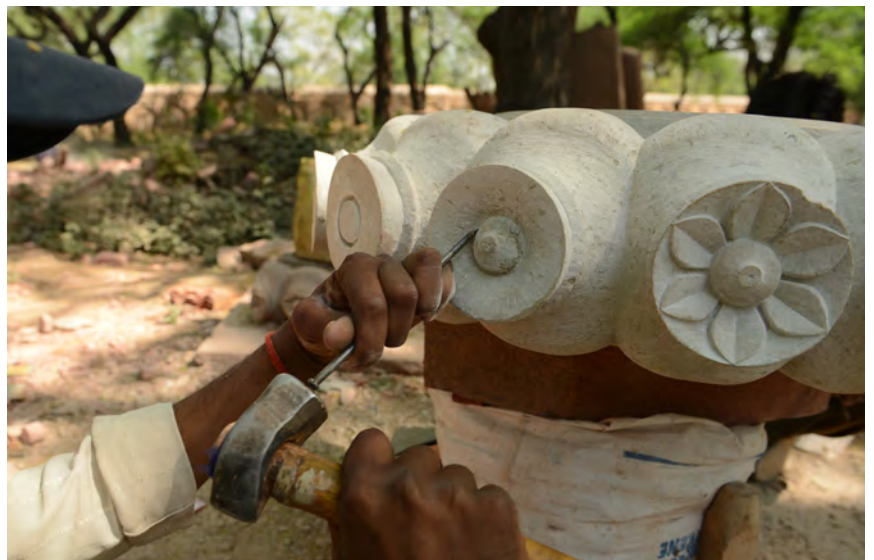
Broken portions of the finial were found collapsed on the roof. Master craftsmen prepared matching finial pieces to restore on the dome.

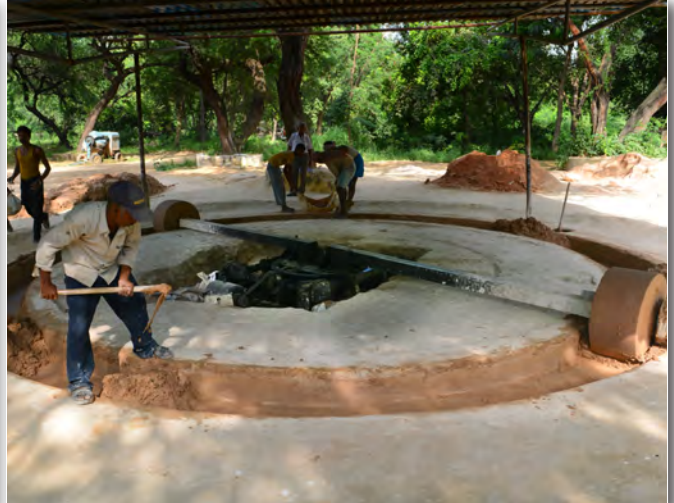
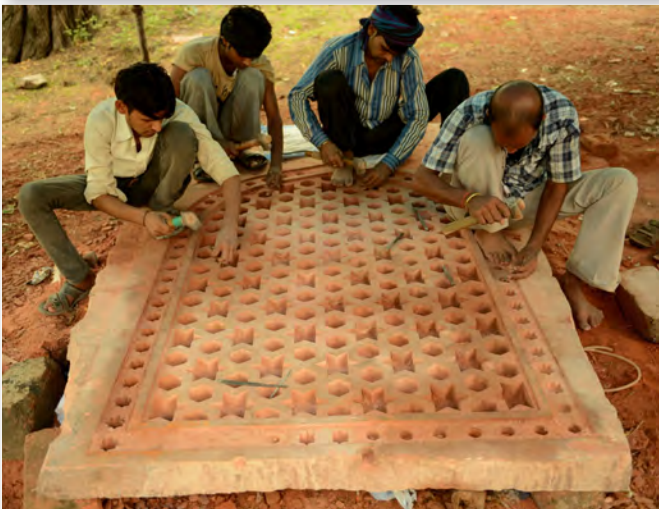
Reviving traditional building craft of Lime

The use of traditional materials, especially lime plaster – even when prepared in a traditional manner – will appear “new” at the onset, but over time the patina comprising organic growth will return on account of the jaggery, lentils, egg whites, pulp of the *bael* fruit that has been used as additives in the lime mortar. At the same time, the traditional methods will ensure the long-term preservation of these sites.

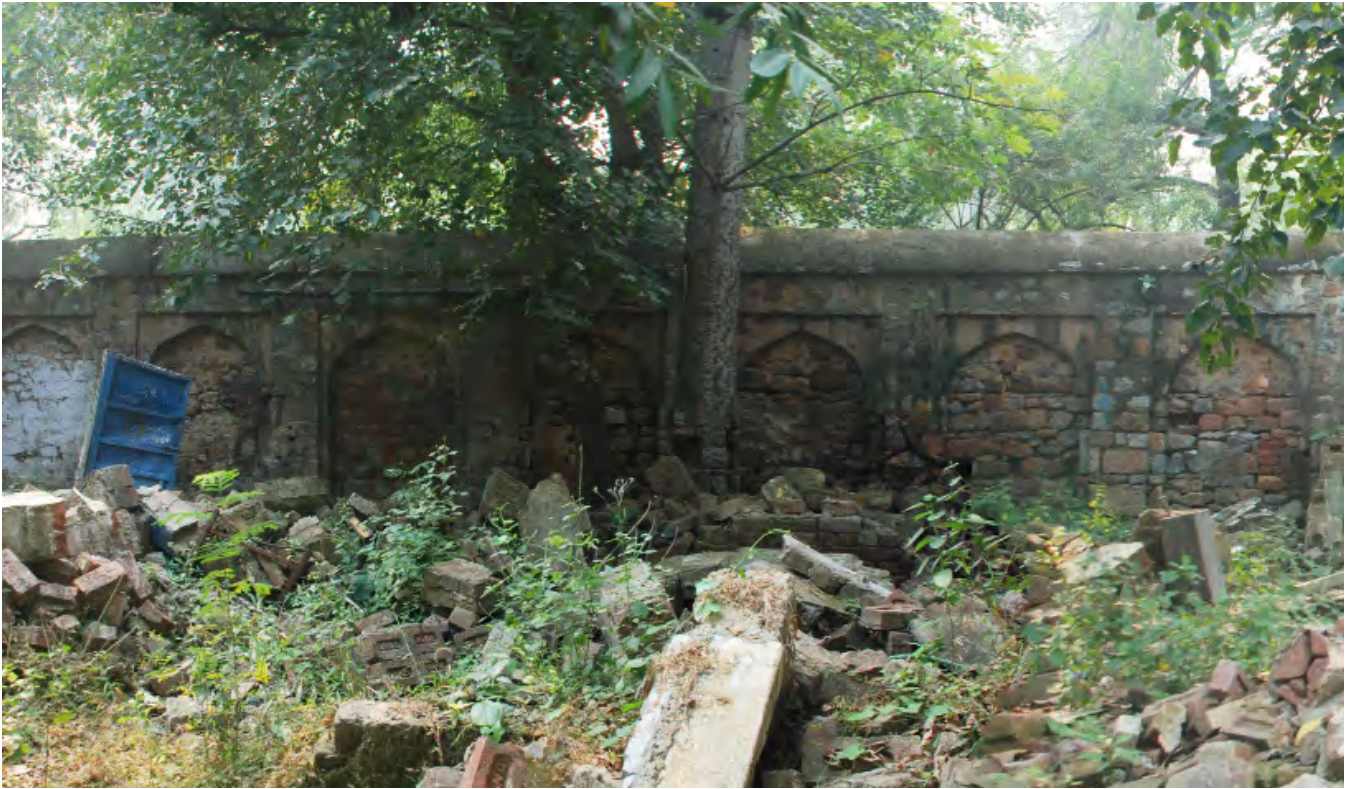
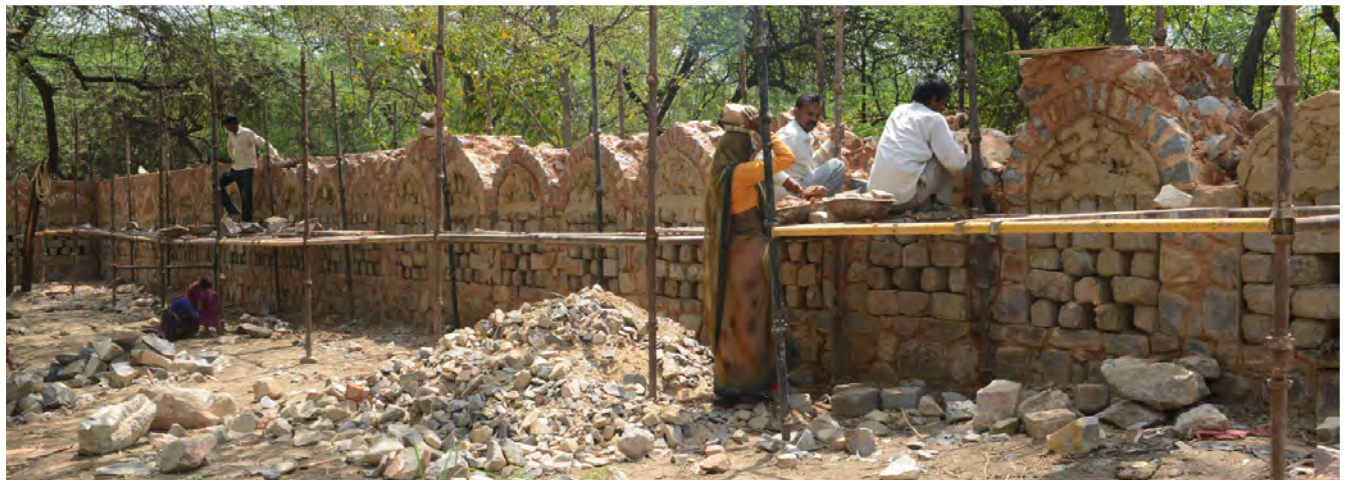
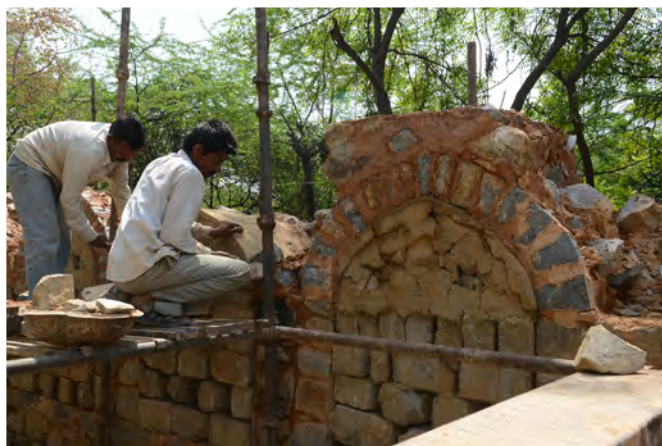
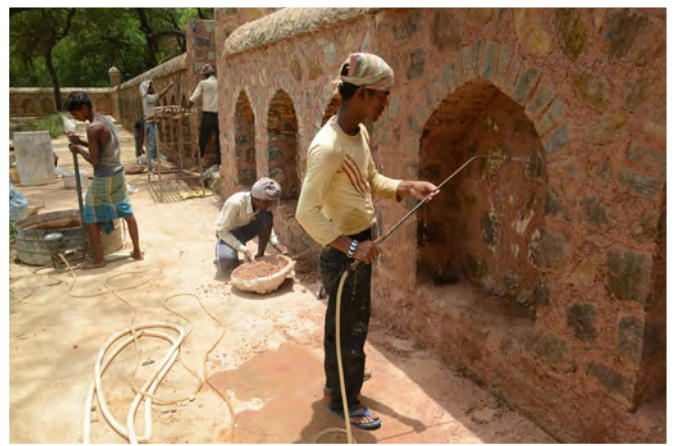
Enclosure Walls

Long stretches of the garden enclosure walls, visible in archival photographs, were demolished in 1989. The foundations of missing portions were excavated in order to guide the reconstruction of these sections. The building techniques, tools and materials employed by the original builders were also used. The bends in the wall indicate other garden enclosure walls – such as those of the adjacent domed Mughal tomb – which clearly pre-date this enclosure.

Large section of the enclosure wall were demolished in 1989 but standing portions and foundations of the entire length were discovered following the demolition of structures built in 1989 - allowing repair and reconstruction of the enclosure wall.
