Batashewala Complex

CONSERVATION & LANDSCAPE RESTORATION

BATASHEWALA ENCLOSURE

BATASHEWALA GARDEN-TOMB

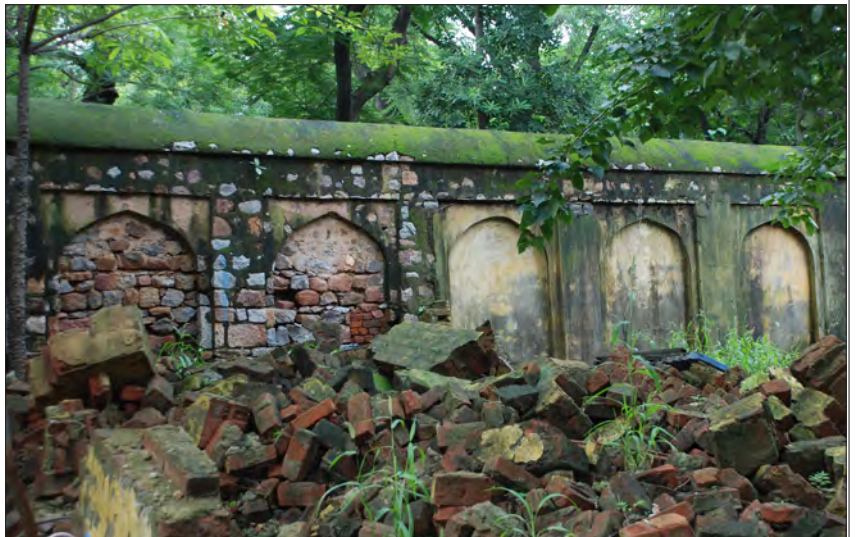
- ASI carried out demolition of over 100 structures built by Bharat Scouts within the complex and used for carrying out illegal activities.
- Conservation works commenced in November 2011 with scientific clearance of earth to reveal the foundation of missing portions of the enclosure wall.

- The entire extent of the enclosure wall has been established though foundations in certain sections were missing as new structures were built over these, thus destroying even the foundations discovered at eight feet depth.

- The Outstanding Universal Value of the Humayun's Tomb World Heritage site is understood, amongst other factors, to be an ensemble of 16th century tomb-gardens. Thus the reconstruction of missing portions of the enclosure wall that defined the significance of the complex will enhance the historic character.

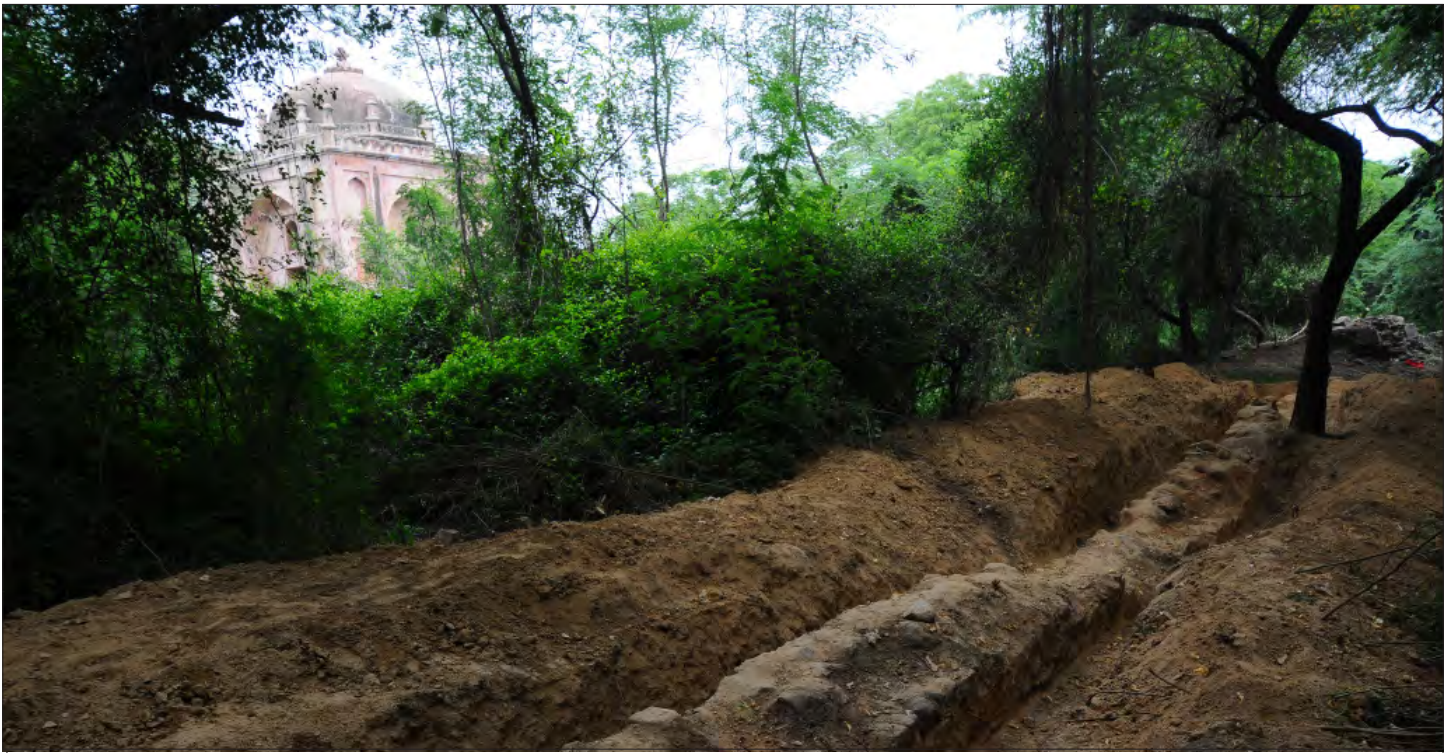
RECONSTRUCTING THE ENCLOSURE WALL

On the demolition of the 150+ illegal structures built on this land by the Bharat Scouts & Guides the southern enclosure wall was revealed. The entire stretch of the wall was also visible in early 20th century photographs taken from the roof of Humayun's Tomb. To respect the Outstanding Universal Value of the Humayun's Tomb World Heritage Site, which lies in the complex being an ensemble of 16th century garden-tombs, it was agreed to reconstruct missing portions of the enclosure wall.

- On the approval of the Conservation Plan for the Batashewala Complex by the Core Committee and the same being forwarded to the Judiciary works here commenced by removal of debris to reveal 560 m of the foundation of the enclosure wall.

- Any trees found to be standing over the wall were allowed to remain; this occurred both in the northern section and in the south-eastern corner.
- On the north-west corner, the excavated foundations, found only in parts, had a significant offset and after much deliberation, it was agreed to follow the alignment of the discovery with the priority being to restore a sense of enclosure for the Batashewala complex.

- The northern stretch of the enclosure wall has been rebuilt in Delhi quartzite random rubble masonry in lime mortar by master craftsmen using traditional building techniques.

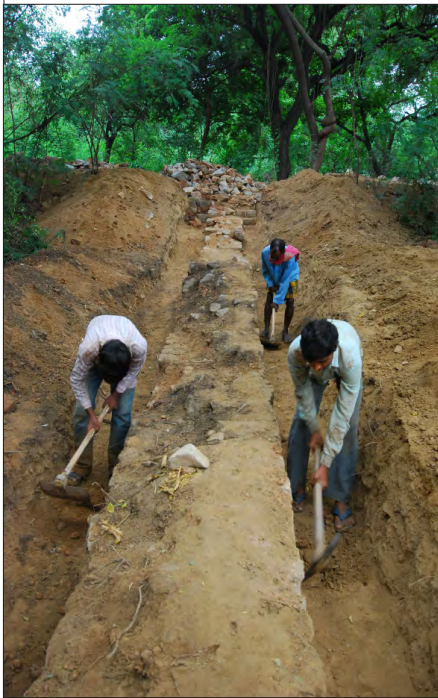
▲ On the north-east corner of the enclosure walls a historic well was discovered and this has been desilted to its original depth, conserved and enclosed within the enclosure

- On the north-east corner of the enclosure wall of Batashewala Complex, a historic well was discovered.
- After proper de-silting to its original depth, the well is now conserved and enclosed within the enclosure.

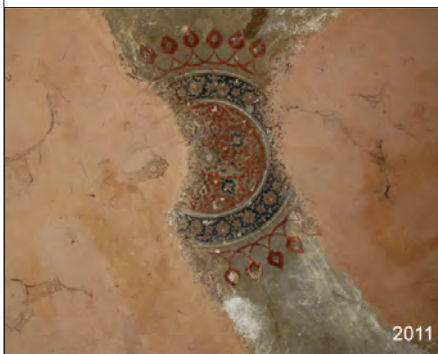
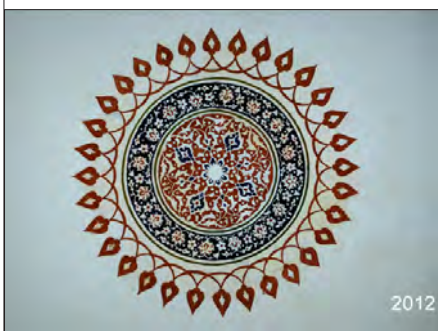
▲ Reconstruction of the missing incised plaster pattern on the dome ceiling

- The monument is significant for its decorative plaster works which include incised plaster works in the dome medallions, wall medallions, walls and arch intrados. Significant amount of decorative plaster works have in the past been replaced with cement plaster and sections were hidden under dust and soot deposits.

- At the onset of conservation works, all surviving decorative patterns were traced and documented to be used to make templates for undertaking their conservation and restoration.

- The existing patterns were cleaned using water based techniques and soft brushes to remove the added layers of dust and soot deposits. After cleaning of the decorative surfaces, original colours of the plaster were revealed and included lime white, red polychromy and indigo blue colour.

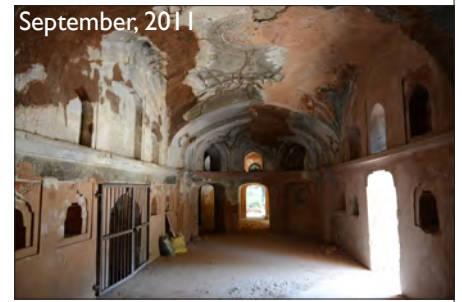
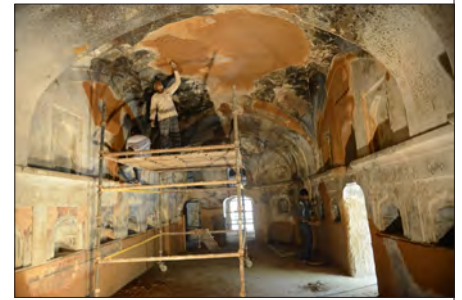
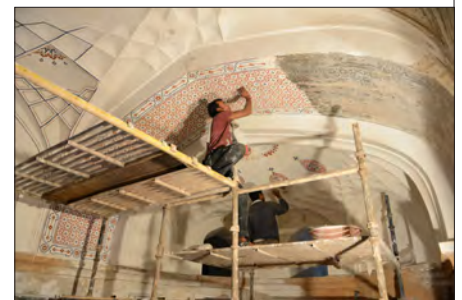
▲ Reconstruction of the missing incised plaster pattern on the dome ceiling, arch soffits and internal wall surfaces

- The conservation of the internal decorative surfaces is now ongoing which includes medallions on the dome ceiling, medallions on both the arches and niches, arch intrados and bands. Work is undertaken following the guidelines mentioned below:

- o Construction of the missing portions of the decorative works based on the existing design in the same panel
 - o Construction of the partially missing small portions in between the large areas

- o Construction of the completely missing patterns based on the existing designs on other symmetrical wall.
 - o All the profiles are under repair using matured lime putty, fine sand and brick dust. After incising the decorative profiles, these are finished with lime punning, red polychromy and blue indigo as per original designs.

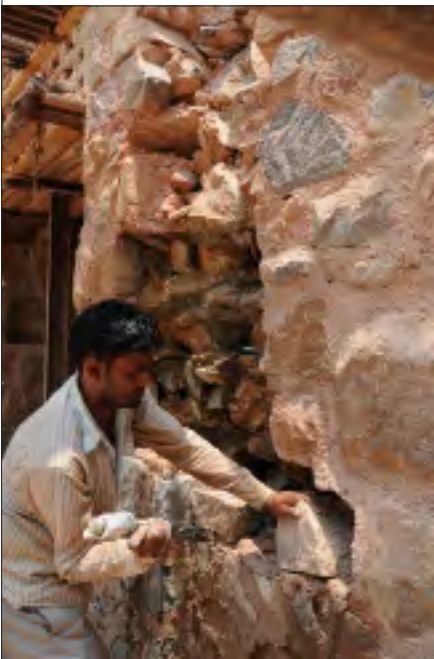
(Left) Consolidation of the collapsed portions and (Below) View of South facade of Mirza Muzaffar Hussain's Tomb during conservation

- The five half-domed bays on the western façade were in an advanced state of collapse and as with the southern façade were reconstructed to the original height of 5.7 m raising the wall levels from the existing 1.4 m level.

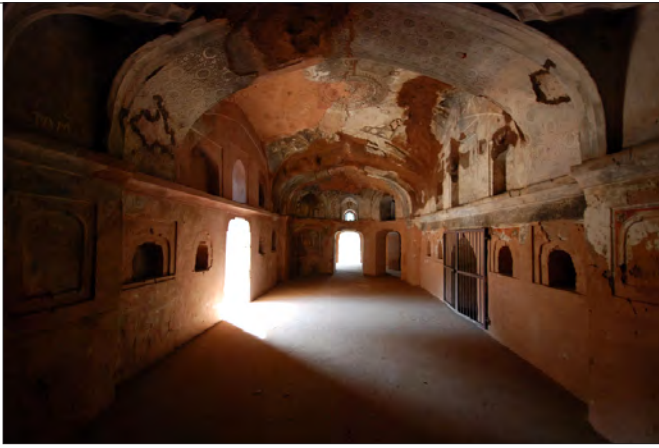
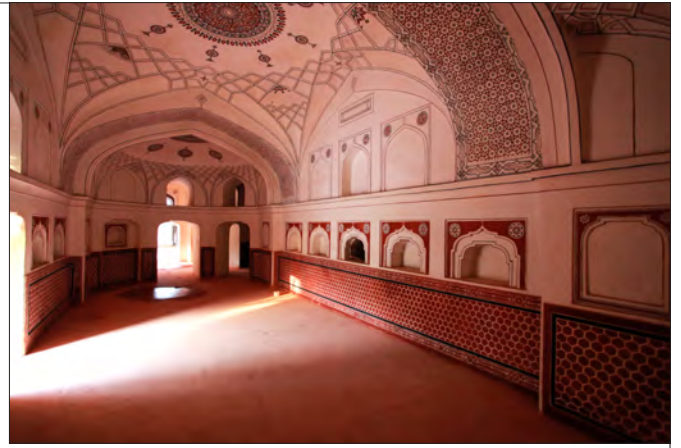
(Above) Before & After Conservation views of the internal chambers of Mirza Muzaffar Hussain's Tomb after the restoration of missing geometric patterns in incised plasterwork on the interior wall and roof surfaces

- The surfaces have now been re-plastered with traditional lime mortar after careful removal of the Cement plaster.
- The plastering layers included coarse lime mortar for the base layer and fine lime mortar for the top layer. Lime Plastering works on the internal wall surfaces including the final 1 mm coat of lime punning which comprises 1:1 ratio of lime and marble dust.

- The geometric patterns done in ornamental plasterwork have been restored where these were missing on the interior wall and roof surfaces. It was finished using fine layer of Lime punning works.

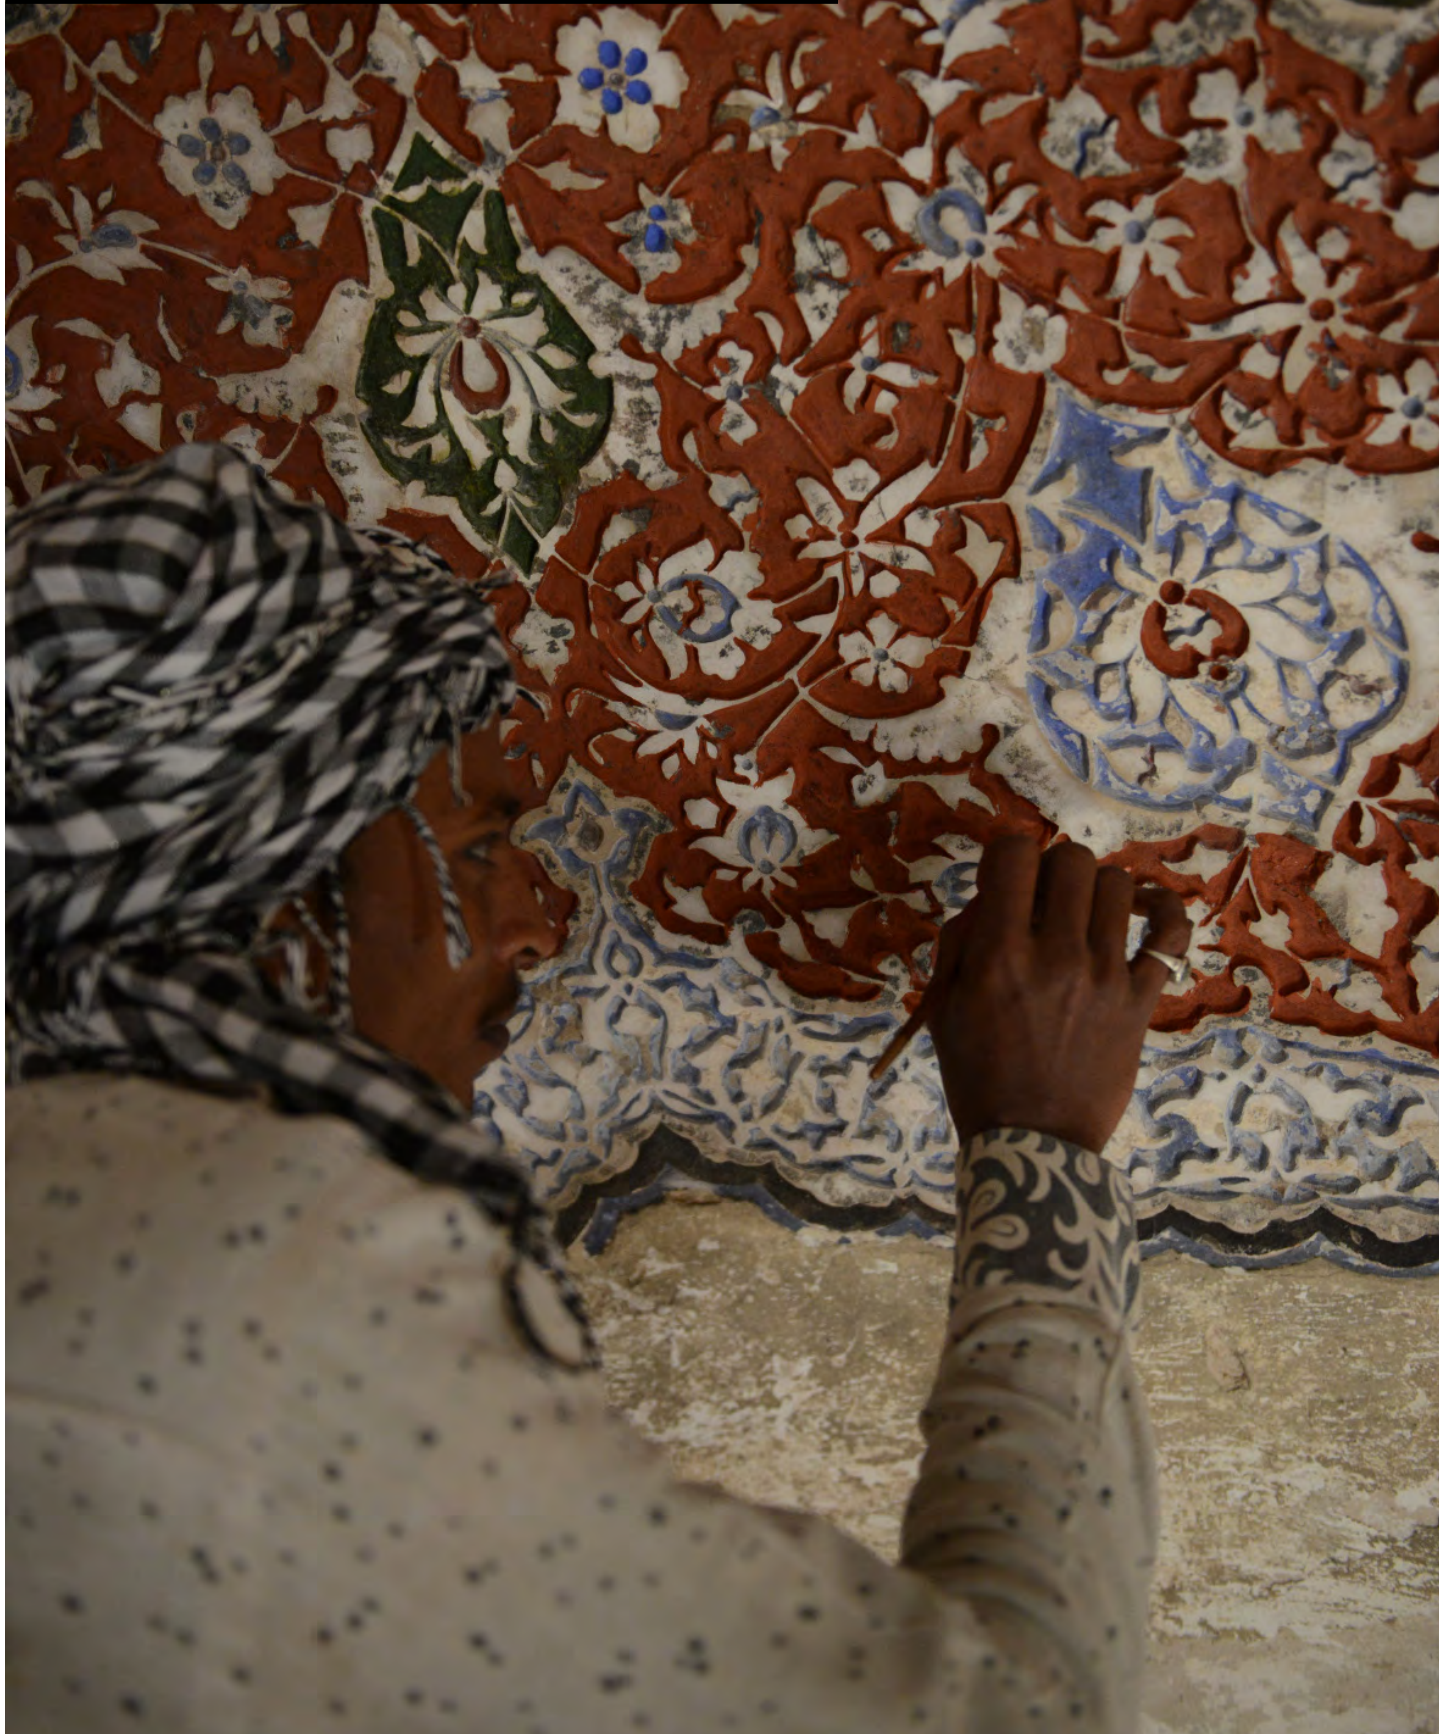
UNKNOWN GARDEN-TOMB

Located in the north of Humayun's Tomb, the enclosure wall of this Garden Tomb has been reconstructed and conservation works have just commenced on the Tomb structure itself.

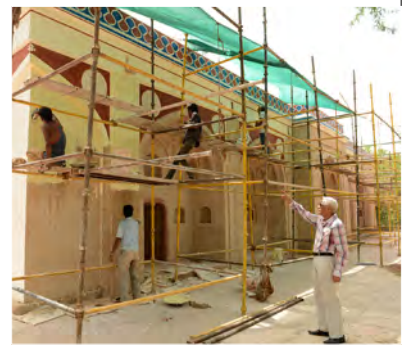
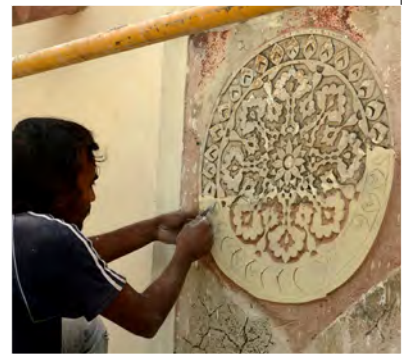
(Right) Mirza Muzaffar Hussain's Tomb is symmetrical along its central axis and thus any half facade is repeated 8 times. Conservation of the collapsed western facade was largely carried out on the basis of the standing eastern arcade.

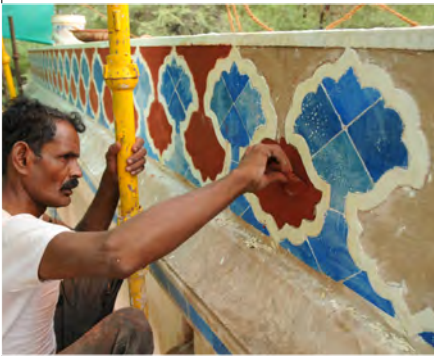
(Above) Tiles, where missing, on the parapet were restored as per the original design and specifications

- The southern and western façade repair works included reconstruction of all the 12 incorrectly built half domed bays as per original constructional details till parapet level.
- As part of this reconstruction, the *kangura* patterns on the parapet were reconstructed by replicating from the existing patterns and finished in red polychromy and turquoise tiles.
- The *kanguras* on the north and eastern façade were broken at many places and the conservation works required consolidating the *kangura* patterns. After consolidation of these patterns, the works were completed by application of red polychromy and tile works.

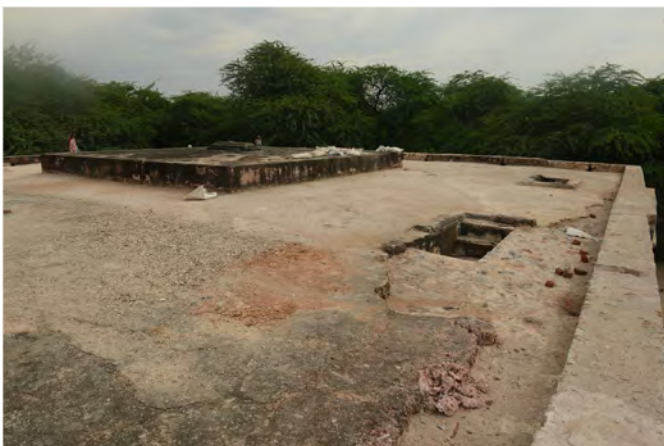
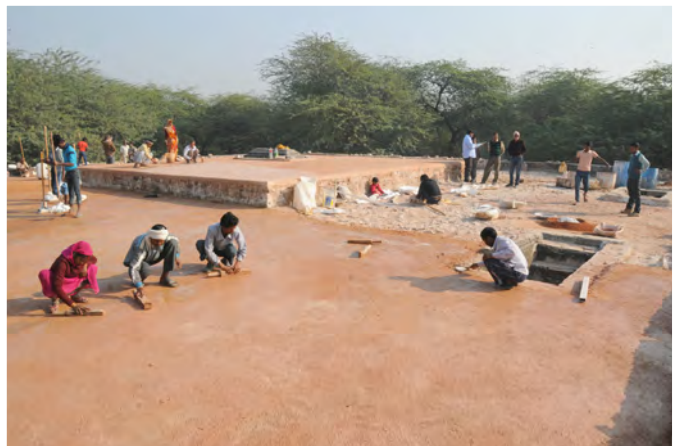
(Left) Cement concrete layers on the roof of the tomb were found to be of poor strength and inappropriately laid, therefore allowing water percolation; (Right) This was carefully and manually dismantled and lined with a traditional layer of lime concrete with brick aggregate and traditional additives and adequate slopes

- During the on-going conservation works the inappropriate past repairs carried out on the terrace like undulating multiple layers of cement concrete were manually removed and surface prepared for providing traditional lime based terrace.

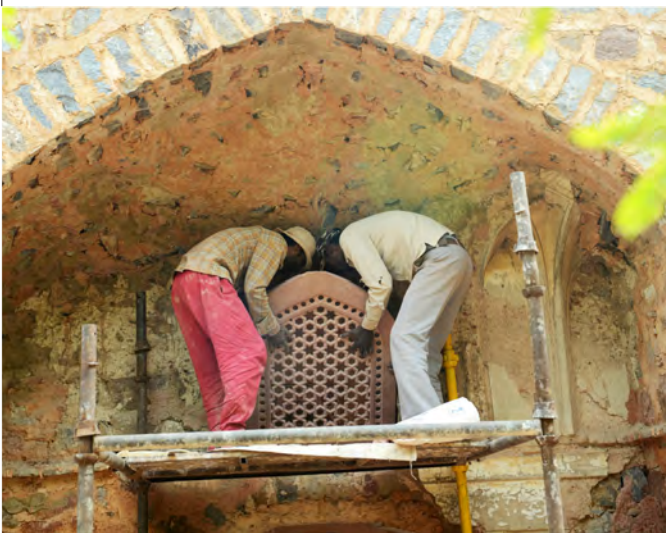
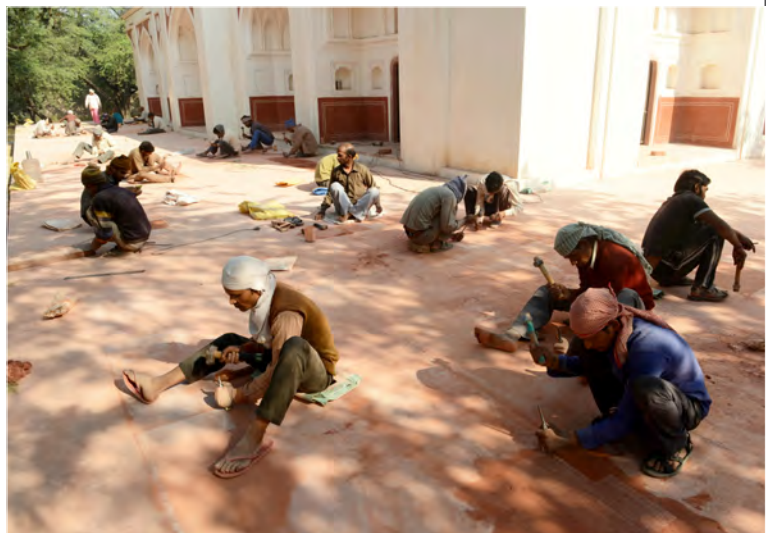
(Below) Sandstone screens, visible in archival photographs had been removed from the monument – possibly for the antique market. These have been restored as has the traditional sandstone flooring.

- After careful inspection and documentation of each arched openings, it was found that the lattice screens installed during earlier repairs varied considerably in size and are poorly crafted. Furthermore, the opening sizes were also disturbed. New sandstone lattice screens prepared individually by the master craftsmen using traditional tools have been installed in the arched openings.
- After the installation of all the hand chiselled lattice screens in the arched openings, the sandstone door frames were provided in all the central openings of all the four facades.
- Wooden doors were then installed in these openings.
- The remaining eight openings are provided with metal screens to prevent the entries of dogs and pigeons while permitting ventilation.

- It included dismantling existing concrete and preparing base using lime concrete which helped in revealing the original floor levels.
- The red sandstone of required quantities for the platform had been procured and the red sandstone flooring was provided along the length of the platform and in the internal chambers.
- The flooring works have now been completed.
- A 3m wide Delhi quartzite plinth protection is provided around the entire length of the platform. After laying the foundation, a lime concrete base was provided over which the Delhi Quartzite stone was laid.
- The Plinth protection works are now complete.

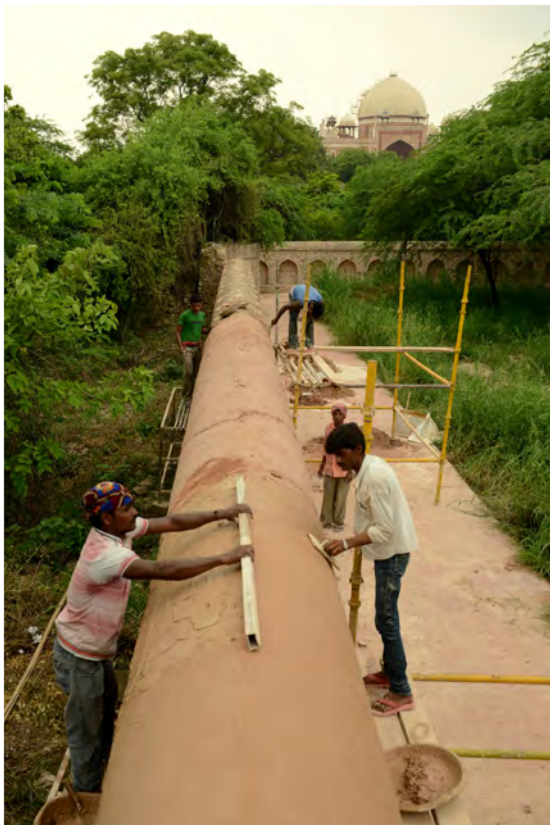
Conservation of Enclosure Wall

(Bottom Left) Stretches of the garden enclosure walls, were demolished in 1989 by Bharat Scouts and Guides. The foundations of missing portions were excavated in order to guide the reconstruction of these sections as per the design and structure of standing portions to restore the tomb - garden enclosure.

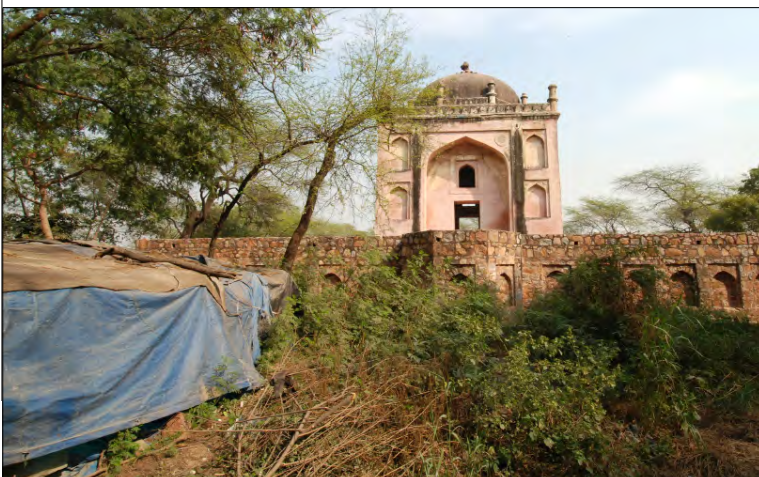
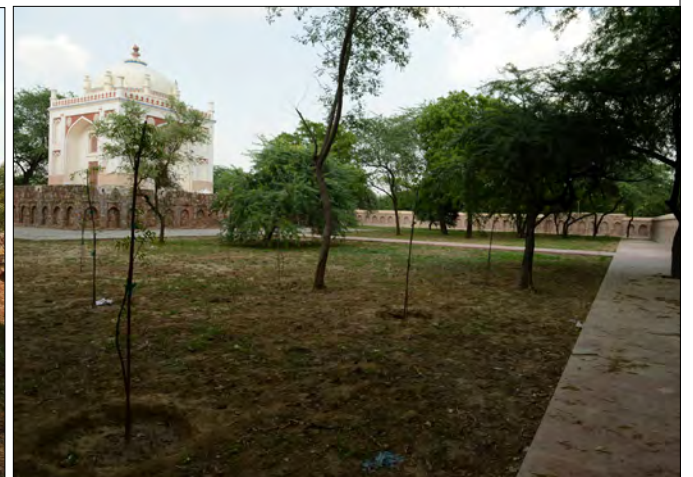
(Left) The Mughal Tomb Complex, before landscape restoration in 2011; and (Right) during landscape restoration in 2014.

- The red sandstone of 7.5 cm thickness has been provided as 3M plinth protection along the length of the enclosure wall of the monument.
- A water channel and tank discovered to the east of the tomb was exposed and repaired.
- The Delhi Quartzite stone was provided as 4.5 M plinth protection around the entire Plinth.
- Completion of all conservation works was then followed by garden restoration where sandstone pathways were laid and Neem trees were planted.

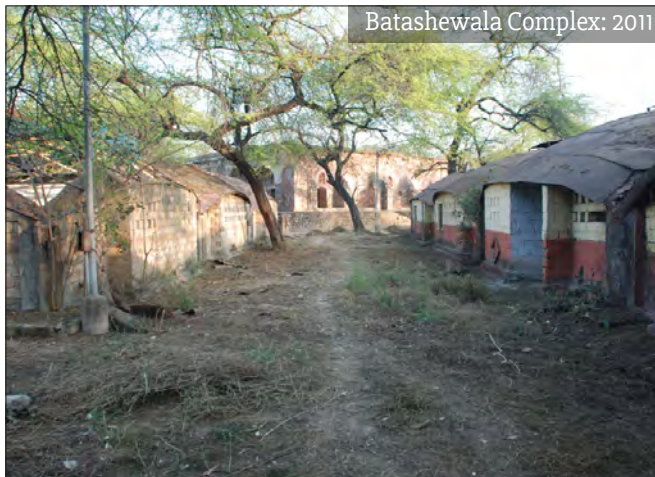
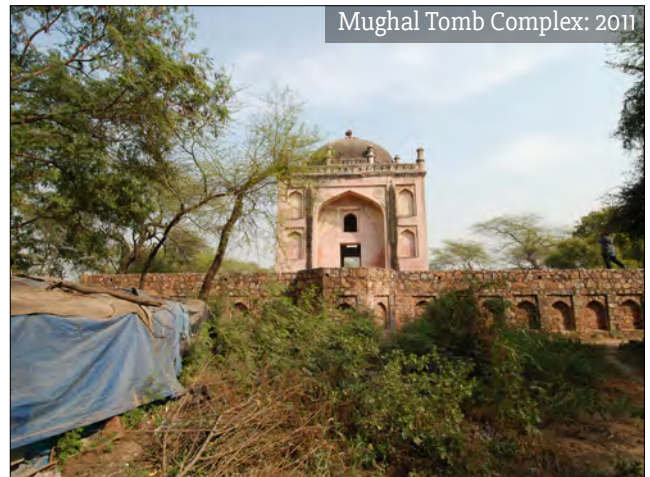
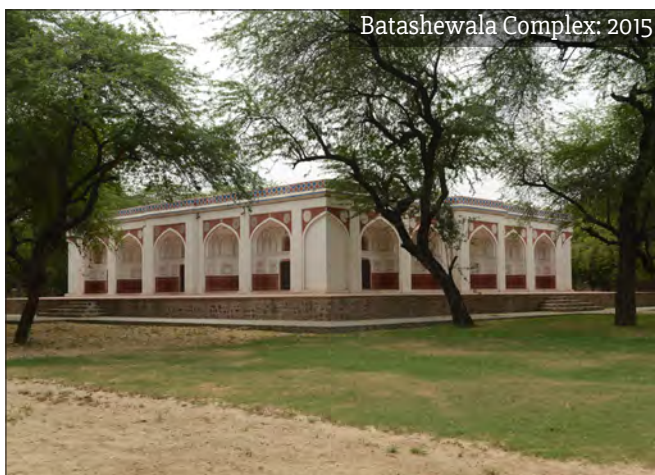
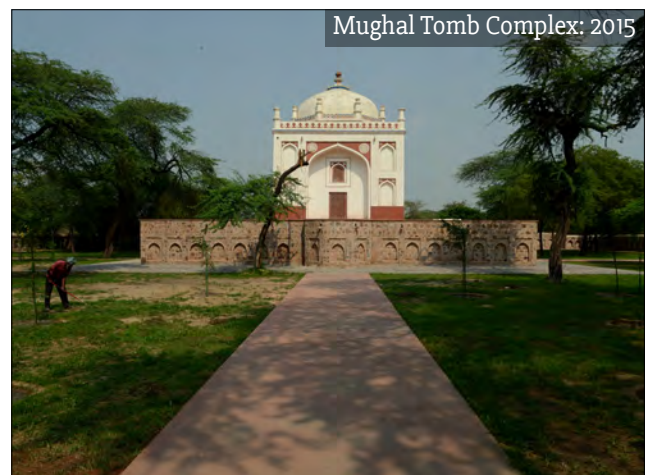
Mirza Muzaffar Hussain's Garden - Tomb

The collapsed eastern facade was restored while the southern facade – inappropriately reconstructed only a decade ago – required dismantling and reconstruction as per the original design. Similarly, the roof, which had deteriorated, was required to be re-laid with lime concrete to create an adequate slope.

Long stretches of the garden enclosure walls, visible in archival photographs, were demolished in 1989. The foundations of missing portions were excavated in order to guide the reconstruction of these sections. The building techniques, tools and materials employed by the original builders were also used. The bends in the wall indicate other garden enclosure walls – such as those of the adjacent domed Mughal tomb – which clearly pre-date this enclosure.
