**Humayun's Tomb - Sundar Nursery - Hazrat Nizamuddin Basti
URBAN RENEWAL INITIATIVE**

TOMB OF ABDUR RAHIM KHAN I KHANAN

CONSERVATION & CULTURAL REVIVAL

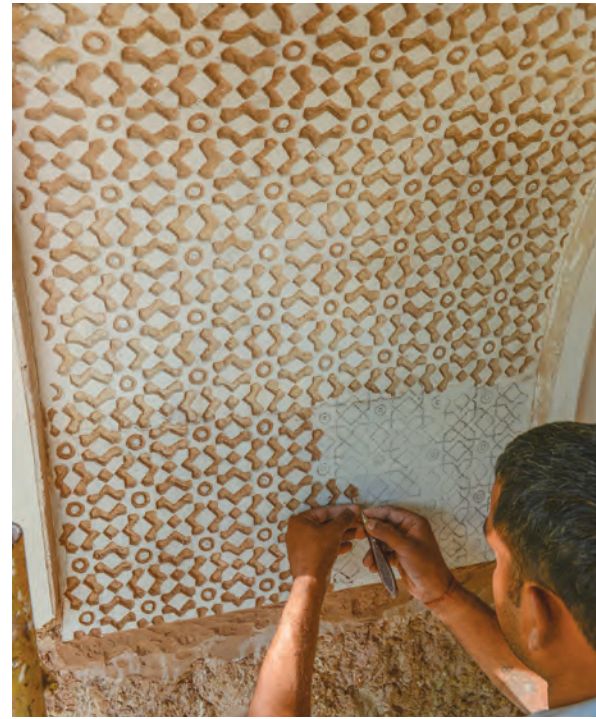
(Top) Mastercraftsman restoring the missing ornamental patterns of the lower arcade in incised lime plaster; (Centre) Craftsmen restoring the lower facade of the tomb; (Bottom) Main Tomb Chamber ceiling during conservation, where the walls and alcoves were cleaned using soft brushes and water.

On each façade are five chambers on the ground level and each of these is profusely ornamented with incised plaster patterns of varying designs. As with the plain plaster of the remaining 12 arches, the lime plaster had been replaced or even plastered over with the pink cement-*surkhi* during earlier repairs. This inappropriate modern plaster was catalysing deterioration and was thus carefully removed in 2016 from both the ground level arcade and other portions of the structure – such as the tomb chamber and roof. All original incised plaster patterns were consolidated and missing portions restored by master craftsmen using tools, techniques and materials used by their forefathers four centuries ago.

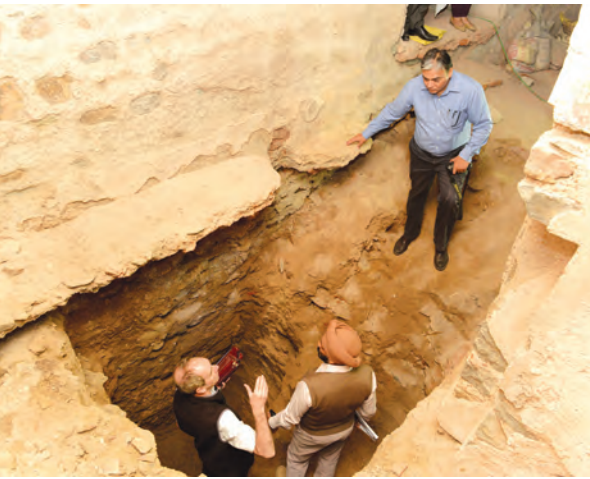
(Top) Following recommendations of the structural engineer and ASI reviews, craftsmen consolidated the foundation of the Tomb; (Centre) Craftsmen repairing deep cracks in the crypt; (Bottom) Regular meetings were held of AKTC and ASI to review the progress of conservation works. Peer reviews with over 30 professionals were held at site to discuss the conservation approach and have informed the conservation effort

With the original quartzite stone paving seen in 1923 images removed from the plinth protection of the arcade and later replaced with sandstone at a lower level, the foundations of the arcade were found to be dangerously exposed by over 40 cm. The more recent sandstone paving is now being removed and will be replaced with the authentic quartzite stone blocks –laid to the original steep slope to ensure quick disposal of rainwater away from the structure.
