Conservation of Sunderwala Burj

# Sunder Nursery Conservation

SUNDERWALA BURJ

## Sundar Burj: Looking New?

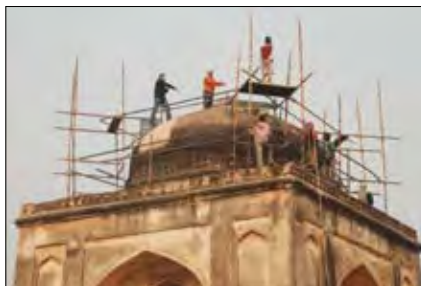
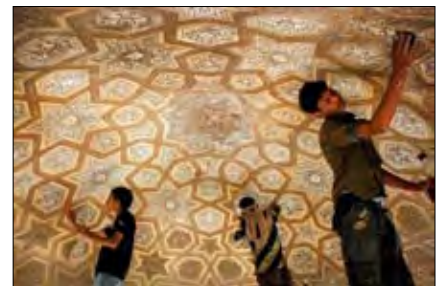
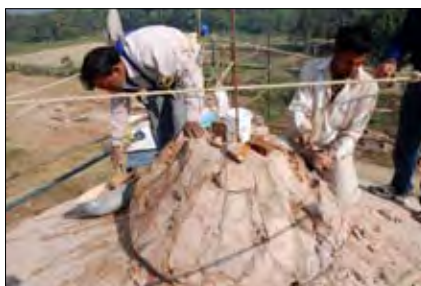
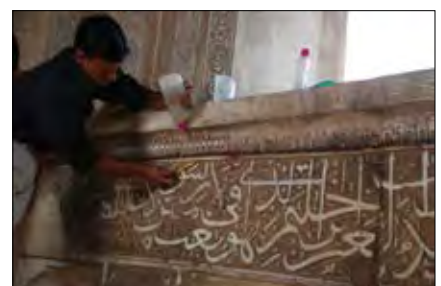
- Incised ceiling with star pattern is now cleaned with water to expose the original surface details
- Missing medallions portions on the decorative ceiling are now reconstructed in incised plasterwork
- Quranic inscription is documented to complete the missing inscription and to understand the calligraphy
- Red sand stone lattice screen are now being prepared to be fixed in the arched openings over the doorways.

- The cement or decayed lime plaster on the dome has been removed and a layer of lime plaster applied.
- The lotus finial on the dome has been repaired and reshaped.

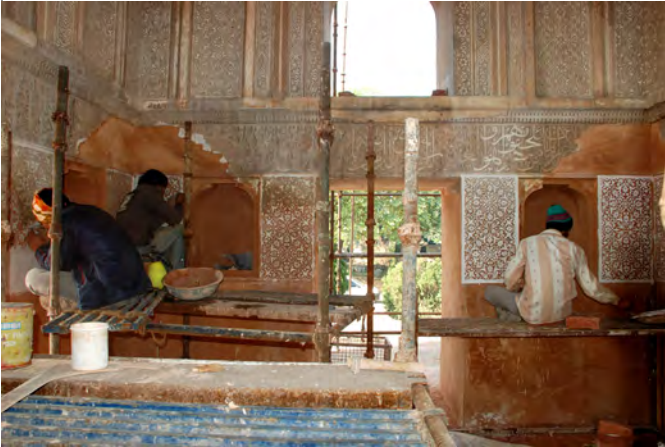
- Structural repairs including cleaning of the cracks, stitching and repairing them with lime mortar. Repairing cracks on the dome was not only required to ensure structural stability but also to ensure no further water penetration causes loss of the decorative plasterwork on the ceiling below.

- The four arched openings over the doorways originally had sandstone lattice screens which were missing at the onset of conservation works. These four red sandstone lattice screens were on a pattern used in several buildings as part of the project using traditional building tools and techniques by master craftsmen. Not only do these screens restore the intended architectural character of the building they also prevent entry of birds into the structure thus preventing decay resulting from bird droppings.

- The cement plaster layers from both the internal and external wall surfaces required to be carefully scrapped off and remaining portions of historic plasterwork carefully cleaned.

- Craftsmen were trained to restore missing portions of the decorative plasterwork on the ceiling and medallions and this plasterwork is considered the most significant aspect of the structure the restoration of which has significantly enhanced the architectural and historic character of the monument.

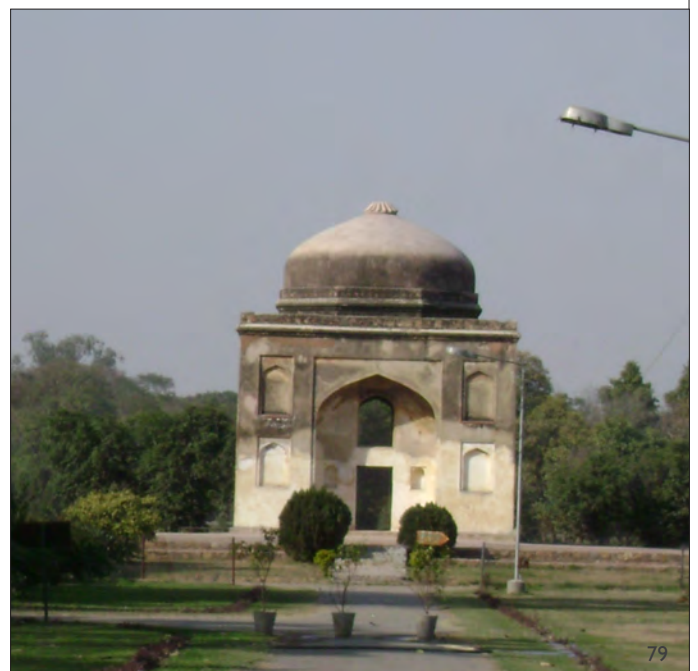
*Sunderwala Burj - before conservation. Note that cement plaster and whitewashed facade compromised the architectural integrity of the monument ►*

- Lime plastering has been completed on the external and internal surfaces after removing the cement plaster layers and replacing it with lime plaster with a finish layer of lime punning (lime +marble dust) using matured lime putty mixing with traditional additives and marble and treating with to get a finish layer.
- Restoring the red polychromy decorative patterns work has been completed which included cleaning of historic wall surfaces on external façade to expose the underneath layers of polychromy plaster and restoring

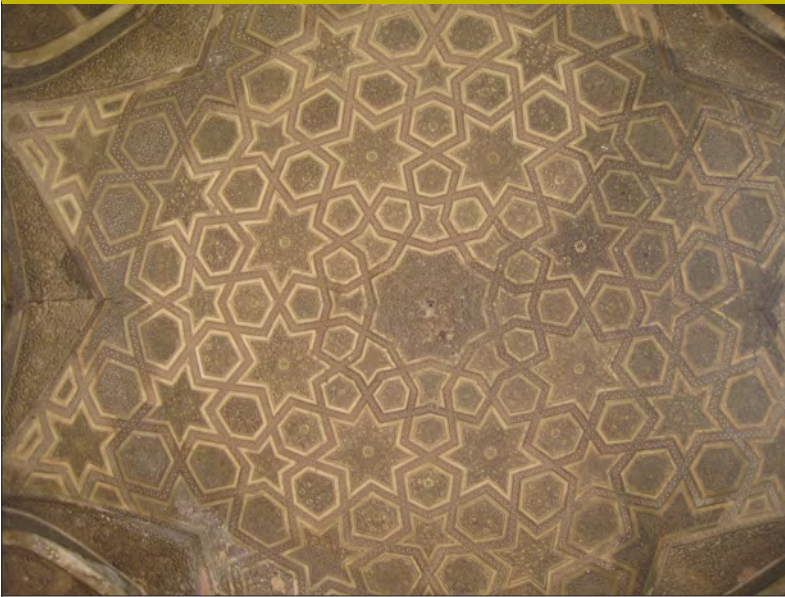
▲ Sunderwala Burj ceiling had suffered due to water seepage and repairs using cement and whitewashing

- Dome repair works included removing cement plaster from the external surface and replastering with lime mortar and cleaning and restoring missing portions of the highly ornamental interior ceiling.

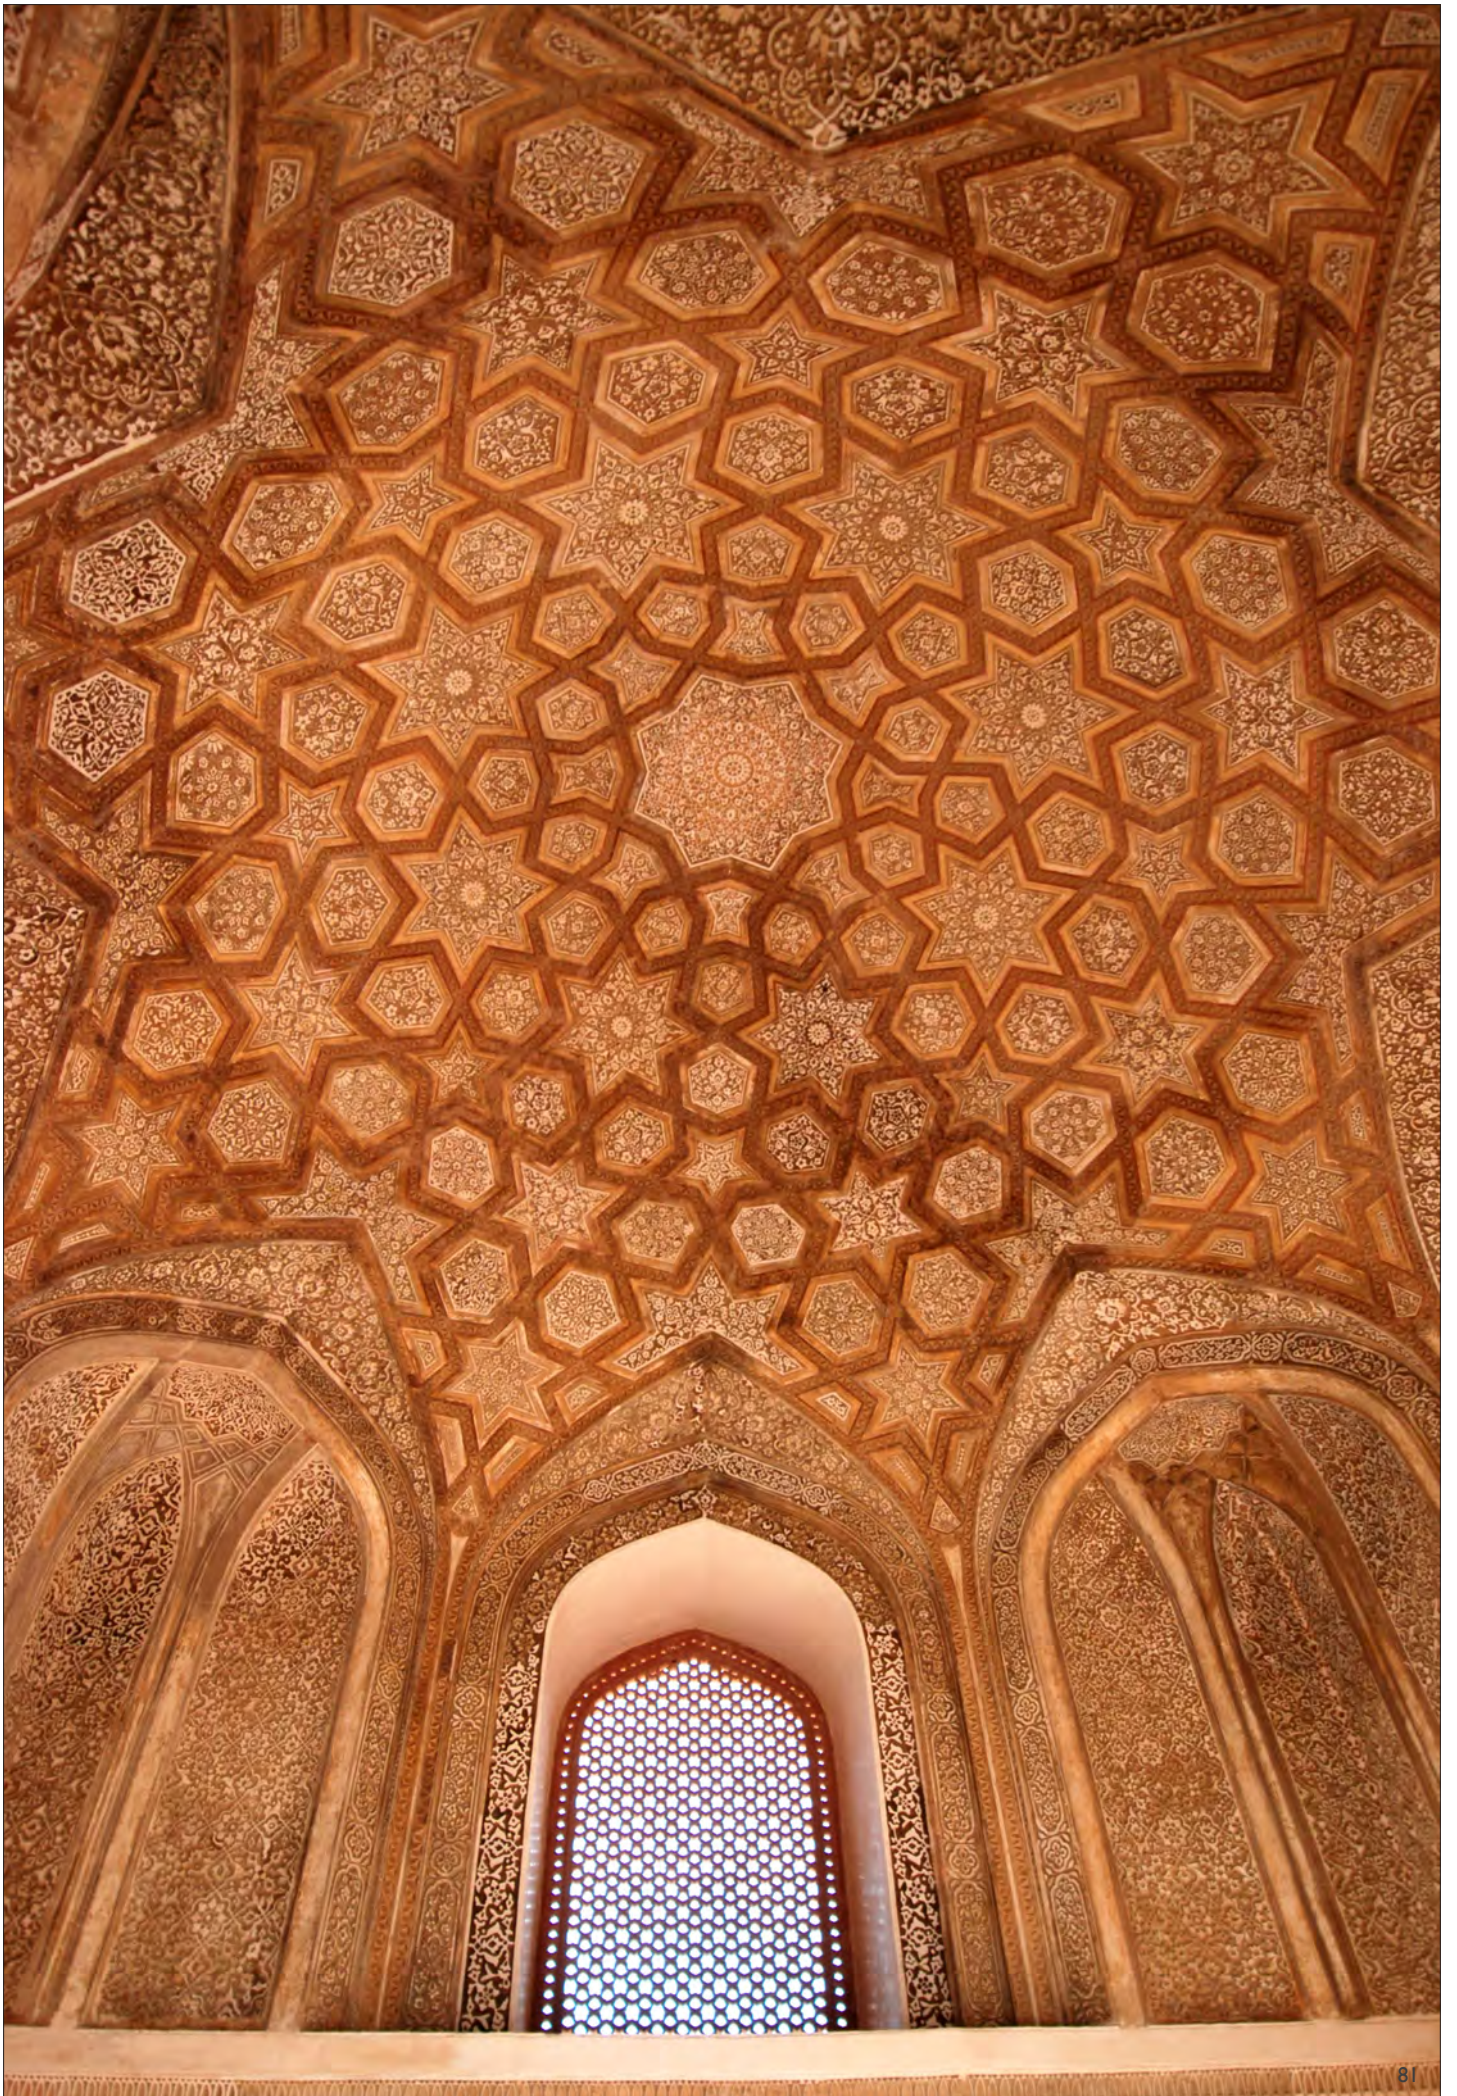
*Sunderwala Burj ceiling after conservation with missing portions carefully restored ►*

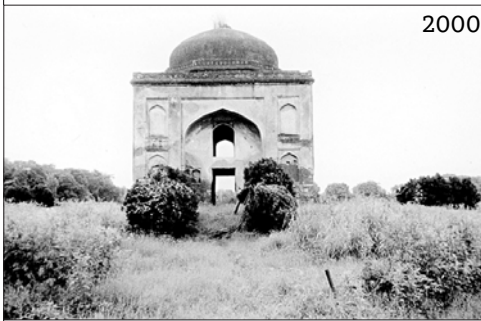
2000

Prior to major repairs carried out in 2003-07

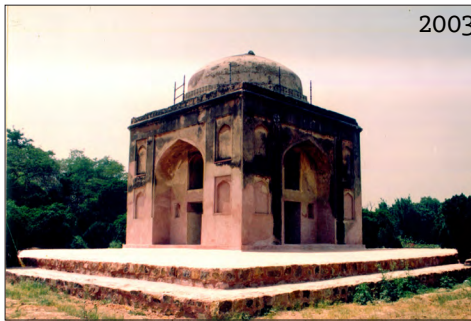
Cement repairs undertaken in 2003

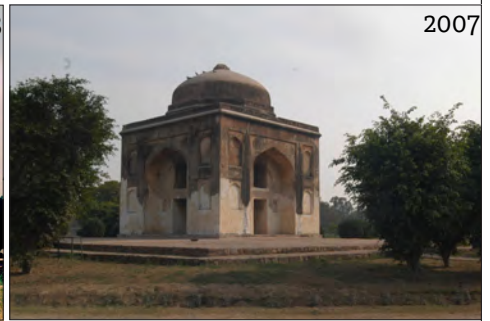
2007

2003 repairs disintegrated, requiring second phase of cement repairs

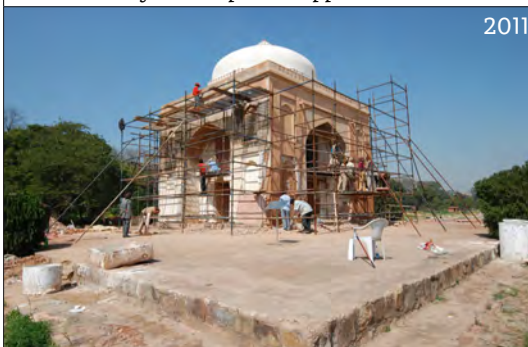
2011

Removal of cement plaster applied in 2003-07

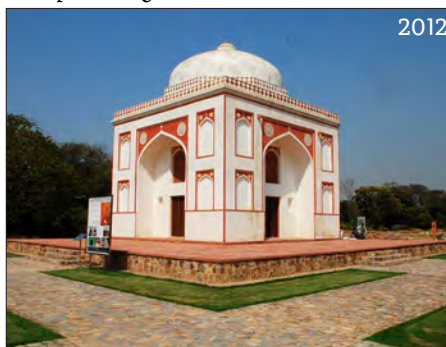
Replastering in lime mortar in 2012

Though the first few layers of lime plaster are prepared with a mix of lime with sand and brick dust, the final protective layer of lime plaster – only 1 mm thick – is composed of only lime and marble dust – both white in colour - and used by the 16<sup>th</sup> century builders to mimic the more desirable and expensive marble appearance. This application of the final plaster layer as part of the conservation effort was essential both to ensure long term preservation and respect (and thus restore) the architectural intention of the original builders.

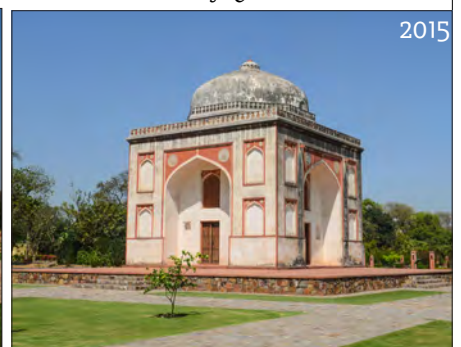
2015

Within two years from the completion of conservation works the patina of organic growth has returned to the dome of Sundar Burj.

Patina of age returns

From the onset of the project there was agreement that artificial means such as chemicals would not be applied to give a fake antique appearance to the monuments and instead the natural processes would be allowed to restore a layer of patina – organic growth - that during monsoons would naturally grow on the traditional lime plaster mixed with traditional organic additives such as egg white and fruit pulp, jaggery in the layer below. The organic growth also enhances the protective nature of the final plaster layer as it fills up any cracks that would have developed in the lime plaster
