# Sundarwala Mahal

The Outstanding Universal Value of the Humayun's Tomb World Heritage Site is due to this area being an ensemble of 16th century garden tombs of which Sundarwala Mahal is a prominent example. Conservation works on Sundarwala Mahal, which is a nationally protected monument included repair and rebuilding the western façade, restoring decorative plasterwork in the muqarnas and ornamentation, reinstallation of jallies, internal and external flooring, restoration of parapet wall.

## Sundarwala Mahal: Conservation & Landscape

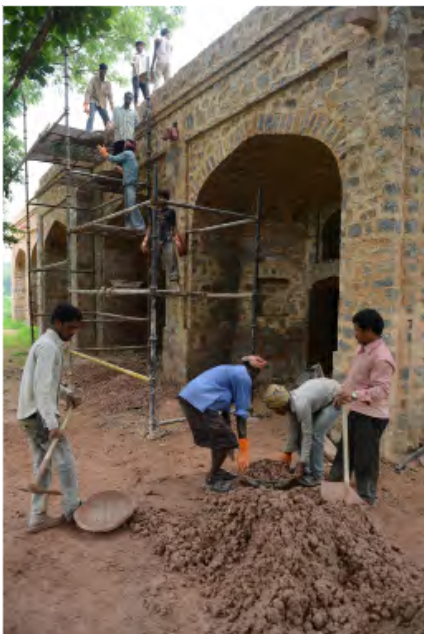
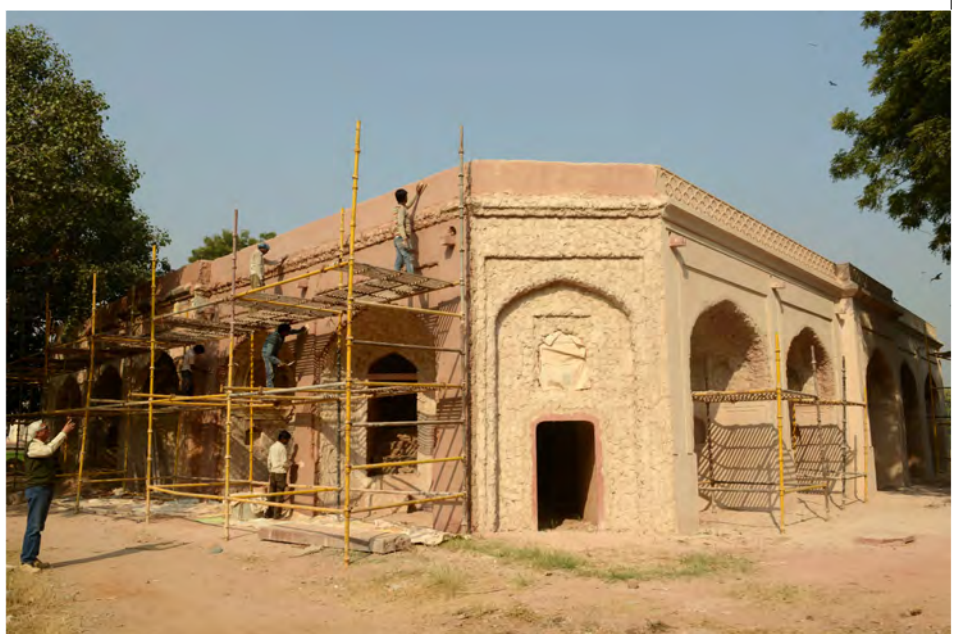
*(Below) The western façade, reconstructed by the ASI in 2001-03 was required to be demolished as half-domes had been rebuilt as arches. The structure has four identical facades.*

- Sundarwala Mahal is a square structure with corners chamfered accommodating an opening on all the four sides. Repairs carried out to the western façade about a decade ago inappropriately altered the profile of the half-domed vaulted chambers to simple pointed arches. This resulted in altering the original architectural style of the monument.
- In order to reverse the damage and ensure integrity, the modern repairs on the structure were dismantled.
- During ongoing conservation works the inappropriate reconstruction on the western façade was carefully dismantled followed by reconstructing the original profiles on each of the five bays.

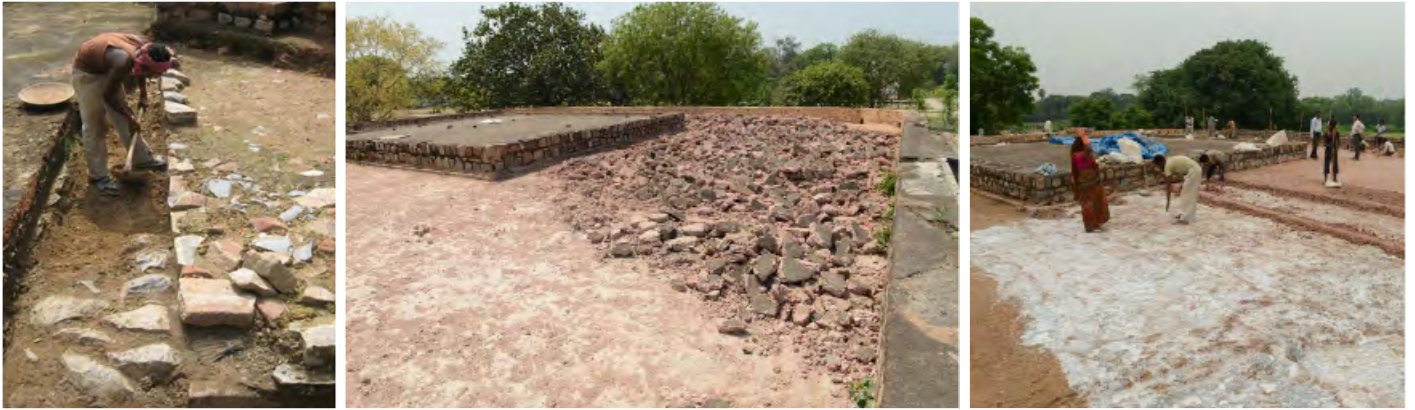
*(Left) Dismantling existing cement concrete from flooring; and (Middle) terrace and (Right) laying lime concrete. The final phase of conservation works at Sundarwala Mahal are supported by HUDCO through NCF*

- It is understood that the structure originally had only lime-concrete flooring that got disintegrated over the years.
- The task of dismantling existing concrete flooring included removal of cement concrete from the floor using non abrasive methods which helped in revealing the original floor levels.
- The red sandstone of required quantities for the internal chambers have also been procured and this will be provided once the plastering works are complete in the internal chambers.

- The inappropriate past repairs carried out on the terrace like undulating multiple layers of cement concrete were manually removed and surface prepared for providing traditional lime based terrace.
- The cement layers on the terrace layer have been removed which exposed masonry and original levels on the roof.

- After completely removing the added cement layers from the terrace, the terracing work has been started using the lime concrete comprising lime mortar and brick aggregate. Traditional organic additives such as Bael Fruit pulp, jaggery are added to make the surface water tight and as per original slopes and details.

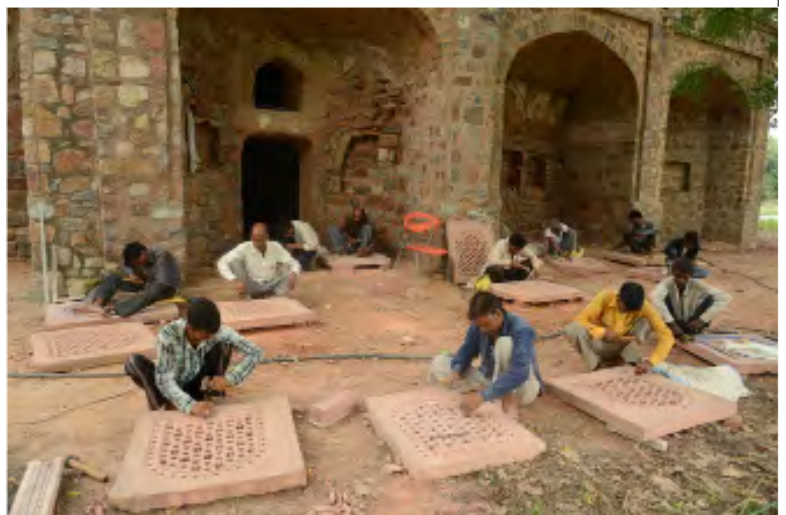
- Three archways on each façade have an arched opening over the doorway, these originally held lattice screens that seem to have been removed from here in the 20th century. These are not only important architectural elements but also serve to prevent the entry of birds.
- After careful inspection and documentation of each arched openings, it was found that the opening sizes were disturbed during earlier repairs and these varied considerably in size.
- New lattice screens prepared individually by the master craftsmen using traditional tools have now been prepared and installed in the arched openings.

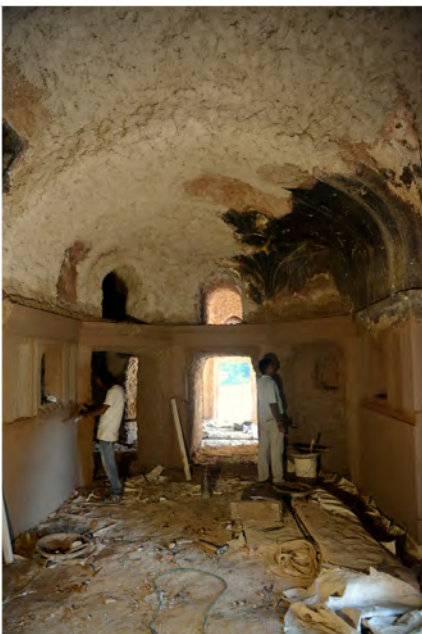
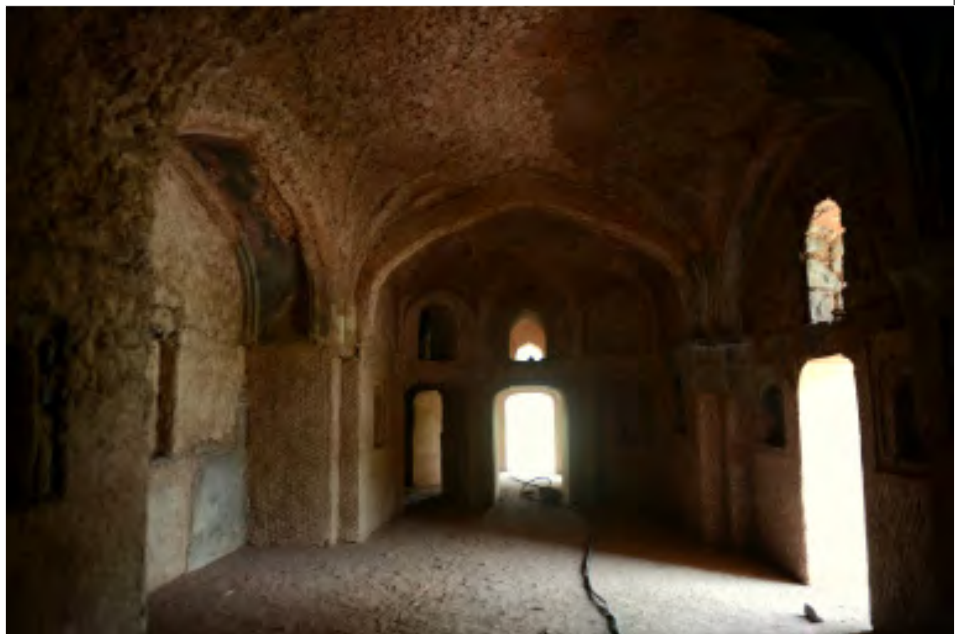
*(Below) The interior wall surfaces were required to be re-plastered in lime mortar*

- The wall surfaces were cleaned to remove later repairworks and other deposits. The cement and dead pointing works were raked out and replaced with lime mortar. The consolidation of the existing masonry was done using the lime based grouting.
- The structural repairs include stitching of the cracks, grouting and anchoring took place.
- The internal surfaces were then plastered using traditional mix of lime mortar, sand and surkhi along with organic additives.
- The plastered surfaces are then rammed to cure shrinkage cracks.
- 10% of the plastering works are now complete.

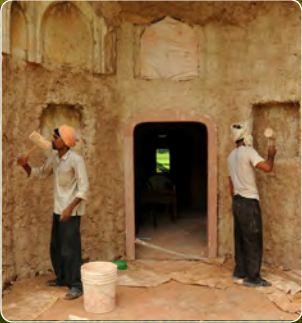
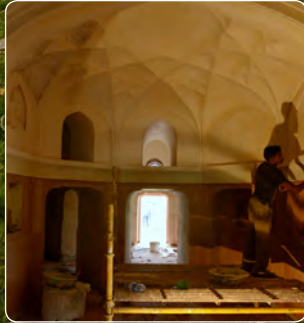
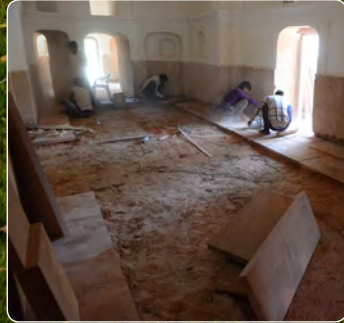
Interiors

*(Below) Sundarwala Mahal interiors - before and after conservation. Following major structural repairs, the brick-surkhi cement plaster applied here in 2003-06 was removed and replaced with traditional lime plaster layers.*
