## PROJECT CONSERVATION

## Isa Khan's Gateway (2010)

## Isa Khan's Tomb (2010)

## Isa Khan's Mosque (2013)

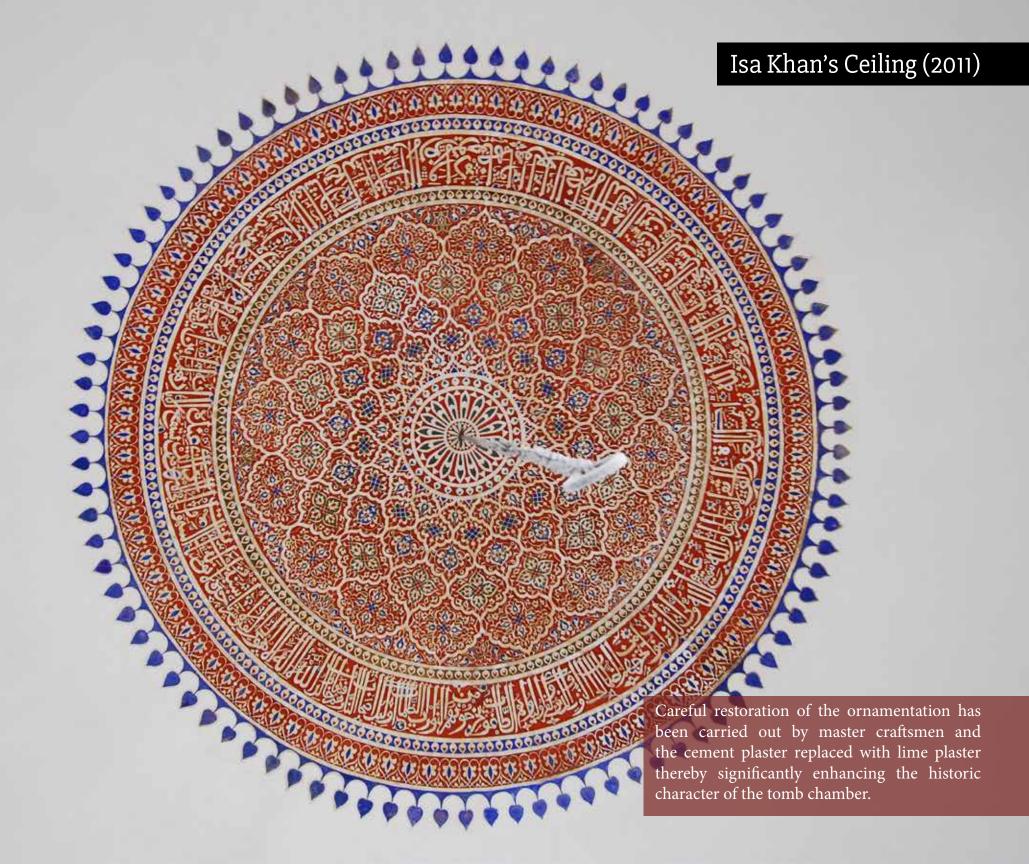
The highly ornamental ceiling of Isa Khan's Tomb had suffered severe decay due to neglect and water ingress.
