g a r d e n p a v i l i o n

SUNDER NURSERY : urban renewal initiative
 HUMAYUN'S TOMB :
 NIZAMUDDIN BASTI :

A PUBLIC-PRIVATE PARTNERSHIP INITIATIVE OF ARCHAEOLOGICAL SURVEY OF INDIA
 MUNICIPAL CORPORATION OF DELHI - CENTRAL PUBLIC WORKS DEPARTMENT
 AGA KHAN FOUNDATION- AGA KHAN TRUST FOR CULTURE

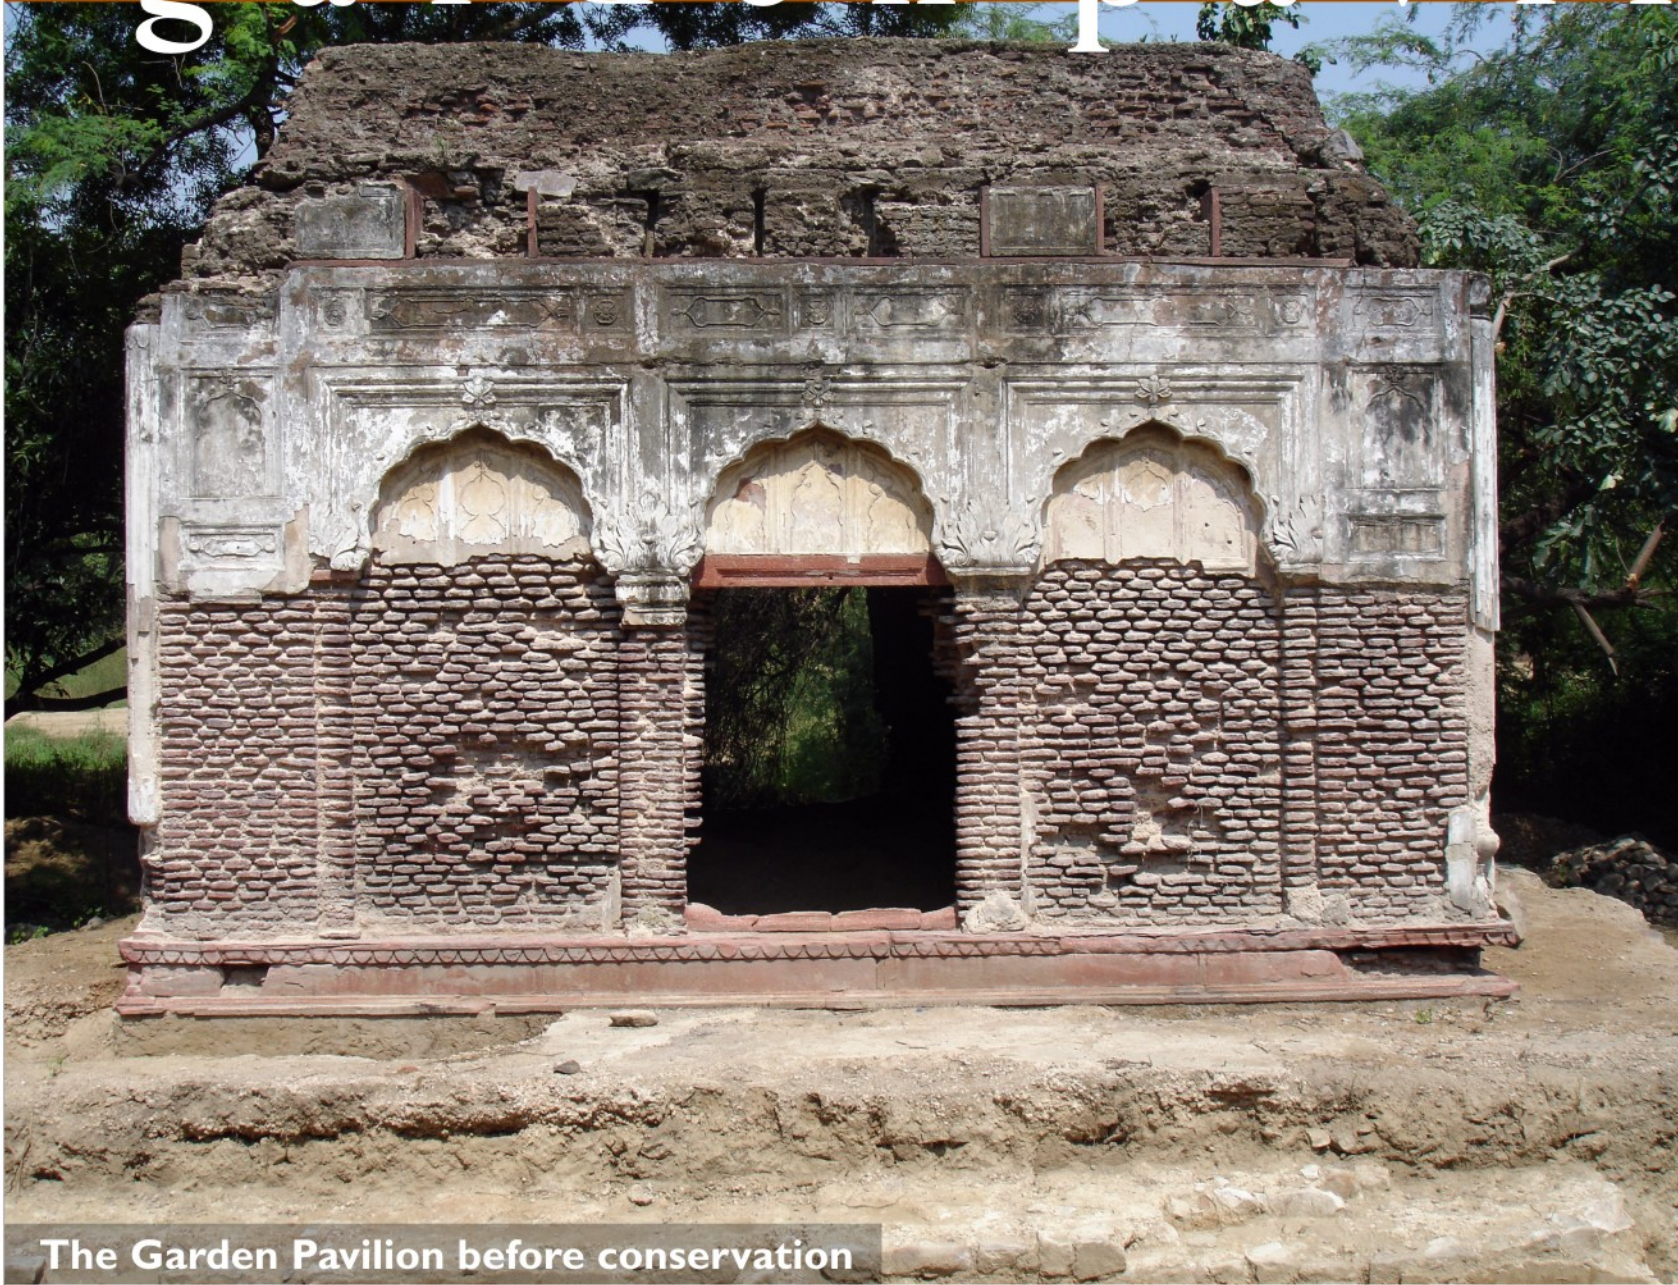
The Garden Pavilion before conservation

When the AKTC began work at Sunder Nursery, the Garden Pavilion was found in ruinous condition, threatened with demolition by the proposed construction of an extension of National Highway 24 through Sunder Nursery to Lodhi Road. Conservation works aimed at enhancing the cultural significance, ensuring structural stability and integrity of this unique building in Delhi.

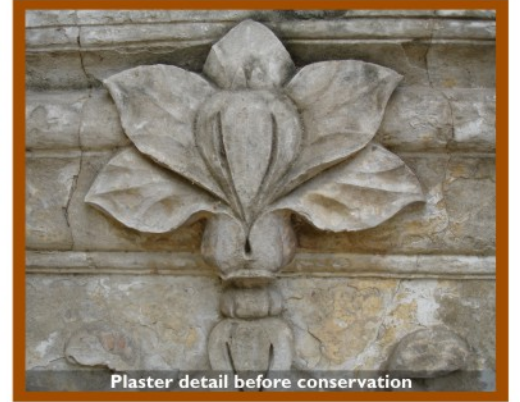
Plaster detail before conservation

A detailed documentation of the structure including architectural drawings, condition assessment and photo documentation was carried out as a first step followed by careful consolidation of plasterwork, re-installation of stone brackets on a design worked out in consultation with stone craftsmen on the basis of the lone surviving bracket, of which only 70% had remained intact. Landscaping around the garden was done to suit the modest scale of the structure and setting. Subsequent conservation works aim to restore the building's dignity.

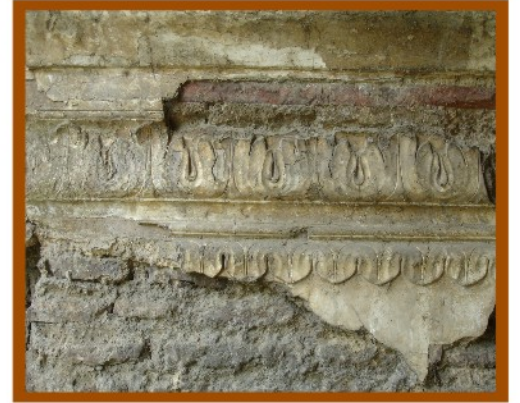
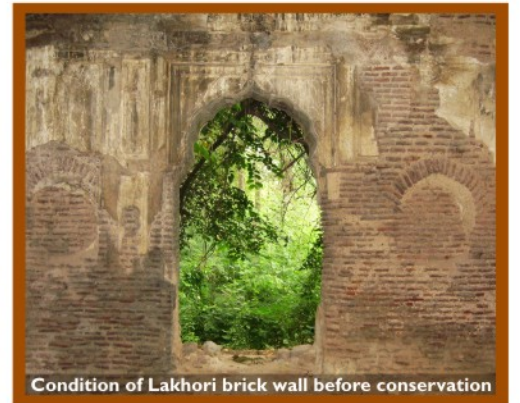
Condition of Lakhori brick wall before conservation

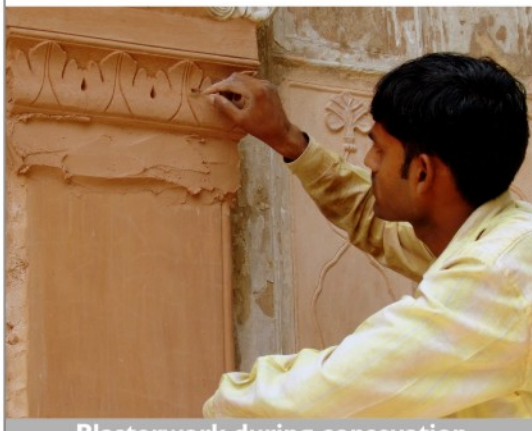
Plasterwork during conservation

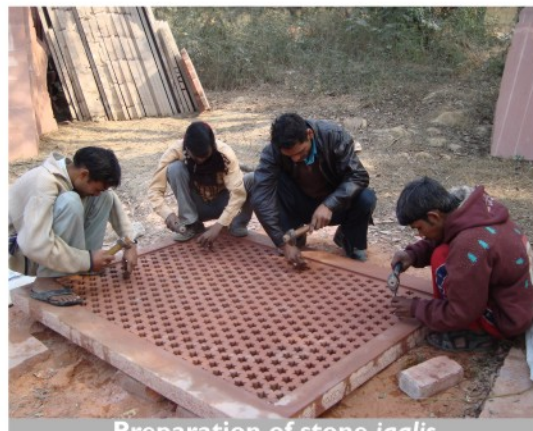
Preparation of stone jaalis

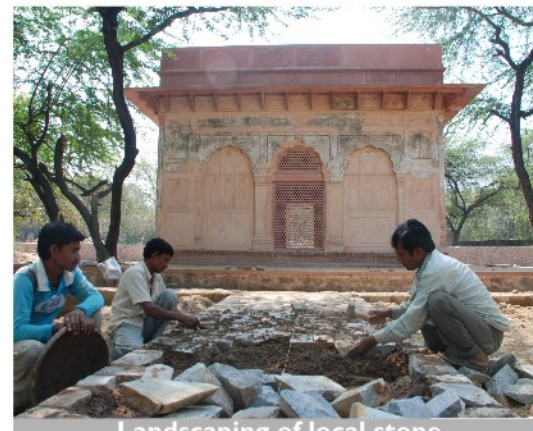
Landscaping of local stone

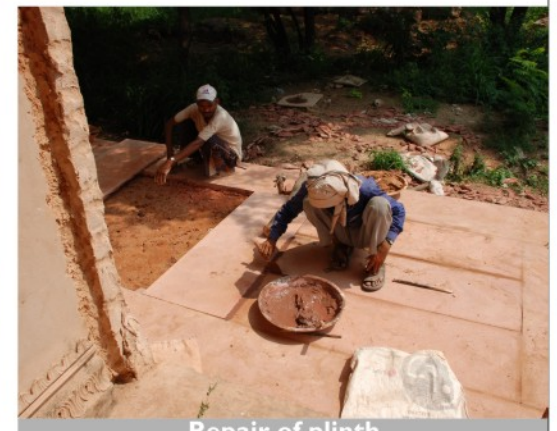
Repair of plinth
