Views of Mughal Tomb Garden in 2010-11

Mughal Tomb Garden

CONSERVATION & LANDSCAPE

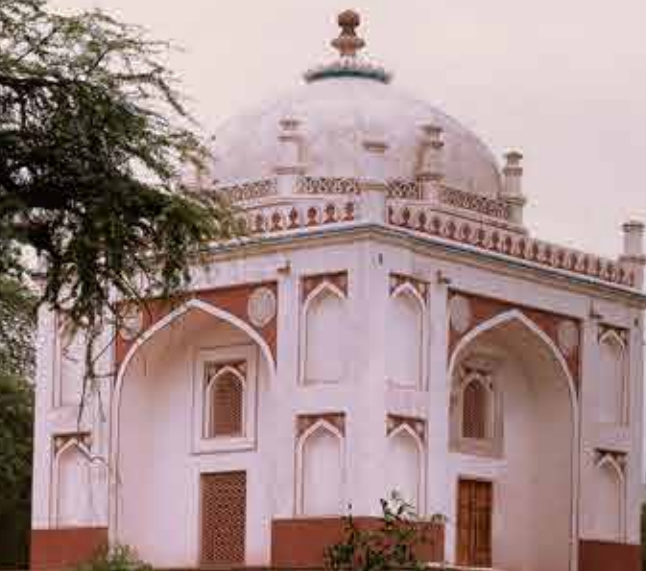
This lofty domed Mughal-era tomb stands on an elevated stone masonry plinth, giving it a fort-like appearance. The domed, decorative tomb, which is visible from afar, affords spectacular views of, and from, Humayun's Tomb.

The structure had suffered from inappropriate repairs in the 20th century. Careful interventions were required to restore the architectural intentions of the Mughal builders, including rebuilding the lower platform and removal of cement plaster, which was used here extensively.

Re-plastering with lime plaster included restoration of the intricate plasterwork on the parapet, interiors and facade. The sandstone lattice screens openings have been restored using Mirza Muzaffar Hussain's tomb as a model.

Collapsed portions of the comparatively low enclosure wall were rebuilt on the original foundations. Because the north-eastern portion had suffered from damage caused by landslides in the past, these portions were raised six metres. A neem orchard has been planted within the garden enclosure.
